Date : 05/09/2023  
Project No : 2022C106  
Client Company : CWM  
Arrival Time : 05/09/2023 12:00  
Onsite Hours : 04:00

ASEC Report ID : 59172  
Name of the Project : Taxiway 2022 Pavement Replacement  
Project Location : HJAIA  
Weather : sunny  
Departure Time : 05/09/2023 16:00  
ASEC Technician Name : Aminullah Azimi

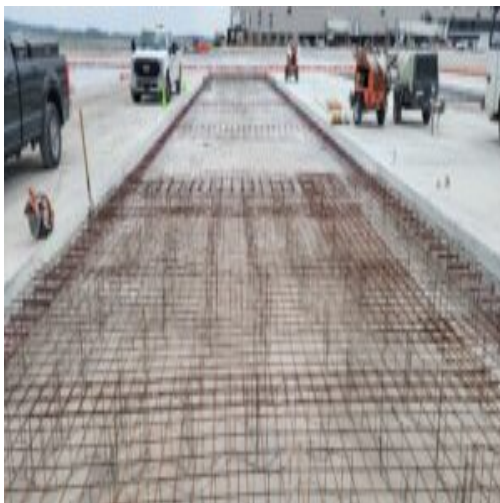
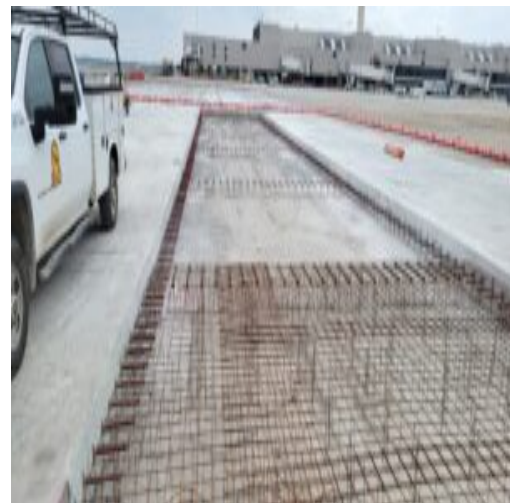
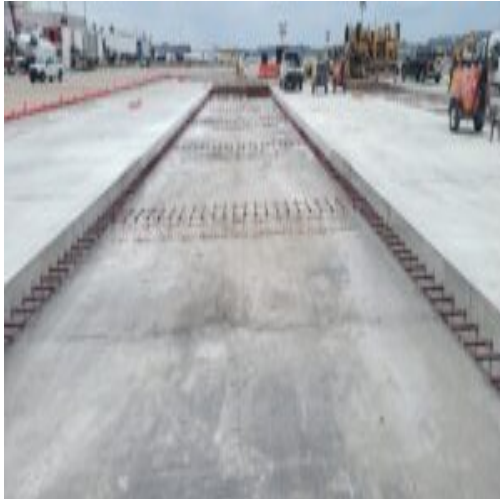
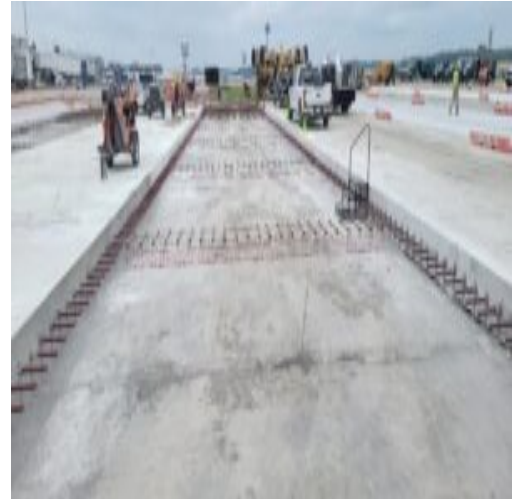
- A pre-pour observation performed in the Lane 5 and Lane 7 portions of the project was performed on this day. The contractor completed rebar and dowel basket placement for these lanes.
- The writer visually inspected the installation and setup of these lanes and advised the contractor representatives of any minor corrections that were required.
- Contractor cleaned loose rock and debris puddles of water from the base.
- Baskets were found to be level and straight and secured.
- Dowel bars have epoxy. Embedment depth was found to be 15" in concrete.
- Our representative along with Sudipto of ATLQA and the ATLNext representative Braylyn and CWM rep Brandon signed the pre-pour card.
