Date : 06/21/2023  
Project No : 2022C106  
Client Company : CWM  
Arrival Time : 06/21/2023 14:00  
Onsite Hours : 04:00

ASEC Report ID : 59903  
Name of the Project : Taxiway 2022 Pavement Replacement  
Project Location : HJAIA  
Weather : rainy  
Departure Time : 06/21/2023 18:00  
ASEC Technician Name : Aminullah Azimi

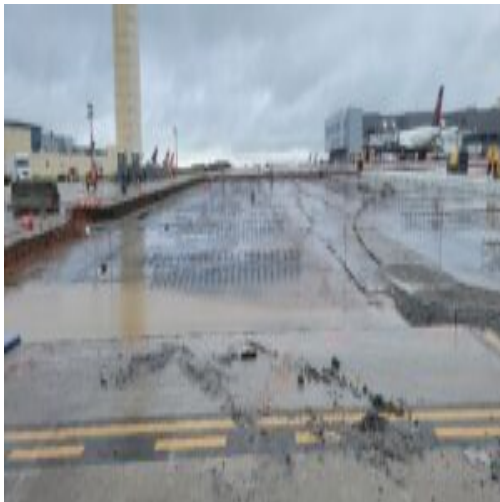
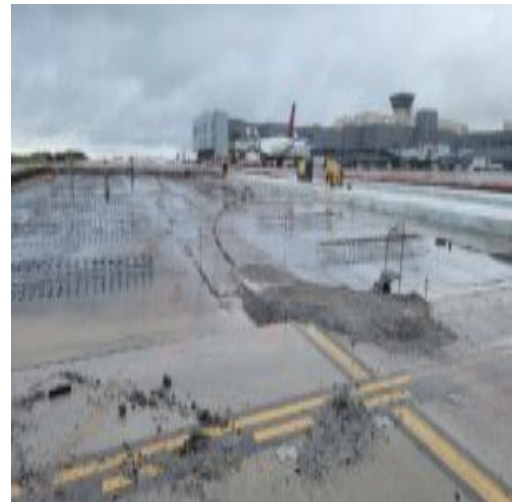
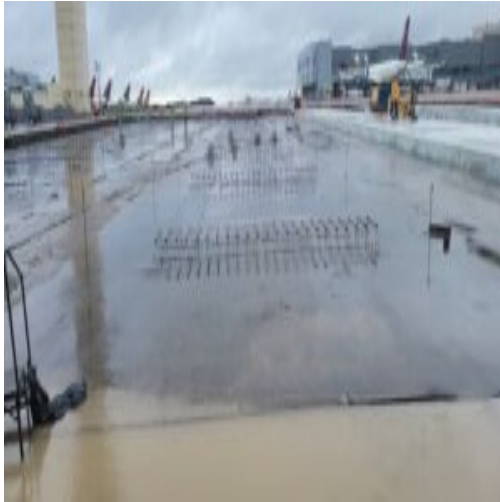
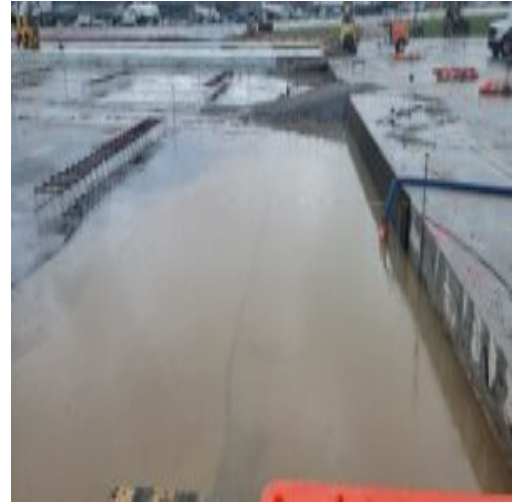
- A pre-pour observation performed in the taxiway, phase 1A, Lane 6 and Lane 8 portions of the project this day. The contractor completed rebar and dowel basket placement for these lanes.
- The writer visually inspected the installation and setup of these lanes and advised the contractor representatives of any minor corrections that were required.
- Contractor cleaned out loose rock.
- Baskets were found to be level and straight and secured.
- Dowel bars have epoxy. Embedment depth was found to be 15" in concrete.
- Our representative along with Depto of ATLQA and the ATLNext representative Cornell did not sign the pre-pour card because in the north end, lane 8 displayed water ponding which the contractor could not remove due to inclement weather. The ATL Next rep moved the pre-pour card signature to the night shift.
