Date : 04/10/2024  
Project No : 2022C106  
Client Company : CWM  
Arrival Time : 04/10/2024  
Onsite Hours :

ASEC Report ID : 65981  
Name of the Project : Taxiway 2022 Pavement Replacement  
Project Location : HJAIA  
Weather : overcast  
Departure Time : 04/10/2024  
ASEC Technician Name : Russell Hendrix

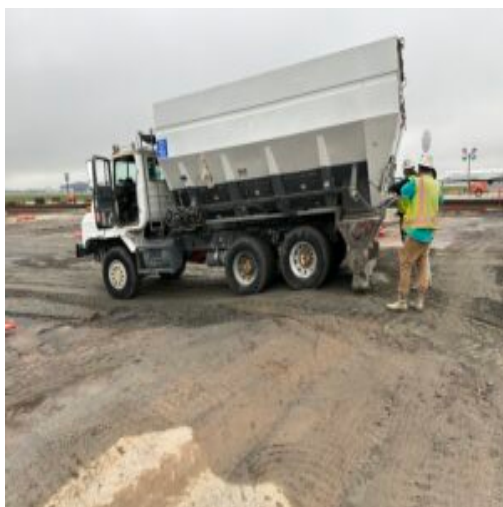
1. **Cement Truck Issues:** Initially, issues were reported with the cement trucks, as documented in the provided photo. However, these issues were later resolved, allowing work to proceed.

Cement truck issues

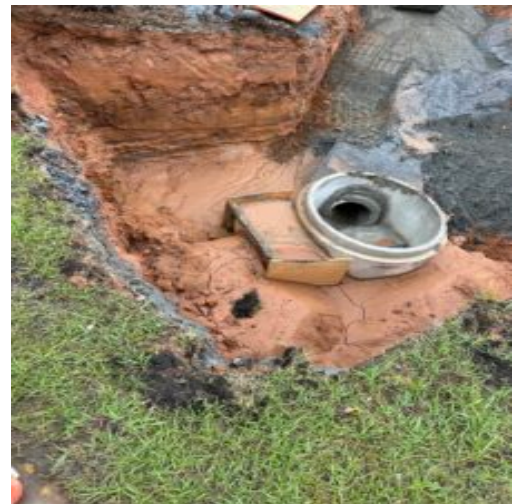
4. **Safety Meeting:** A safety meeting was conducted with CW Matthews safety manager and the project manager, necessitated by a site-wide shut down.
5. **Moisture Issue at A4:** Quality Assurance (QA) identified high moisture soil around A4, prompting its removal and replacement with No. 89 stone, as evidenced in the provided photo.

soil with high moisture content/request for removal  
at A4

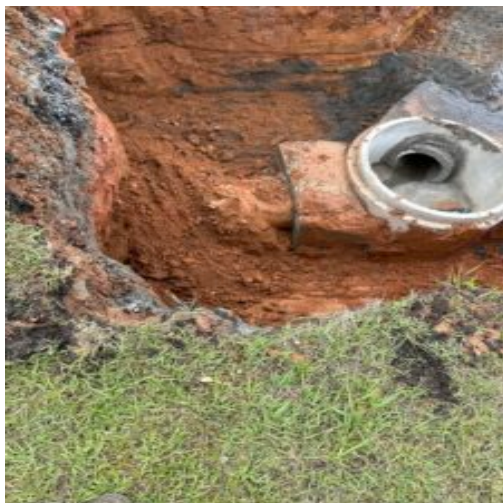
high moisture soil removed at A4

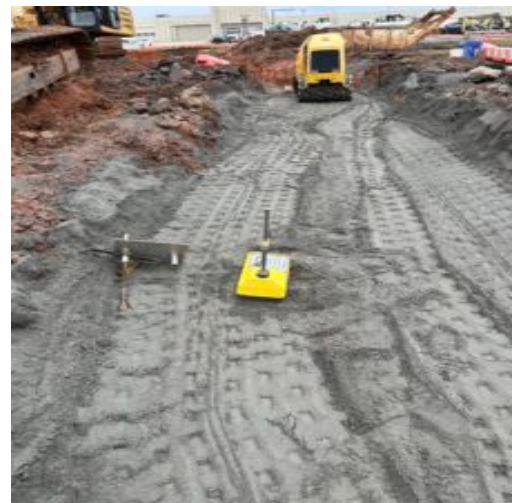
testing

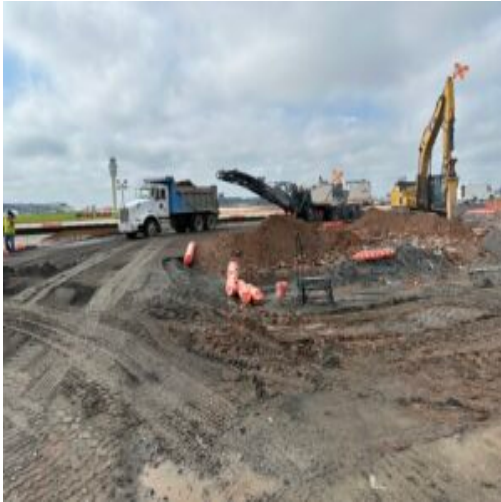
2. **Pre-pour Card:** No pre-pour card was completed due to an impending rain event.
3. **Asphalt Milling:** Asphalt milling was underway on the west shoulder at various depths, as illustrated in the attached photo.

Asphalt milling

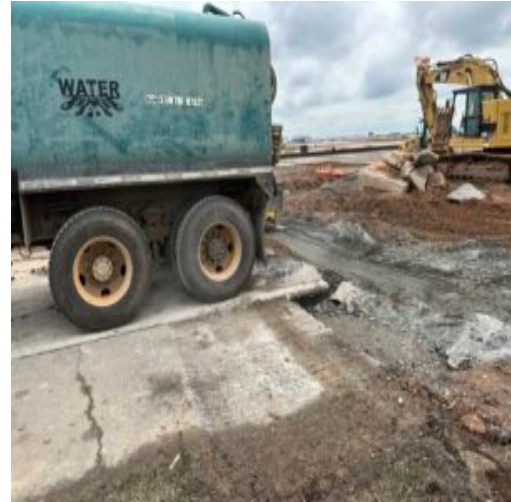
Water truck

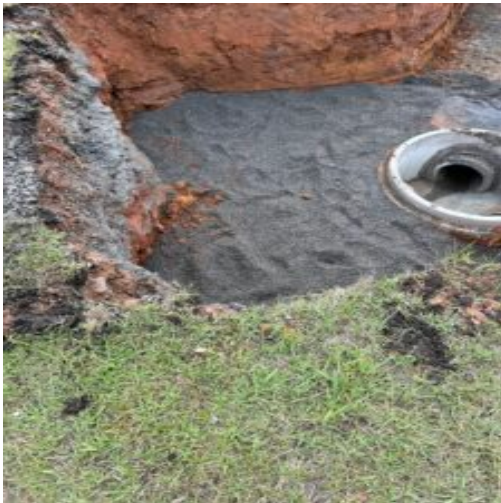
High moisture area with 89 stone after soil removal  
at A4

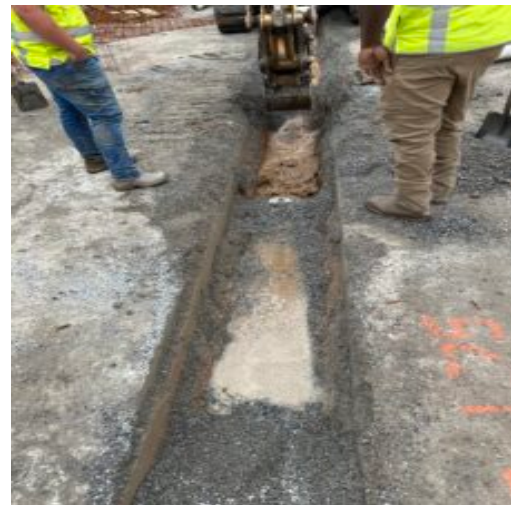
7. **Underdrain Elevation Issue:** It was discovered that the underdrain near 972.500 was placed at an incorrect elevation. Excavation began on site to address this issue, but completion was pending as the extent of the incorrect elevation had not been determined at the time.

Underdrain issues

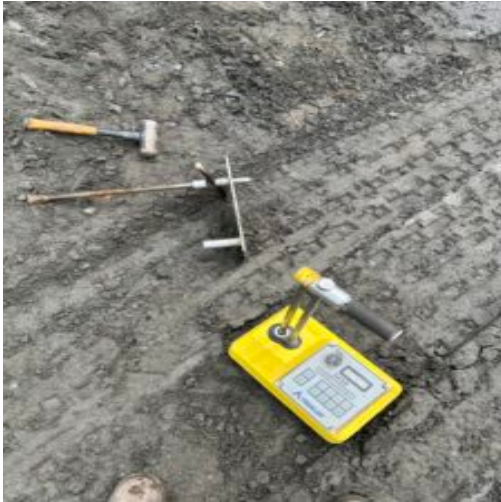
testing

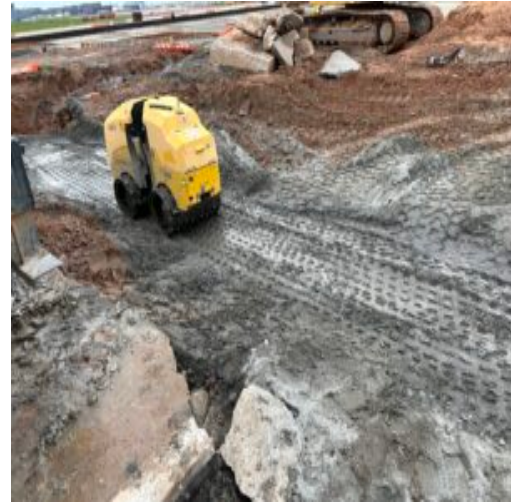
Trench packer
