Date : 02/07/2023  
Project No : 2022C174  
Client Company : CWM  
Arrival Time : 02/07/2023  
Onsite Hours :

ASEC Report ID : 57357  
Name of the Project : CWM Plant on Mulberry Rock Road  
Project Location : Dallas, Paulding County  
Weather : Sunny  
Departure Time : 02/07/2023  
ASEC Technician Name : Russell Hendrix

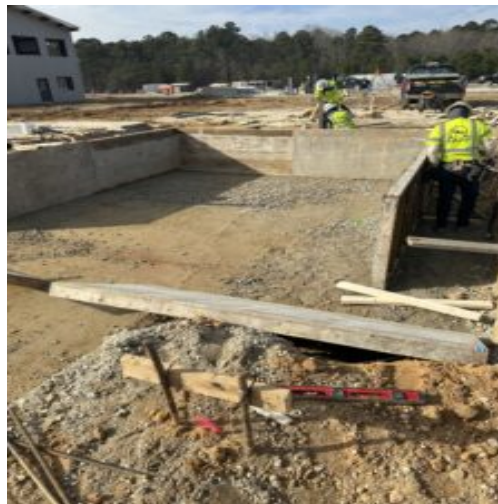
A request was made for subgrade soils testing on an approximate 17' x 17' slab (see photo) located in the far southeast of the project. Upon arrival our representative observed that graded aggregate base (GAB) had already been placed and was not tested. Our representative excavated down through the GAB to perform a Dynamic Cone Penetrometer (DCP) test in the approximate center of the slab.

1st foot - GAB (not tested)

2nd foot - 20 blows- soils were visually identified as a red sandy silt

3rd foot - 20 blows - soils were visually identified as a red sandy silt

4th foot - 20 blows - soils were visually identified as a brown silty sand

No nuclear gauge density testing could be performed.
