Date : 04/16/2023  
Project No : 2022C178  
Client Company : CW Matthews  
Arrival Time : 04/16/2023 12:00  
Onsite Hours : 07:00

ASEC Report ID : 58620  
Name of the Project : Ramp 2 Pavement Replacement  
Project Location : HJAIA  
Weather : cloudy  
Departure Time : 04/16/2023 19:00  
ASEC Technician Name : Aminullah Azimi

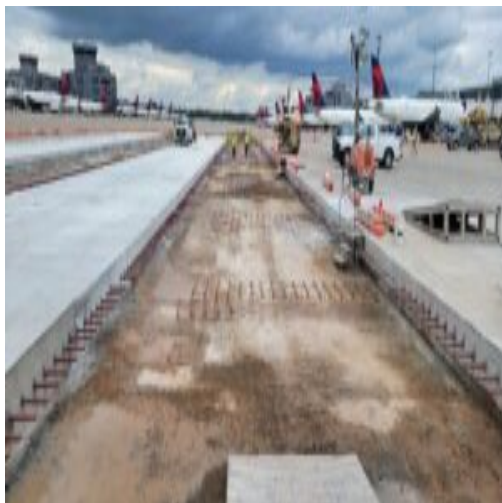
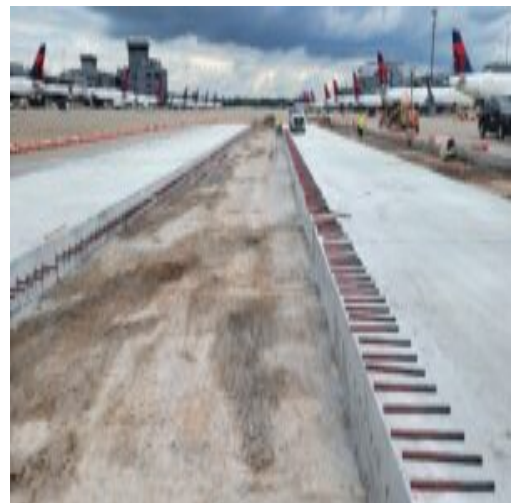
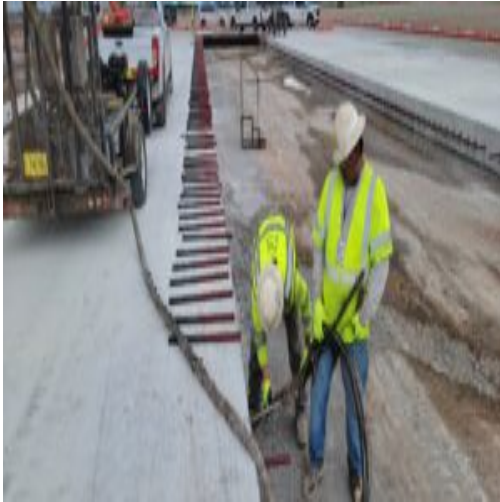
- Pre-pour observation performed in the Lane 1 and lane 3 portions of the project on this day. Contractor completed rebar and dowel basket placement for these lanes.
- The writer visually inspected the installation and setup of these lanes and advised the contractor representatives of any minor corrections that were needed.
- The contractor cleaned loose rock and debris and standing water from the base.
- Baskets were found to be level, straight and secured.
- Dowel bars were found to have epoxy. Embedment length was found to be 15 inches into concrete.
- The writer along with Saketh of ATLQA and ATLNext representative Craig Garland and CWM rep Brandon signed the pre-pour card.
