ASEC Report ID : 61073  
Name of the Project : Ramp 20 Pavement Replacement -  
IFB-1230102  
Project Location : HJAIA  
Weather : sunny  
Departure Time : 08/25/2023 19:00  
ASEC Technician Name : Aminullah Azimi

## Daily Field Report

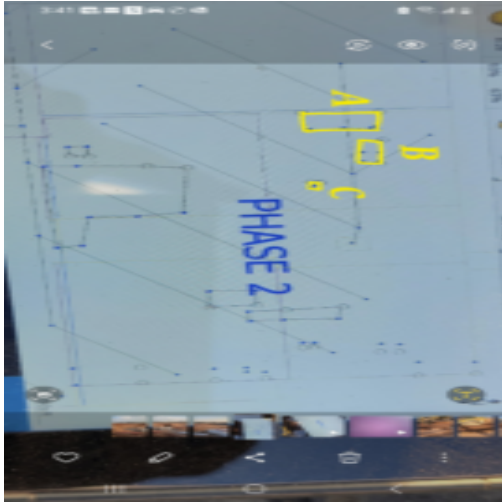
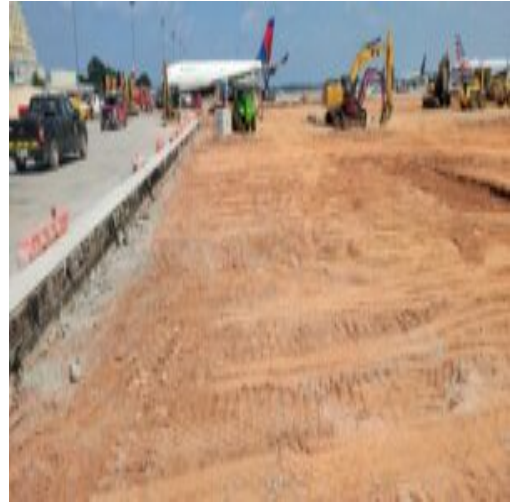
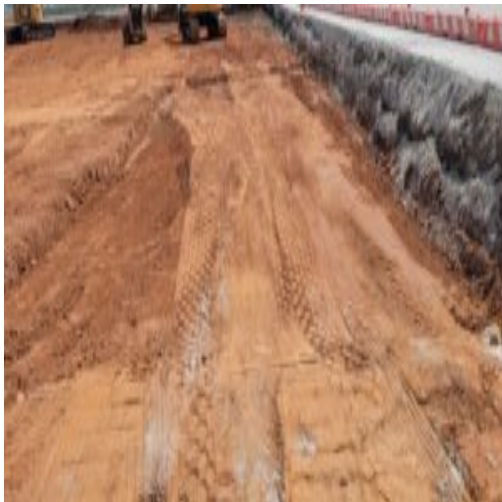
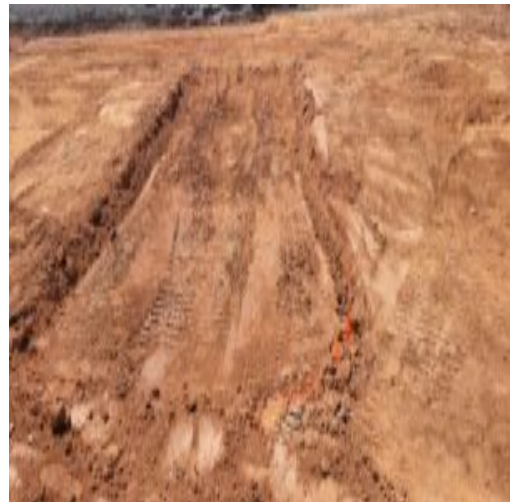
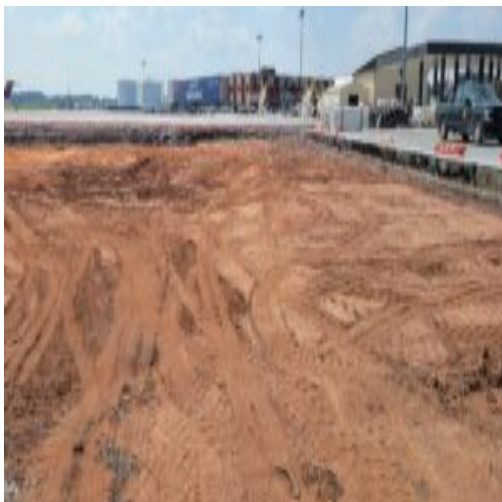
1. A proof-roll observation was carried out in the Ramp 20, Northwest corner (measuring 120'x164') area of phase 2.
2. For the proof-roll, a fully loaded tandem-axled dump truck was utilized. The truck made multiple passes across the subgrade in the aforementioned area.
3. Severe yielding and deflection were not observed during the proof-roll across most of the mentioned areas. However, there were exceptions in three smaller areas. These areas are identified as follows: area A = 1044 square feet, area B = 412 square feet, and area C = 47 square feet. These areas are highlighted with the label "Yalow" on the provided picture or plan.

- Area A: Issues were identified in an area measuring 1044 square feet. The coordinates for this area are N 9825.4, E 11743.0; N 9823.2, E 11766.5; N 9779.4, E 11766.6; N 9776.83, E 11742.65.
- Area B: Irregularities were found in an area spanning 412 square feet. The coordinates for this area are N 9825.2, E 11781.5; N 9822.5, E 11813.1; N 9809.5, E 11811.7; N 9811.9, E 11781.0.
- Area C: Deficiencies were identified in an area of 47 square feet. The coordinates for this area are N 97883.5, E 11838.2; N 9786.0, E 11846.5; N 9776.3, E 11844.7; N 9778.1, E 11837.4.

In light of these observations, it was recommended to address the issues by excavating to a depth of 6 inches and replacing the compromised areas with suitable compacted fill.
