Date : 05/23/2023  
Project No : 2022C227  
Client Company : Artisan  
Arrival Time : 05/23/2023 9:00  
Onsite Hours : 08:00

ASEC Report ID : 59481  
Name of the Project : Riverwalk Manor (CMT) Unit 2, PH 4E  
and 4F  
Project Location : Dallas  
Weather : cloudy  
Departure Time : 05/23/2023 17:00  
ASEC Technician Name : Aminullah Azimi

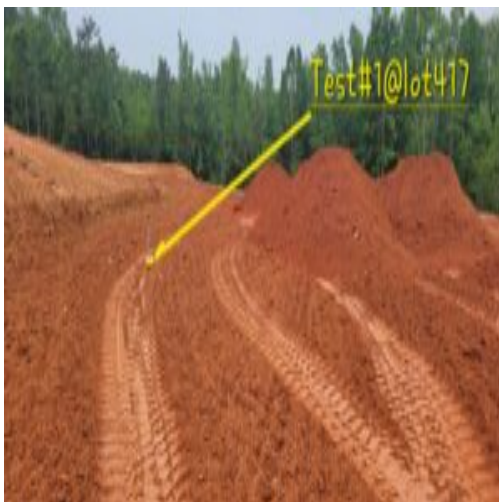
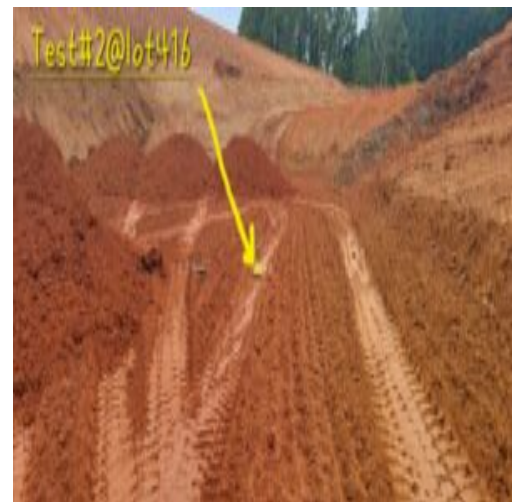
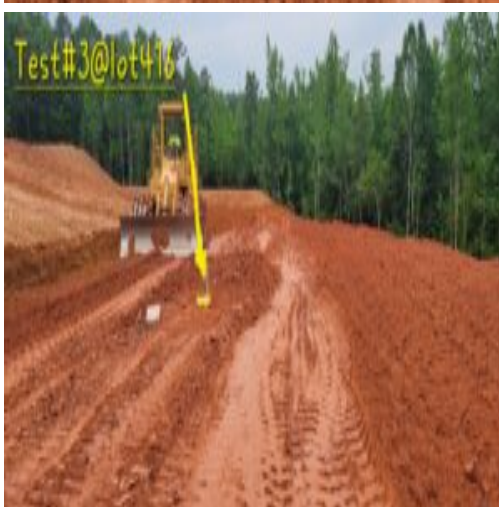
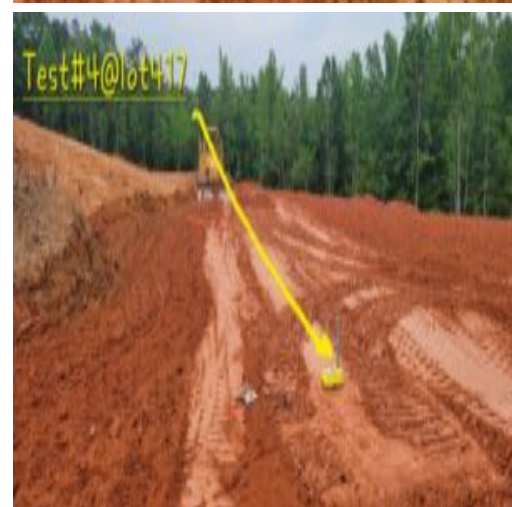
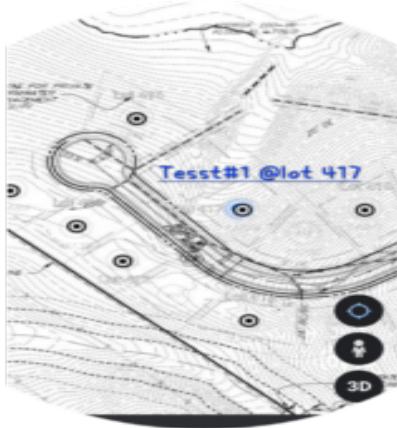
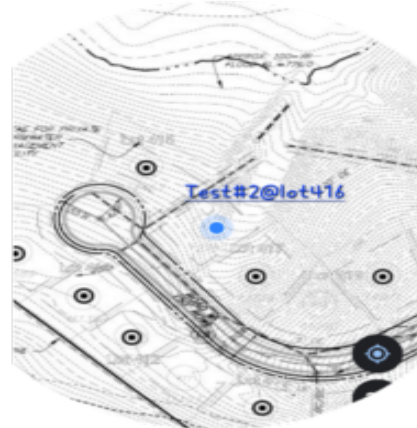
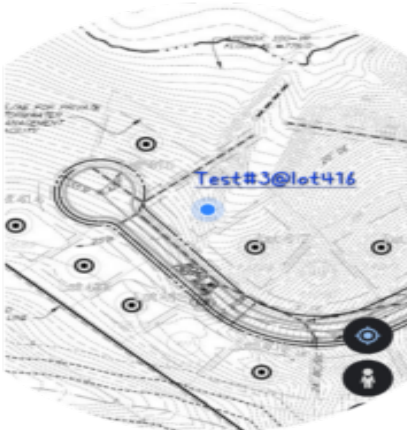
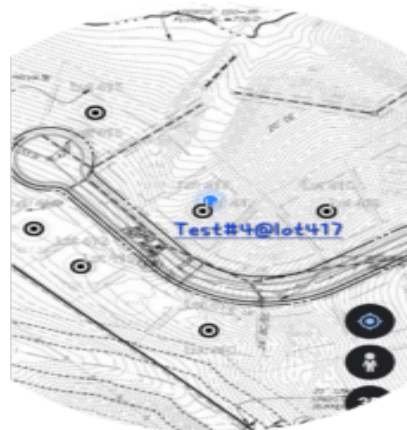
The placement and compaction of backfill soils for Lots #415, 416 and 417 continued this day.

At the time of arrival, our representative observed that work was in progress with lifts being placed to about 20 feet below finished grade and compacted using a 810 compactor.

The density test results are on hold until I receive the proctor from the lab, however, in-place moisture contents were found to be high.
