Date : 09/22/2023  
Project No : 2022C227  
Client Company : Artisan  
Arrival Time : 09/22/2023 14:00  
Onsite Hours : 03:00

ASEC Report ID : 61847  
Name of the Project : Riverwalk Manor (CMT) Unit 2, PH 4E  
and 4F  
Project Location : Dallas  
Weather : Sunny  
Departure Time : 09/22/2023 17:00  
ASEC Technician Name : Vidal Dias

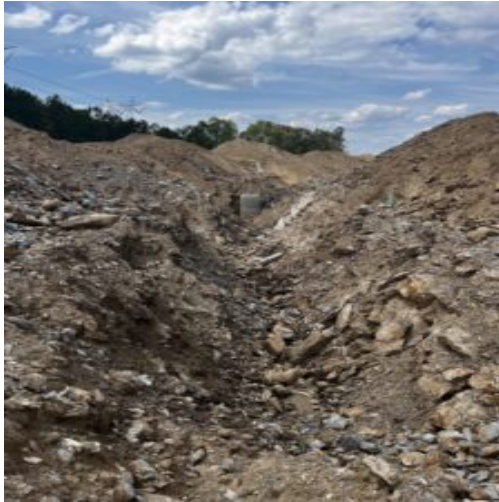
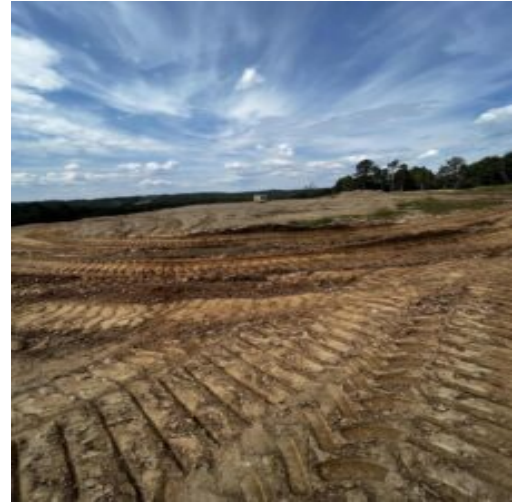
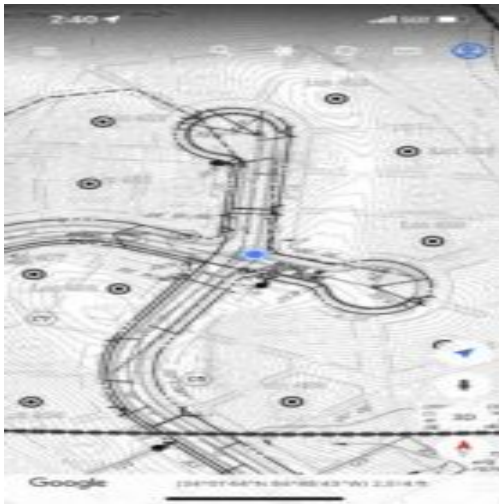
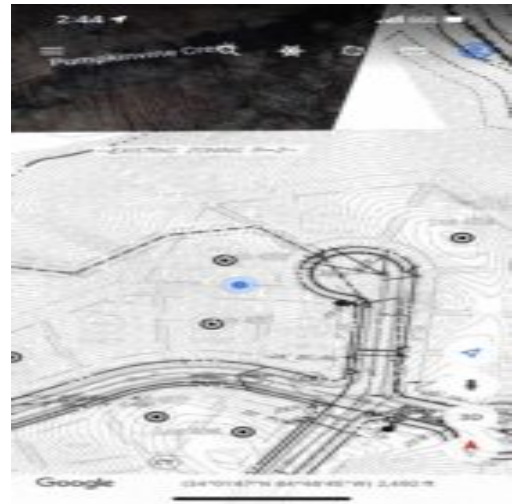
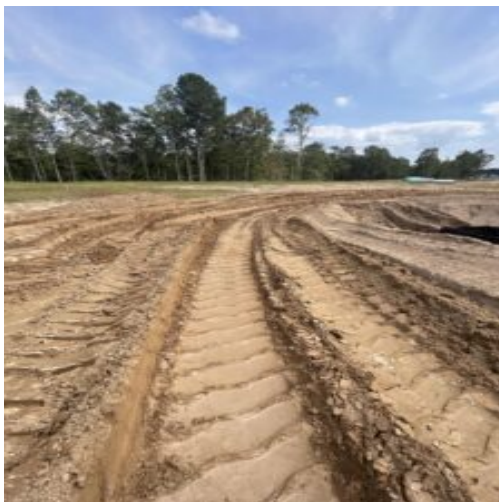
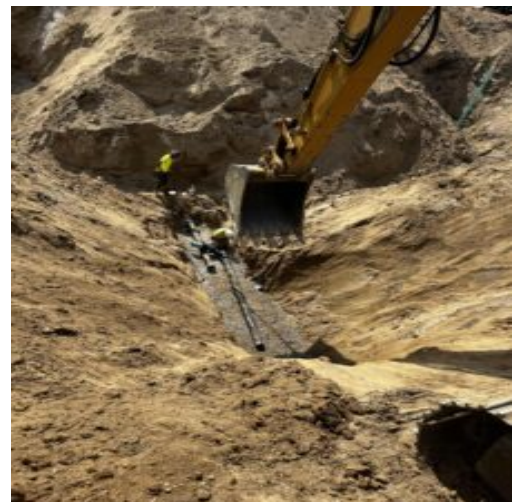
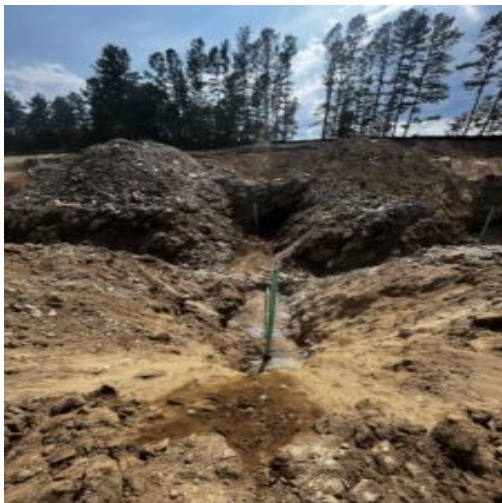
The undersigned ASEC representative was on-site to observe and document activities. During the site visit, several key activities were observed. In the south-west portion of the site, specifically for Lots #55 to 59, sewer pipes were being placed. The geological characteristics of this area were notably rocky. The placement of these sewer pipes appeared to be installed as per drawing specifications. Moving to the north side, behind Lot #423 and 424, excavation and placement of large boulder fill was underway. The geological characteristics of this area included the presence of large boulder fill. The boulder fill should not be utilized within the top 10 feet of areas requiring structural fill. Lastly, significant soil deflection was observed in the area designated for future road construction, specifically in front of Lots #428 and 426. Surficial soil stabilization will be required to remediate the deflecting soils.

- **Location:** South-west portion of the site
- **Geological Characteristics:** Rocky terrain
- **Activity Observed:** Sewage pipes were being placed.
- **Compliance:** The placement was in accordance with the drawing specifications.
- **Recommendations:** No immediate corrective actions are required.

- **Location:** North side behind lots 423 and 424
- **Geological Characteristics:** Presence of large boulder fill
- **Activity Observed:** Excavation and placement of large boulder fill.
- **Compliance:** Not assessed during this visit.
- **Recommendations:** Further geotechnical analysis may be required.

- **Location:** Future street construction area in front of Lot #428 and 426.
- **Geological Characteristics:** Not specified.
- **Activity Observed:** Soil deflection.
- **Compliance:** Not in accordance with standard construction practices.
- **Recommendations:** Remediation of deflecting soils are required.
