Date : 09/26/2023  
Project No : 2022C227  
Client Company : Artisan  
Arrival Time : 09/26/2023 09:00  
Onsite Hours : 04:00

ASEC Report ID : 62228  
Name of the Project : Riverwalk Manor (CMT) Unit 2, PH 4E  
and 4F  
Project Location : Dallas  
Weather : Sunny  
Departure Time : 09/26/2023 13:00  
ASEC Technician Name : Vidal Dias

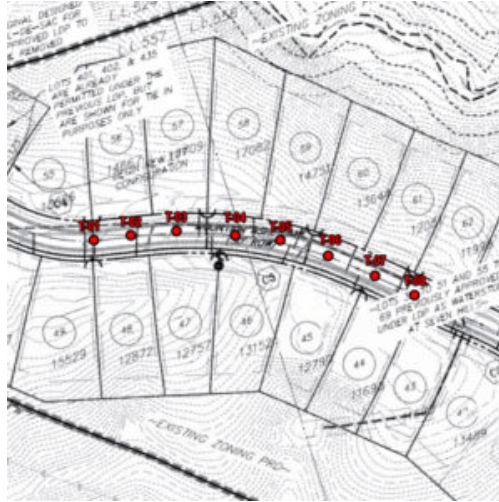
The assigned ASEC representative was on-site at the Riverwalk Manor Project to observe the ongoing work in accordance with project plans, specifications, and standards. During our time on-site, 8 compaction tests were performed in the center of the road located on the southern portion of the site. The locations are marked on the attached drawing.
