Date : 02/17/2023  
Project No : 2022C235  
Client Company : Jackson Demolition Service, Inc.  
Arrival Time : 02/17/2023 06:00  
Onsite Hours : 10:30

ASEC Report ID : 57170  
Name of the Project : Plant Gorgas Demolition and Grading  
Project Location : 460 Gorgas Rd, Parrish, AL 35580  
Weather : Rainy  
Departure Time : 02/17/2023 16:30  
ASEC Technician Name : Vidal Dias

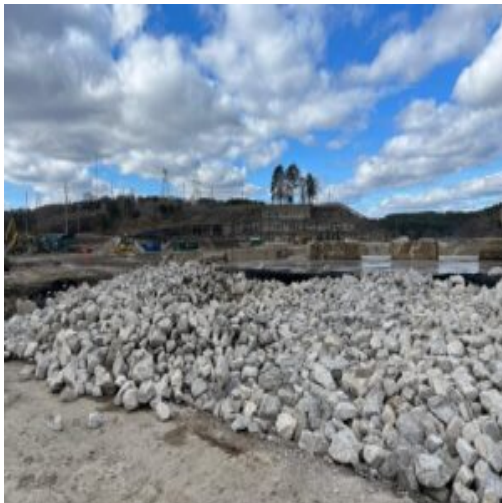
Rip-rap installed in the trench in areas F7 and F8

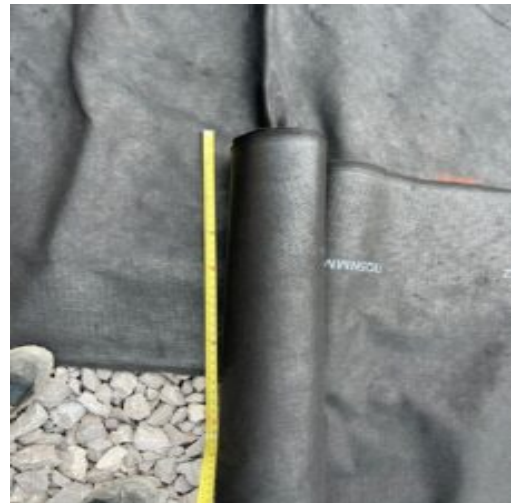
Fabric with 2 feet of continuous overlap.

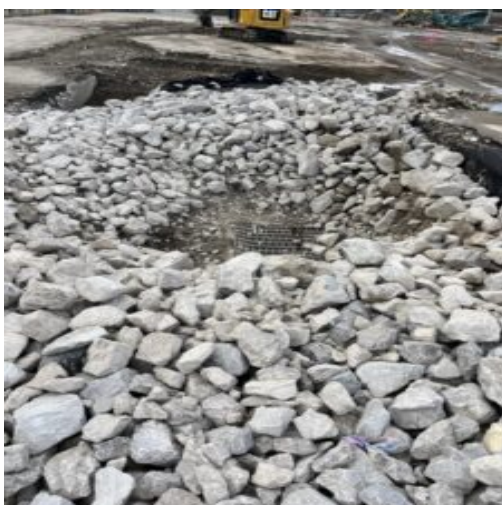
Rip-rap installed in the trench in areas F7 and F8

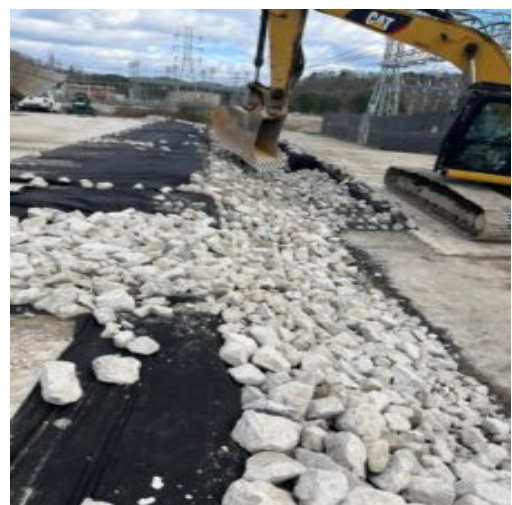
Rip-rap installed in the trench in areas F7 and F8

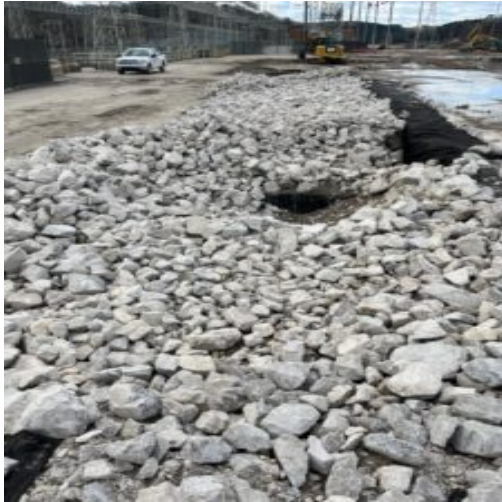
Rip-rap installed in the trench in areas F7 and F8

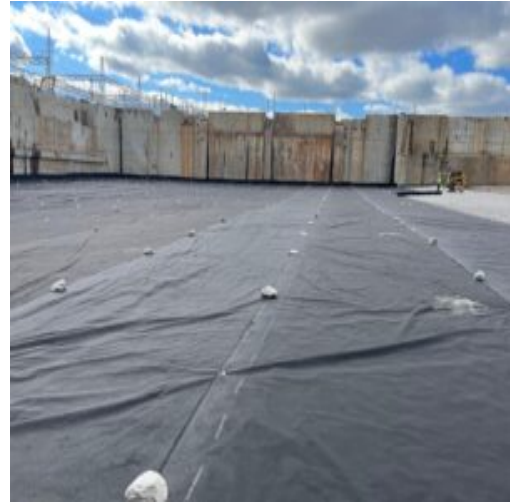
Fabric with 2 feet of continuous overlap.
