Date : 02/24/2023  
Project No : 2022C235  
Client Company : Jackson Demolition Service, Inc.  
Arrival Time : 02/24/2023  
Onsite Hours :

ASEC Report ID : 57297  
Name of the Project : Plant Gorgas Demolition and Grading  
Project Location : 460 Gorgas Rd, Parrish, AL 35580  
Weather : cloudy  
Departure Time : 02/24/2023  
ASEC Technician Name : Vidal Dias

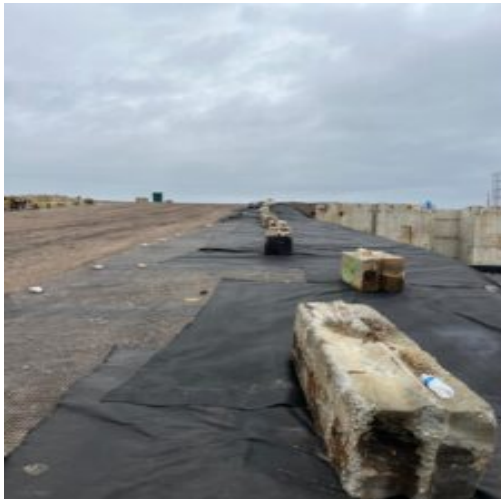
Terrafabric in the basement's upper half on the ramp's east slope

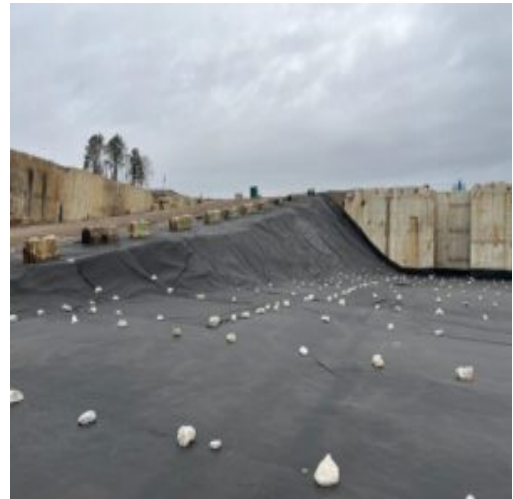
Terrafabric in the basement's upper half on the ramp's east slope

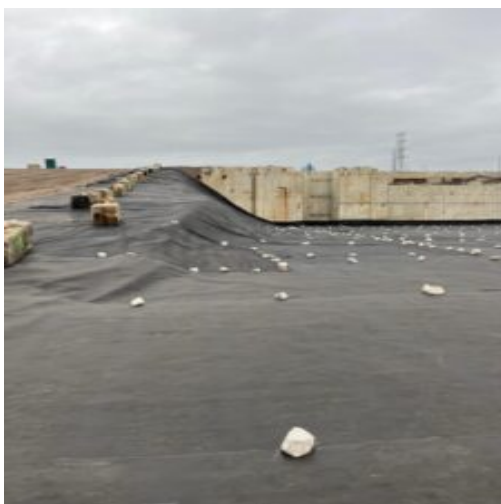
Terrafabric in the basement's upper half on the ramp's east slope
