Date : 03/06/2023  
Project No : 2022C235  
Client Company : Jackson Demolition Service, Inc.  
Arrival Time : 03/06/2023 06:00  
Onsite Hours : 10:30

ASEC Report ID : 57473  
Name of the Project : Plant Gorgas Demolition and Grading  
Project Location : 460 Gorgas Rd, Parrish, AL 35580  
Weather : Partly Cloudy  
Departure Time : 03/06/2023 16:30  
ASEC Technician Name : Vidal Dias

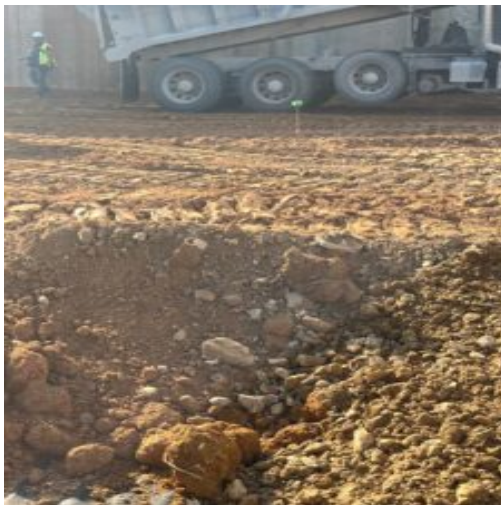
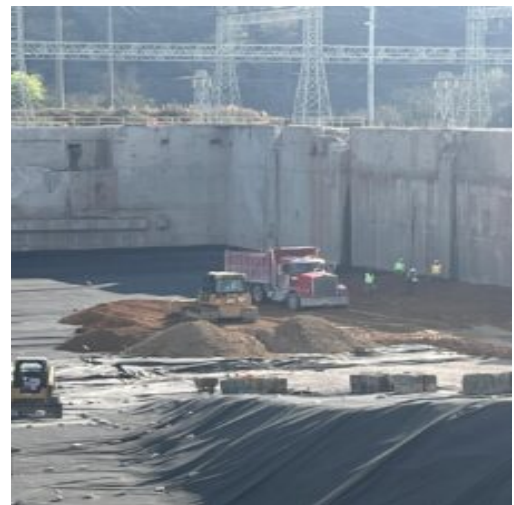
Clay being placed

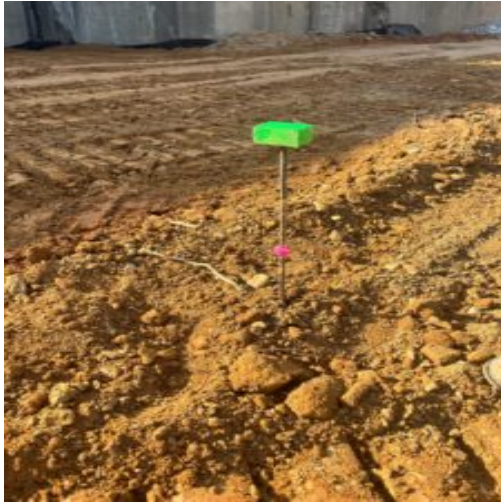
2 foot mark shown on stake
