ASEC Report ID : 58866  
Name of the Project : Plant Gorgas Demolition and Grading  
Project Location : 460 Gorgas Rd, Parrish, AL 35580  
Weather : Sunny  
Departure Time : 04/24/2023 16:00  
ASEC Technician Name : Vidal Dias

AS ENGINEERING AND CONSULTING, LLC (ASEC) representative Vidal Dias visited the site at the request of Jackson Demolition representative Josh Kelly. The undersigned representative was present to monitor, verify and document the ongoing project activities. (reference drawing E720661 S1 - R5, E720659 S1-R5.)

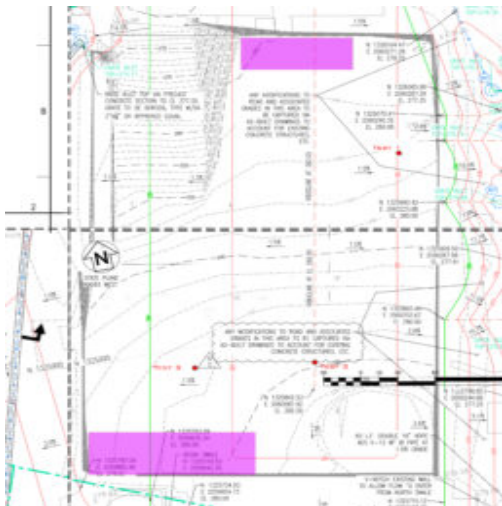
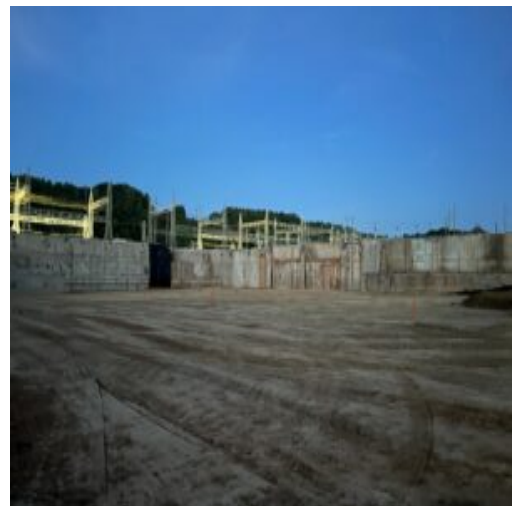
1. One thousand eight hundred and ninety (1890) cubic yards of fill materials were received and placed for lift five (5) in section 2 area G7 (drawing E720659) of the basement, and lift eight (8) section one (1) area B7 (drawing E720661). The materials were placed in accordance with ITP-001, and the fill area is highlighted in blue on the attached drawing.
2. Three moisture density tests were performed in section 1, area B7 (E720661 S1 - R5); the testing locations are marked on the attached drawing.
3. All three tests passed compaction and tests two and three were within optimum moisture. Test one was 1% below moisture; water was applied to the area. The section was retested, and moisture increased to 15%, which meets the specifications.
