Date : 05/09/2023  
Project No : 2022C235  
Client Company : Jackson Demolition Service, Inc.  
Arrival Time : 05/09/2023 06:30  
Onsite Hours : 10:00

ASEC Report ID : 59252  
Name of the Project : Plant Gorgas Demolition and Grading  
Project Location : 460 Gorgas Rd, Parrish, AL 35580  
Weather : Partly Cloudy  
Departure Time : 05/09/2023 16:30  
ASEC Technician Name : Ramchandra Mogulla

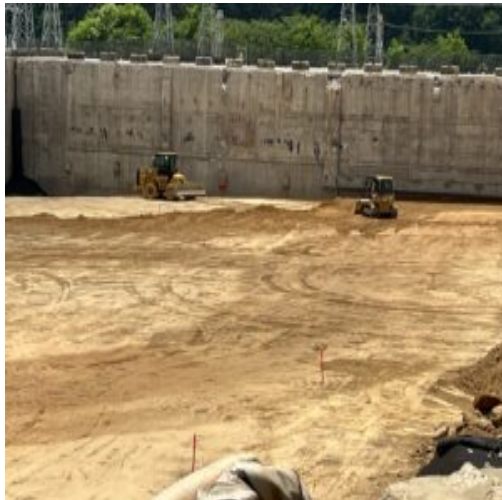
Backfill being placed as lift 8 in the Section 2 area

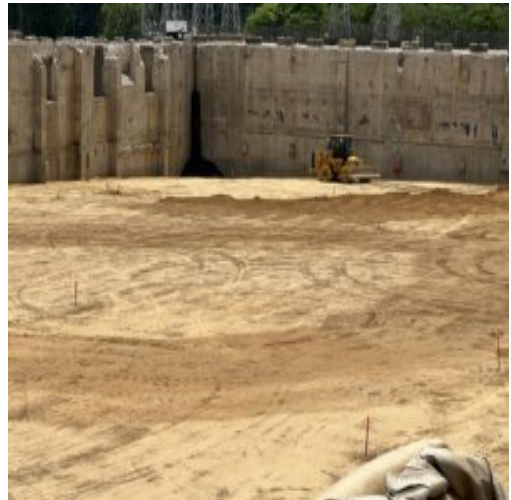
Backfill being placed as lift 8 in the Section 2 area

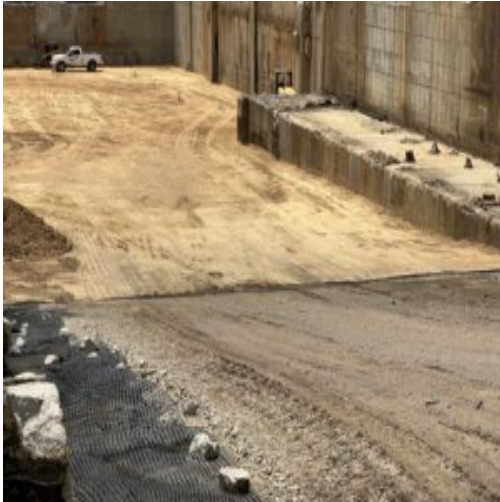
Backfill being placed as lift 8 in the Section 2 area
