Date : 06/09/2023  
Project No : 2022C235  
Client Company : Jackson Demolition Service, Inc.  
Arrival Time : 06/09/2023 06:00  
Onsite Hours : 10:30

ASEC Report ID : 59667  
Name of the Project : Plant Gorgas Demolition and Grading  
Project Location : 460 Gorgas Rd, Parrish, AL 35580  
Weather : SUNNY  
Departure Time : 06/09/2023 16:30  
ASEC Technician Name : Avinash Bandham

AS ENGINEERING AND CONSULTING, LLC (ASEC) representative Avinash Bandam visited the site at the request of Jackson Demolition representative Josh Kelly. The undersigned representative was present to monitor, verify and document the ongoing project activities. (reference drawing E720661 S1 - R8, E720659 S1-R8.)

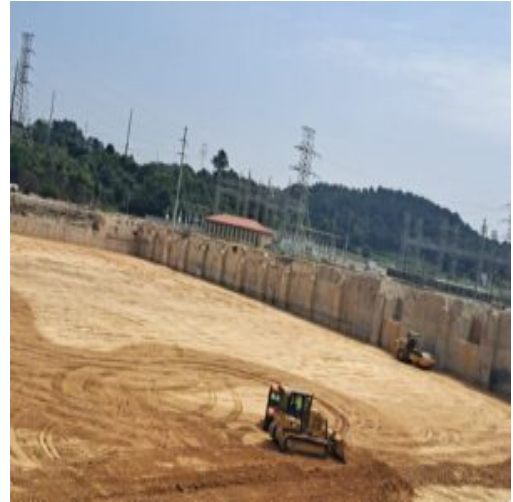
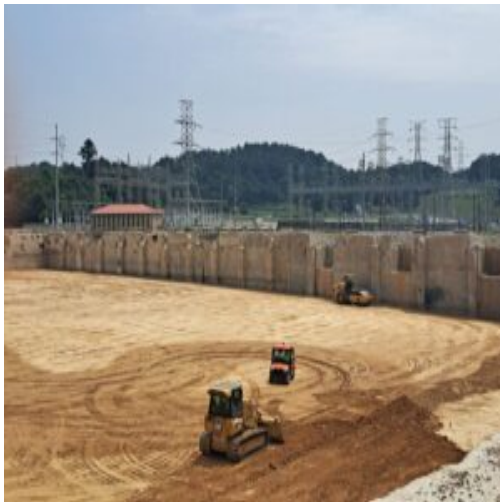
Project: Plant Gorgas Demolition and Restoration ASEC  
Personnel: Avinash Bandham  
Date: 06-09-2023

1. One thousand (1134) cubic yards of fill materials were placed for lift (13) in section 2 part 2 area G7 of the second part (drawing E720659) of the basement. The materials were placed in accordance with ITP-001, and the fill area is highlighted in brown as depicted in the attached drawing.
2. The area was probed, and three moisture density tests were performed in the basement, section 1 basement area B7 and in section 2 basement area G7. The attached drawing depicts the approximate test locations.
