Date : 07/17/2023  
Project No : 2022C235  
Client Company : Jackson Demolition Service, Inc.  
Arrival Time : 07/17/2023 06:00  
Onsite Hours : 10:30

ASEC Report ID : 60316  
Name of the Project : Plant Gorgas Demolition and Grading  
Project Location : 460 Gorgas Rd, Parrish, AL 35580  
Weather : SUNNY  
Departure Time : 07/17/2023 16:30  
ASEC Technician Name : Avinash Bandham

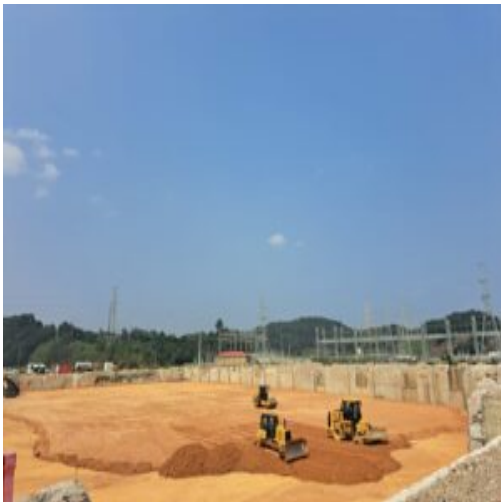
Placement of fill material in section 2 part 1

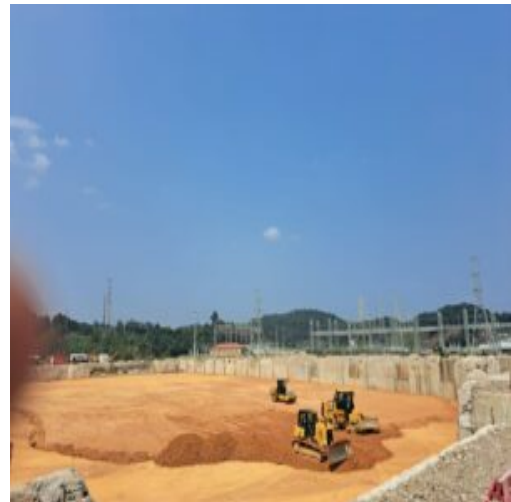
Placement of fill material in section 2 part 1

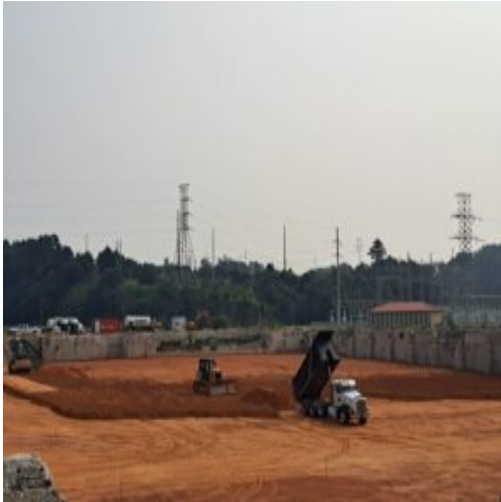
Started the placement of fill material in section 2

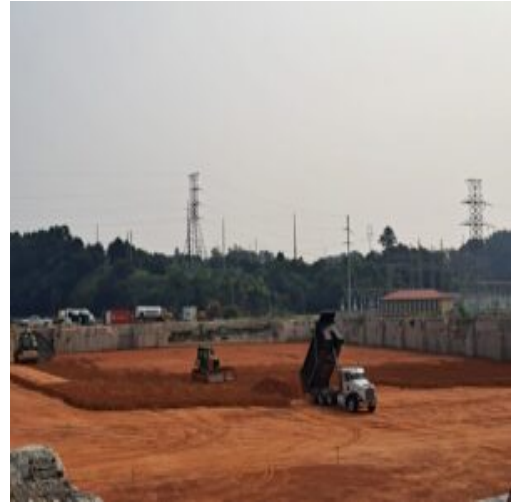
Started the placement of fill material in section 2

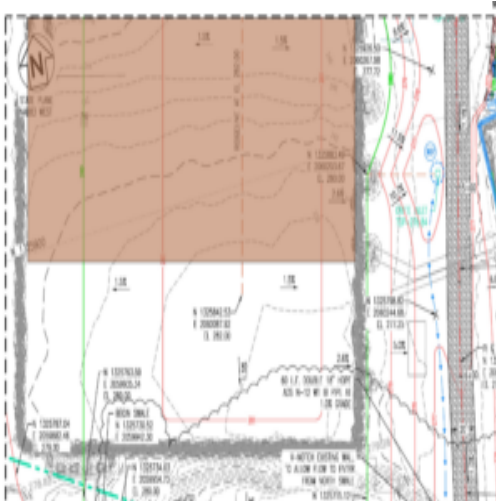
1. Two thousand four hundred and sixty-six (2466) cubic yards of fill materials were placed for lift (20) in section 2 part 1 area G7 (E720659 S1-R8). The materials were placed and compacted in accordance with ITP-001, and the fill area is highlighted in brown as depicted in the attached drawing.
2. No testing was performed on this day. Testing of section 1 and section 2 is planned to be performed the next day or at the completion of the entire lift. Therefore, no density reports were generated on this day.

Highlighted area depicts fill material placement
