Date : 07/18/2023  
Project No : 2022C235  
Client Company : Jackson Demolition Service, Inc.  
Arrival Time : 07/18/2023 06:00  
Onsite Hours : 10:30

ASEC Report ID : 60345  
Name of the Project : Plant Gorgas Demolition and Grading  
Project Location : 460 Gorgas Rd, Parrish, AL 35580  
Weather : SUNNY  
Departure Time : 07/18/2023 16:30  
ASEC Technician Name : Avinash Bandham

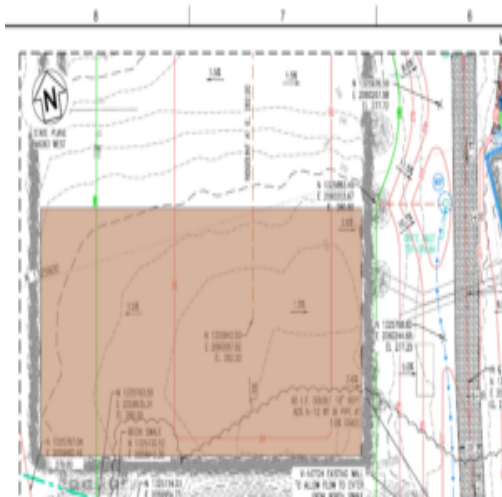
The attached drawing shows the placement of fill material

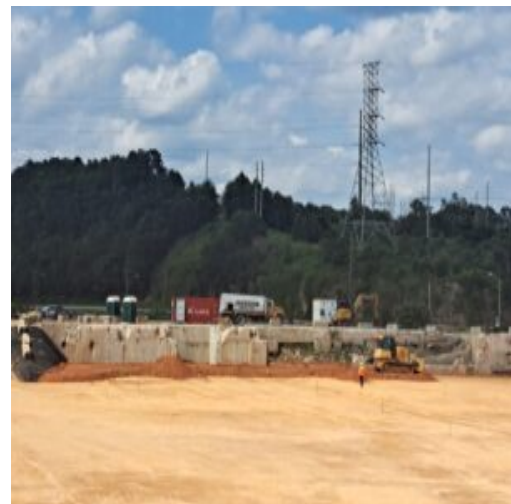
Started the placement of fill material in section 1 basement area B7

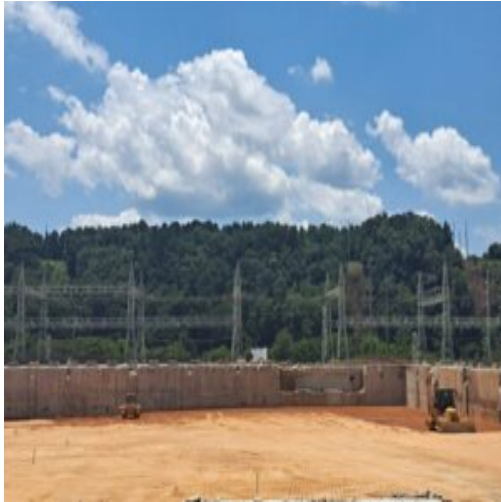
Placement of fill material section 2 part 2

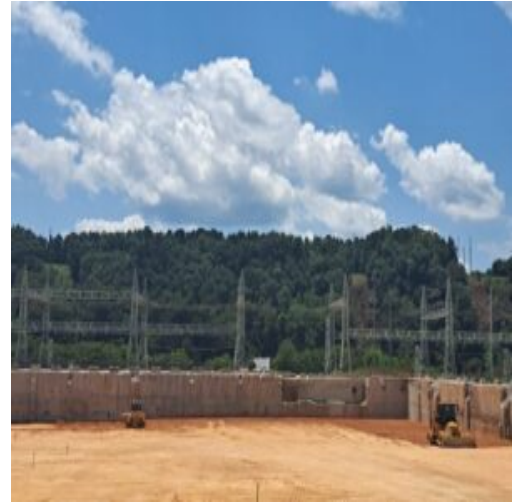
Placement of fill material section 2 part 2

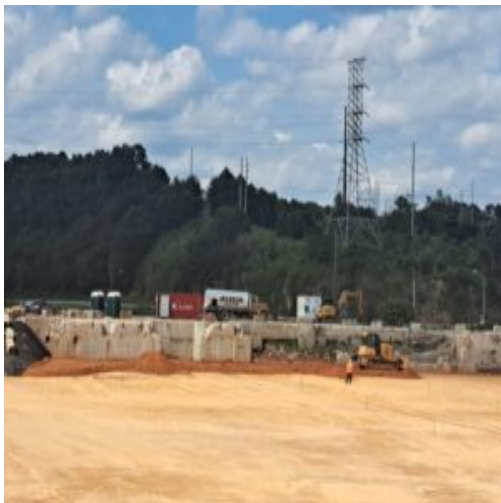
Started the placement of fill material in section 1  
basement area B7
