Date : 07/21/2023  
Project No : 2022C235  
Client Company : Jackson Demolition Service, Inc.  
Arrival Time : 07/21/2023 06:00  
Onsite Hours : 10:30

ASEC Report ID : 60437  
Name of the Project : Plant Gorgas Demolition and Grading  
Project Location : 460 Gorgas Rd, Parrish, AL 35580  
Weather : SUNNY  
Departure Time : 07/21/2023 16:30  
ASEC Technician Name : Avinash Bandham

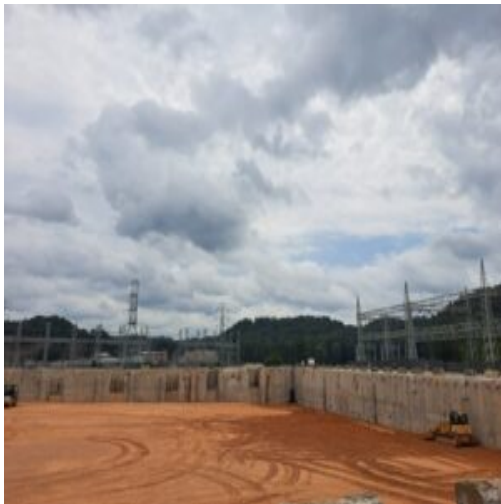
The fill materials placed in section basement area G7

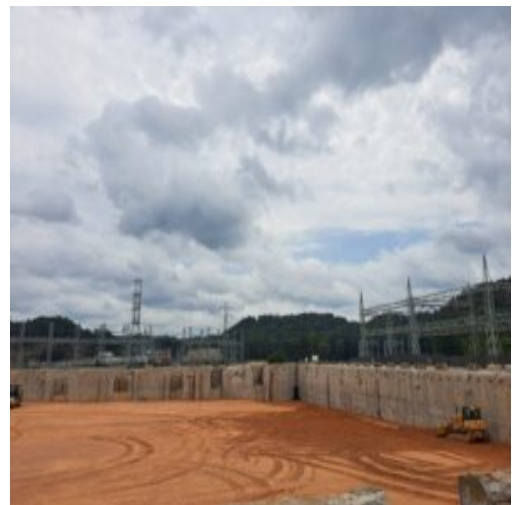
The fill materials placed in section basement area G7

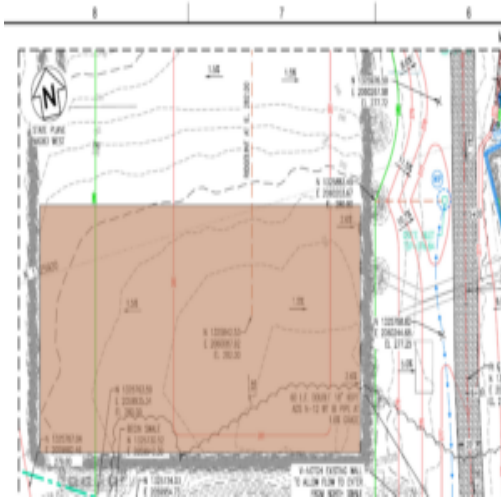
1. Two thousand three hundred and ninety-four (2394) cubic yards of fill materials were placed for lift (21) in section 2 part 2 basement area G7 (E720659 S1-R8). The materials were placed and compacted in accordance with ITP-001, and the fill area is highlighted in brown as depicted in the attached drawing.
2. The area was probed using the hand probe and performed three moisture density tests in section 1 and section 2 and verified with a check-plug.

The highlighted region shows the placement of fill materials
