Date : 07/20/2023  
Project No : 2022C235  
Client Company : Jackson Demolition Service, Inc.  
Arrival Time : 07/20/2023 06:00  
Onsite Hours : 10:30

ASEC Report ID : 60398  
Name of the Project : Plant Gorgas Demolition and Grading  
Project Location : 460 Gorgas Rd, Parrish, AL 35580  
Weather : SUNNY  
Departure Time : 07/20/2023 16:30  
ASEC Technician Name : Avinash Bandham

AS ENGINEERING AND CONSULTING, LLC (ASEC) representative Avinash Bandam visited the site at the request of Jackson Demolition representative Josh Kelly. The undersigned representative was present to monitor, verify and document the ongoing project activities. (Reference drawing E720661 S1 - R8, E720659 S1-R8.)

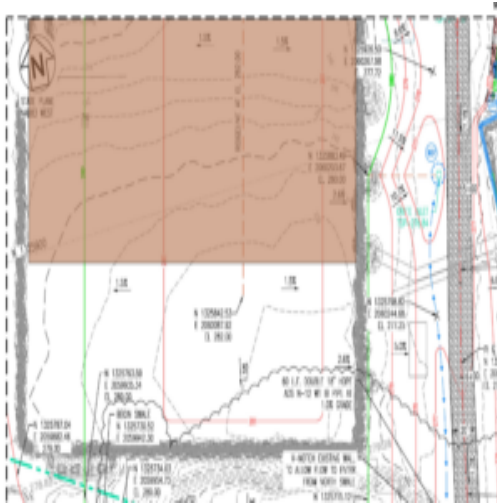
1. Two thousand three hundred and ninety-four (2394) cubic yards of fill materials were placed for lift (21) in section 2 part 1 basement area G7 (E720659 S1-R8). The materials were placed and compacted in accordance with ITP-001, and the fill area is highlighted in brown as depicted in the attached drawing.
2. No testing was performed on this day. Testing of section 1 and section 2 is planned to be performed the next day or at the completion of the entire lift. Therefore, no density reports were generated on this day.

Drawing shows the placement of fill material in section 2 part 1

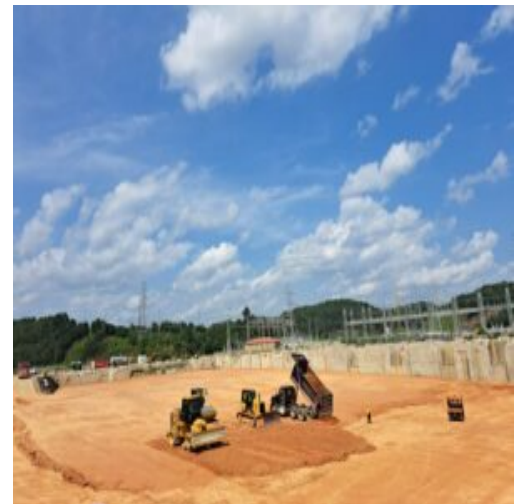
Placed the fill material in section 2 part 1

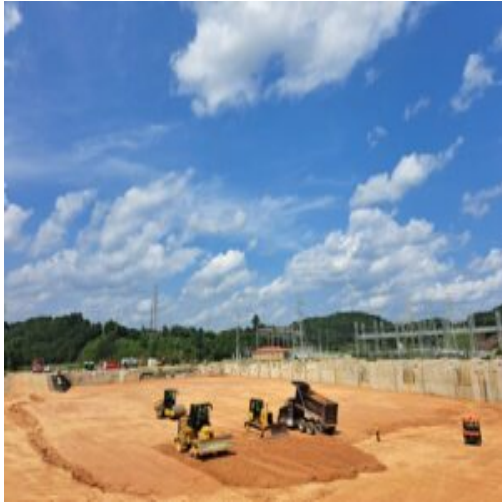
Placed the fill material in section 2 part 1

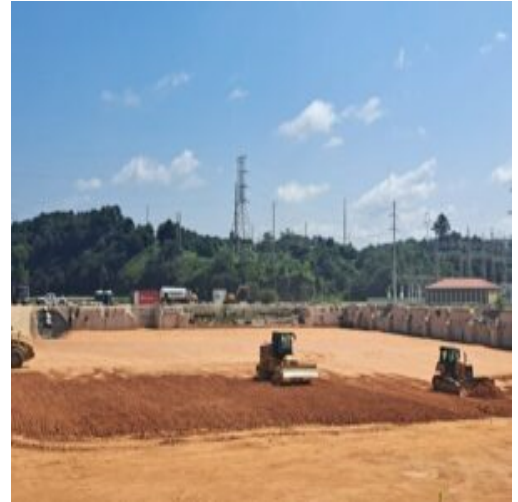
Placed the fill material in section 2 part 1

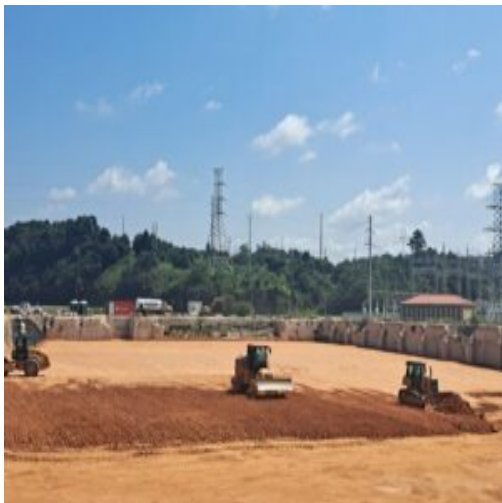
Placed the fill material in section 2 part 1
