Date : 07/24/2023  
Project No : 2022C235  
Client Company : Jackson Demolition Service, Inc.  
Arrival Time : 07/24/2023 06:00  
Onsite Hours : 10:30

ASEC Report ID : 60469  
Name of the Project : Plant Gorgas Demolition and Grading  
Project Location : 460 Gorgas Rd, Parrish, AL 35580  
Weather : SUNNY  
Departure Time : 07/24/2023 16:30  
ASEC Technician Name : Avinash Bandham

AS ENGINEERING AND CONSULTING, LLC (ASEC) representative Avinash Bandam visited the site at the request of Jackson Demolition representative Josh Kelly. The undersigned representative was present to monitor, verify and document the ongoing project activities. (Reference drawing E720661 S1 - R8, E720659 S1-R8.)

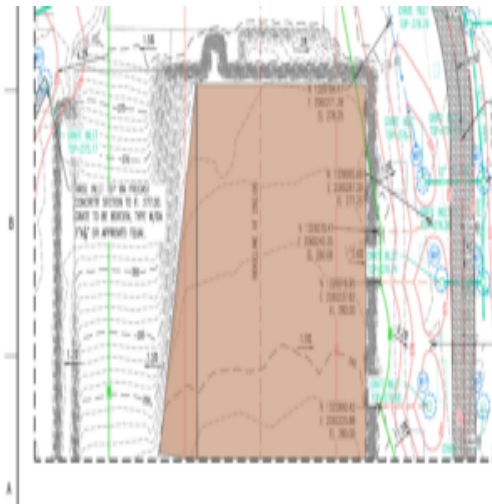
1. Two thousand one hundred and twelve (2412) cubic yards of fill materials were placed for lift (23) in section 1 basement area B7 (E720661 S1-R8). The materials were placed and compacted in accordance with ITP-001, and the fill area is highlighted in brown as depicted in the attached drawing.
2. No testing was performed on this day. Testing of section 1 and section 2 is planned to be performed the next day or at the completion of the entire lift. Therefore, no density reports were generated on this day.

The Highlighted area in the Drawing shows the placement of fill material

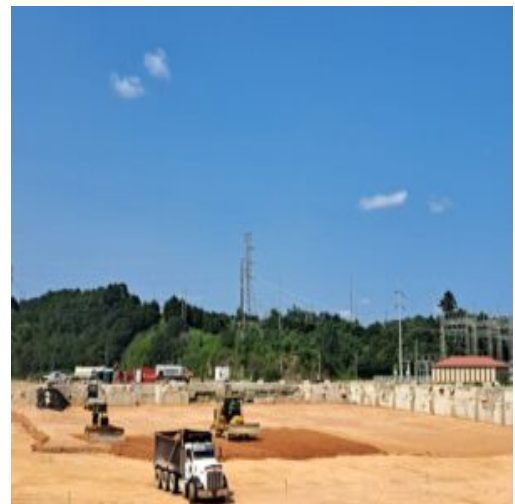
Fill materials placed in Section 1 basement area B7

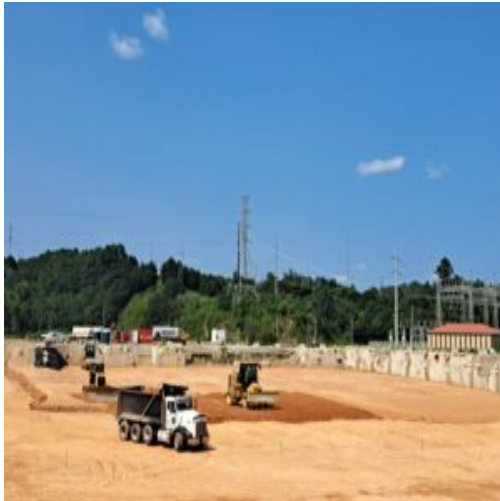
Fill materials placed in Section 1 basement area B7

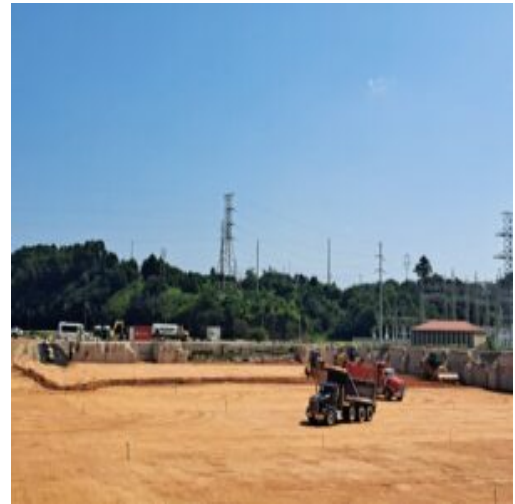
Placed the fill material in mid way of the section 1 basement area B7

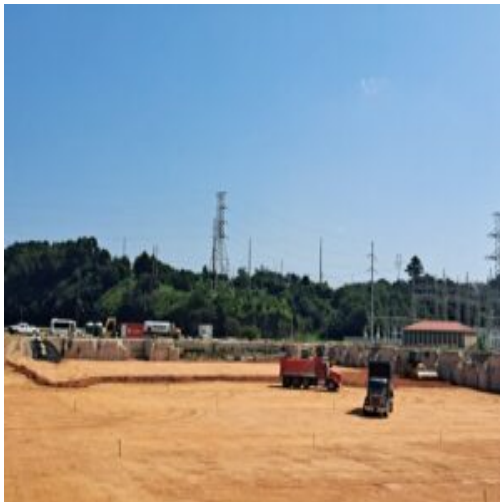
Placed the fill material in mid way of the section 1 basement area B7
