Date : 07/26/2023  
Project No : 2022C235  
Client Company : Jackson Demolition Service, Inc.  
Arrival Time : 07/26/2023 06:00  
Onsite Hours : 10:30

ASEC Report ID : 60502  
Name of the Project : Plant Gorgas Demolition and Grading  
Project Location : 460 Gorgas Rd, Parrish, AL 35580  
Weather : SUNNY  
Departure Time : 07/26/2023 16:30  
ASEC Technician Name : Avinash Bandham

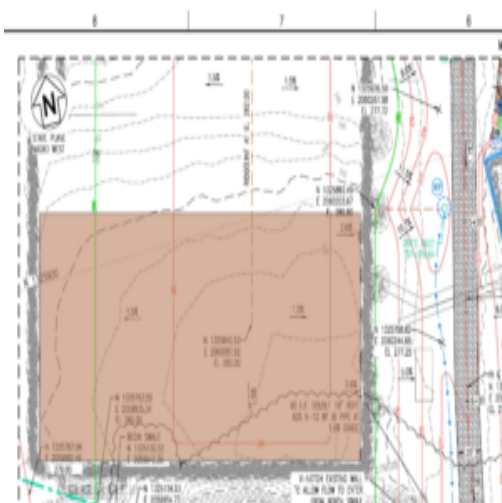
1. Two thousand two hundred and sixty-eight (2268) cubic yards of fill materials were placed for lift (22) in section 2 part 2 basement area G7 (E720659 S1-R8). The materials were placed and compacted in accordance with ITP-001, and the fill area is highlighted in brown as depicted in the attached drawing.

Highlighted region shows the location of the placement of fill material

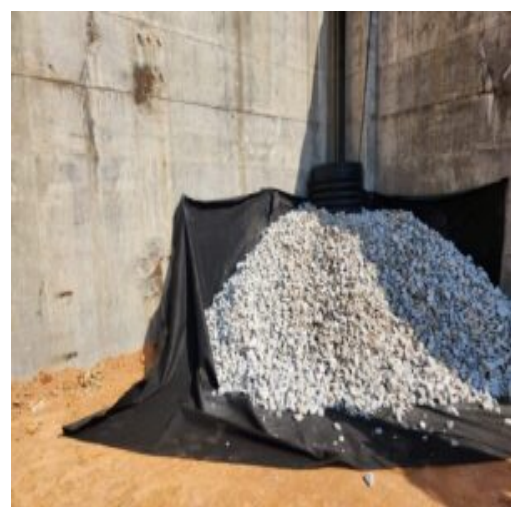
4. #24 stone was placed around the HDPE pipe on the south-east corner before it was covered with the geo-fabric. The placement of the aggregate and the geo-fabric materials were in accordance with ITP-003 and ITP-006.

Placed aggregate around the HDPE pipe before covering with fabric

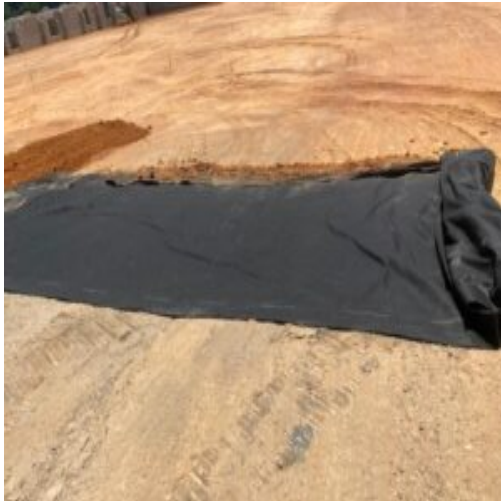
3. Geo-grid and geo-fabric were placed on the ramp before additional fill material was extended in that direction. The placement of geo-grid and geo-fabric and overlaps were noted to be in accordance with ITP-005 and ITP-006.

Placed Geo-fabric after the placement of geo-grid

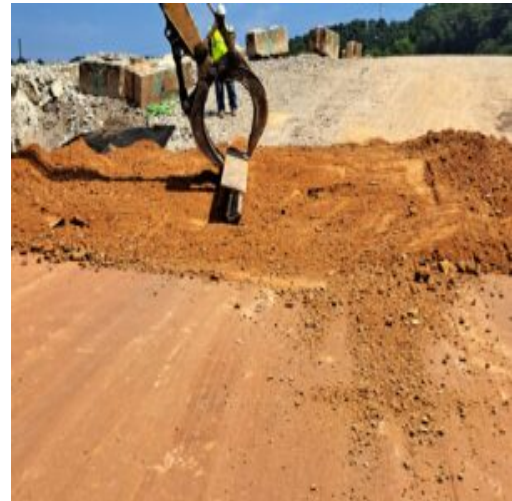
Spreading and covering the fill-material on the geo-fabric on the ramp of the basement

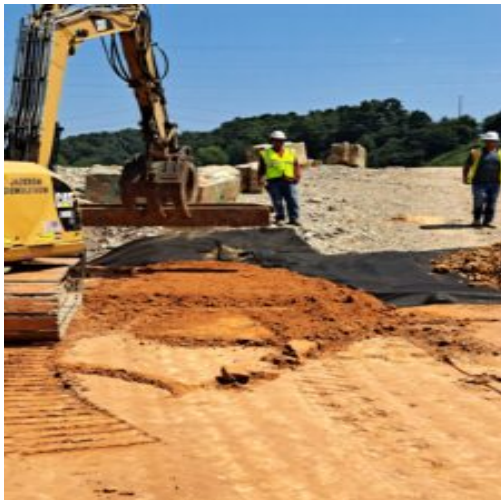
Covering the geo-fabric with fill-material

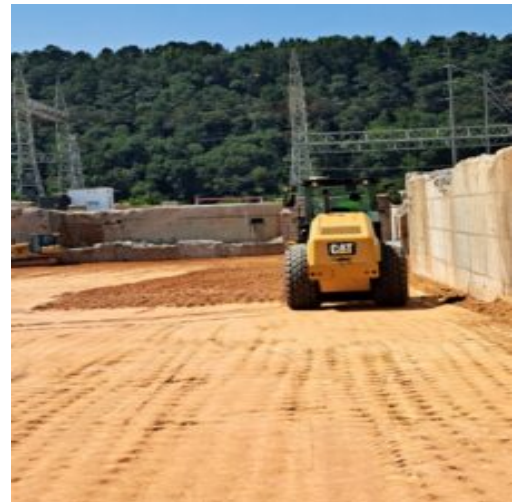
Vibratory roller for compaction of fill material in section 2

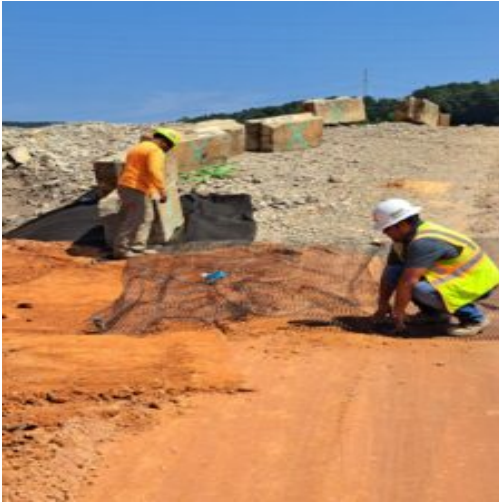
placement of the geo-grid at the bottom of the ramp

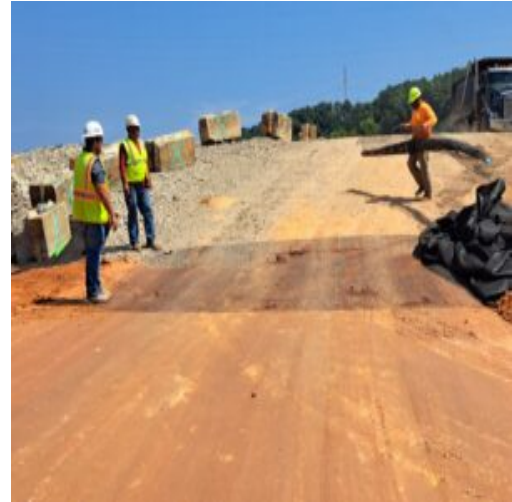
Placing geo-grid

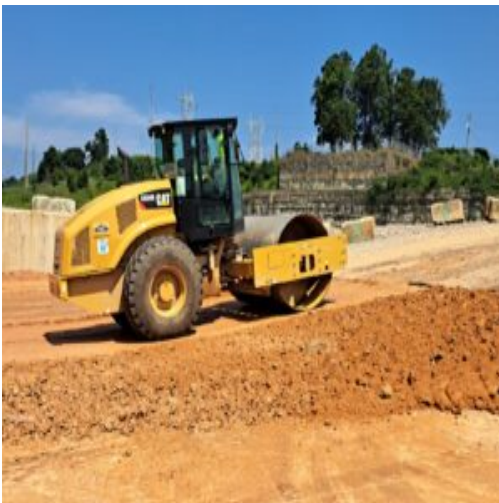
Compacting fill-material using vibratory roller

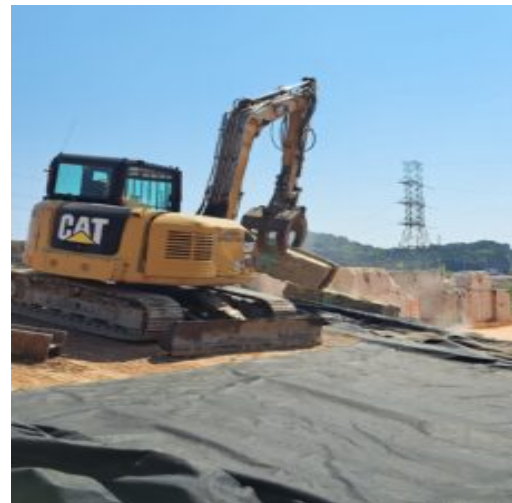
Placed the geo-fabric on the bottom of the ramp

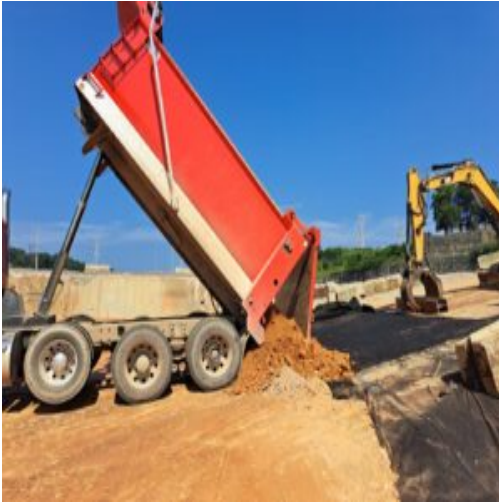
Placement of the fill material on the ramp
