Date : 07/31/2023  
Project No : 2022C235  
Client Company : Jackson Demolition Service, Inc.  
Arrival Time : 07/31/2023 06:00  
Onsite Hours : 10:30

ASEC Report ID : 60624  
Name of the Project : Plant Gorgas Demolition and Grading  
Project Location : 460 Gorgas Rd, Parrish, AL 35580  
Weather : SUNNY  
Departure Time : 07/31/2023 16:30  
ASEC Technician Name : Avinash Bandham

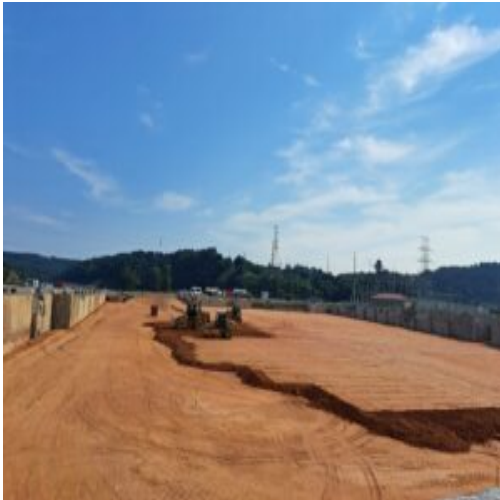
Fill-materials are placed in section 2 basement area G7 part 2

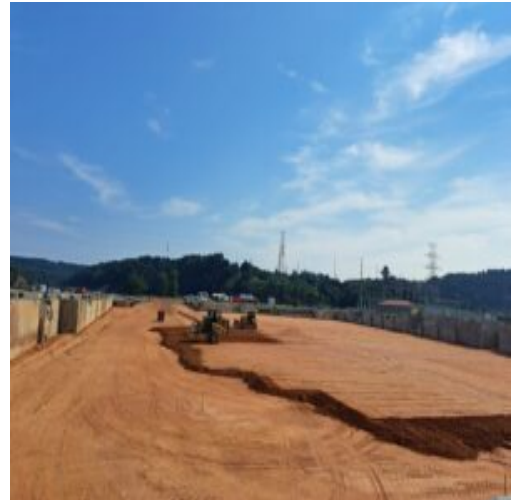
Fill-materials are placed in section 2 basement area G7 part 2

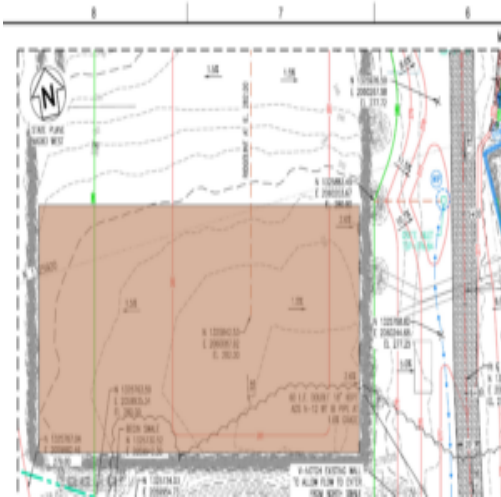
1. Two thousand one hundred and twenty-four (2124) cubic yards of fill materials were placed for lift (23) in section 2 basement area G7 (E720659 S1-R8). The materials were placed and compacted in accordance with ITP-001, and the fill area is highlighted in brown as depicted in the attached drawing.
2. The basement area was probed using the 3/8" diameter probe rod. In addition, three moisture density tests were performed in the basement followed with a check-plug to verify the density test results with the Moisture-Density Relationship. The test locations are marked on the enclosed drawing.

The highlighted region shows the placement of fill-material
