Date : 08/18/2023  
Project No : 2022C235  
Client Company : Jackson Demolition Service, Inc.  
Arrival Time : 08/18/2023 06:00  
Onsite Hours : 10:30

ASEC Report ID : 60925  
Name of the Project : Plant Gorgas Demolition and Grading  
Project Location : 460 Gorgas Rd, Parrish, AL 35580  
Weather : SUNNY  
Departure Time : 08/18/2023 16:30  
ASEC Technician Name : Avinash Bandham

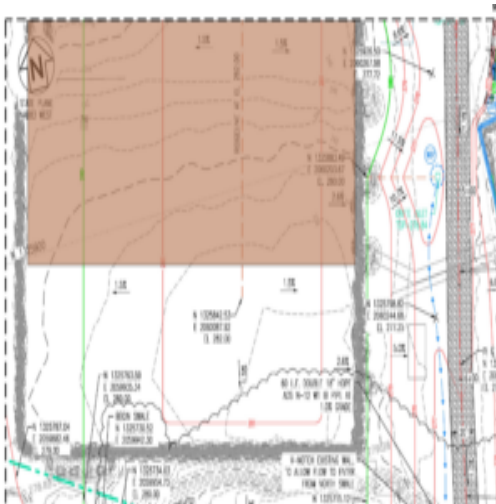
- Approximately 2,466 cubic yards of fill materials were placed for Lift 31 in two distinct sections: Section 1 basement area B7 (Reference: E720661 S1-R8) and Section 2 part 1 basement area G7 (Reference: E720659 S1-R8).
- The placement and compaction of the fill materials were conducted in general accordance with the guidelines outlined in ITP-001.
- The designated fill area is highlighted in brown on the attached drawing.

Highlighted region depicts the placement of fill materials in section 2 part 1

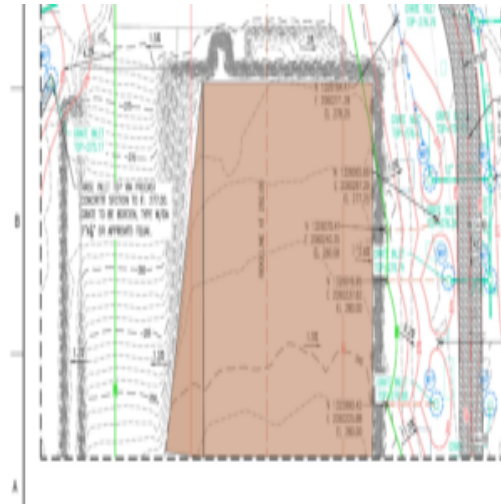
The highlighted region depicts the placement of fill materials in section 1

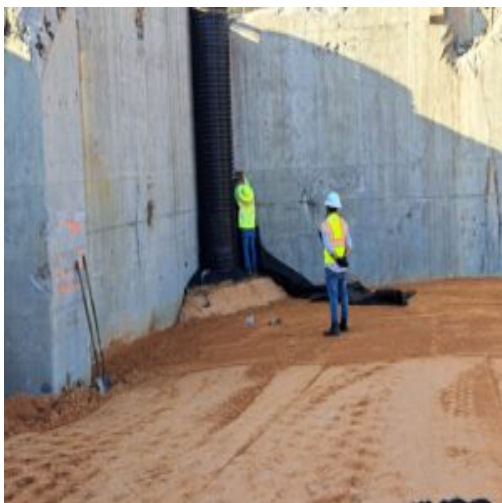
- Around the HDPE pipe, which functions as a dewatering well located at the southeast corner, aggregate was carefully placed. This serves to facilitate dewatering operations.
- Subsequently, the aggregate was wrapped with geo-fabric to prevent the migration of fines. This step aligns with the measures specified in ITP-003, aimed at maintaining the integrity of the dewatering system.

Placement of geo-fabric around HDPE pipe

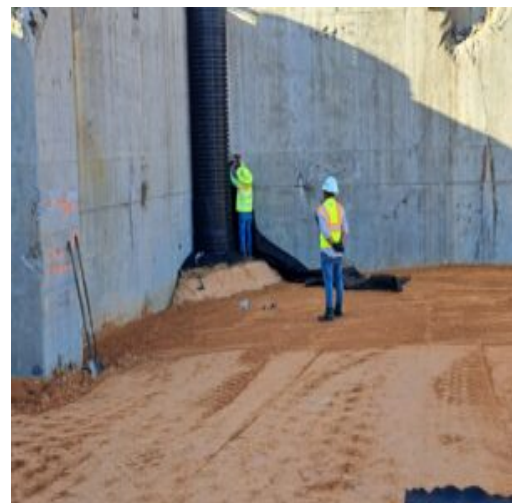
Placement of geo-fabric around HDPE pipe

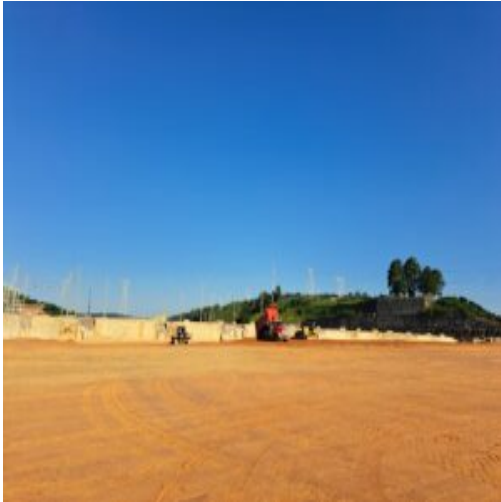
Started the new lift in section 1

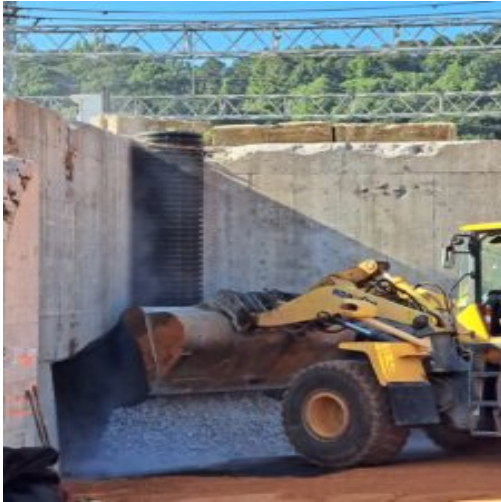
Placement of stone aggregate around the HDPE  
before the coverage of geo-fabric

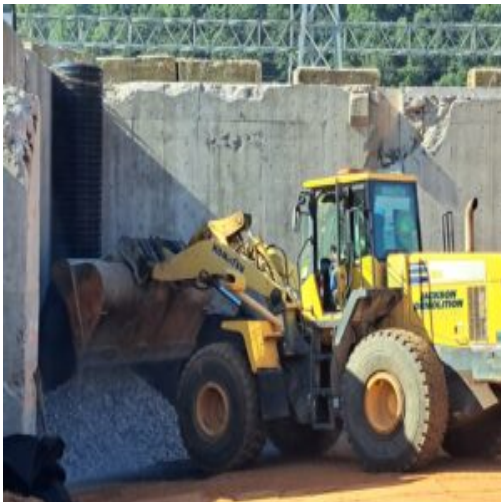
Placement of stone aggregate around the HDPE  
before the coverage of geo-fabric

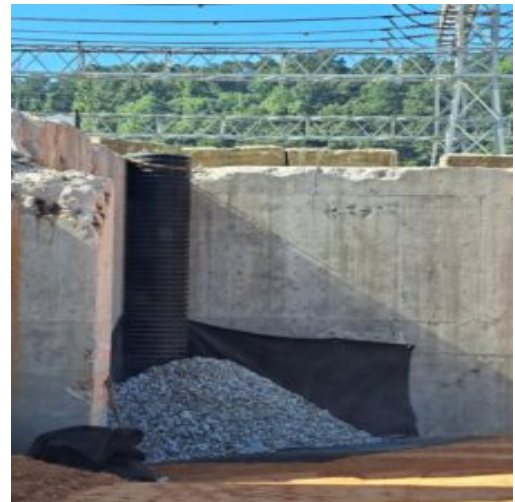
Placement of stone aggregate around the HDPE  
before the coverage of geo-fabric

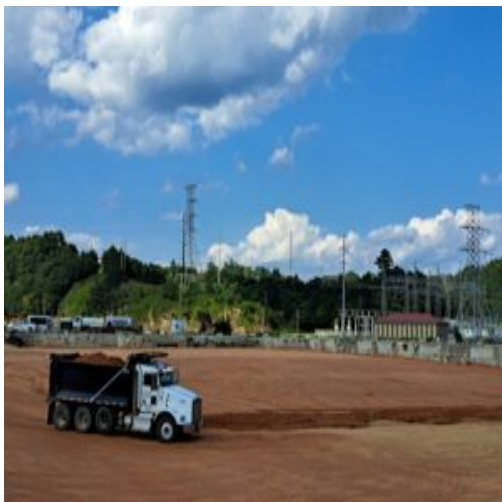
Placement of fill material in section 2 part 1
