ASEC Report ID : 60949  
Name of the Project : Plant Gorgas Demolition and Grading  
Project Location : 460 Gorgas Rd, Parrish, AL 35580  
Weather : Sunny  
Departure Time : 08/21/2023 16:30  
ASEC Technician Name : Avinash Bandham

## Site Visit Observation Report

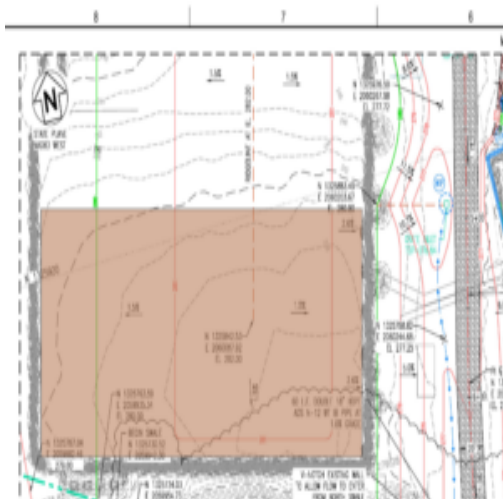
Highlighted region depicts placement of fill material  
section 2 part 2

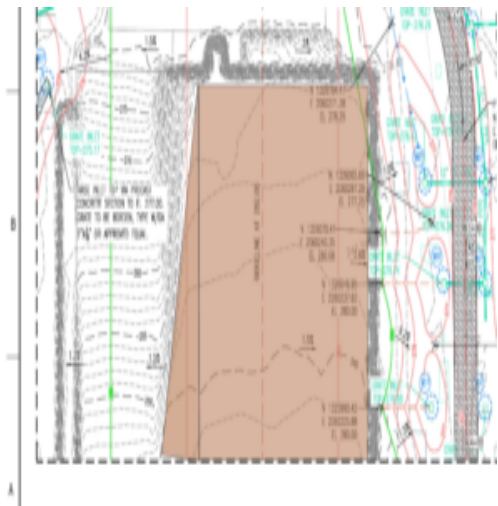
Highlighted region depicts placement of fill  
material section 1

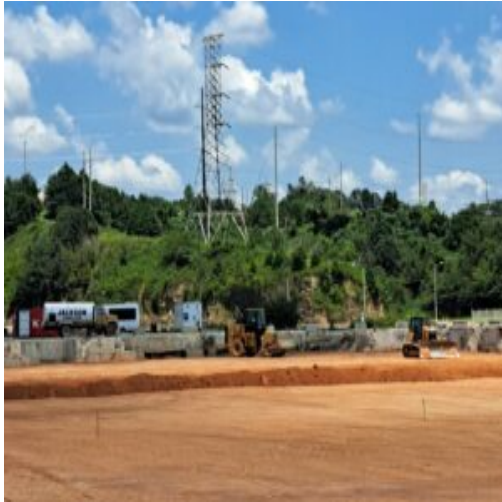
Placement of fill materials in section 1
