ASEC Report ID : 61128  
Name of the Project : Plant Gorgas Demolition and Grading  
Project Location : 460 Gorgas Rd, Parrish, AL 35580  
Weather : Sunny  
Departure Time : 08/24/2023 16:30  
ASEC Technician Name : Avinash Bandham

AS ENGINEERING AND CONSULTING, LLC (ASEC) representative Avinash Bandam visited the site at the request of Jackson Demolition representative Josh Kelly. The undersigned representative was present to monitor, verify and document the ongoing project activities. (reference drawing E720661 S1 - R5, E720659 S1-R5.)

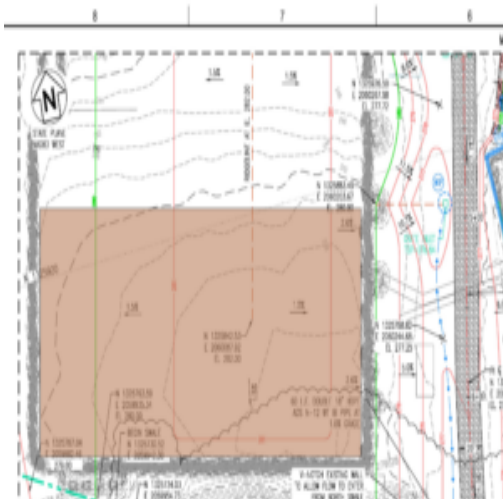
Highlighted region depicts the section 2

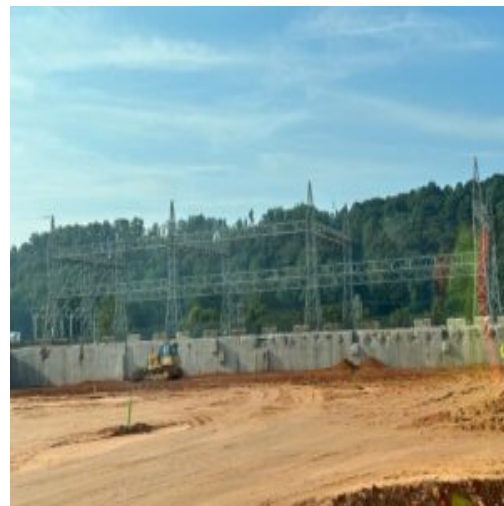
1. Two thousand one hundred twenty-four (2124) cubic yards of fill materials were placed for lift (33) in section 1 area B7 (drawing E720661) and continued the placement of in the section 2 for lift (33) are G7 (drawing E720659) of the basement. The materials were placed in accordance with ITP-001, and the fill area is highlighted in purple on the attached drawing.
2. The basement area was probed using the hand probe and three moisture density test were performed in the basement followed with a check-plug to verify the results with the ASTM proctor curve standards. The test locations were marked on the enclosed drawing.
3. Geo fabric is placed in French Drain Water treatment area.

Lift is placed on section 2

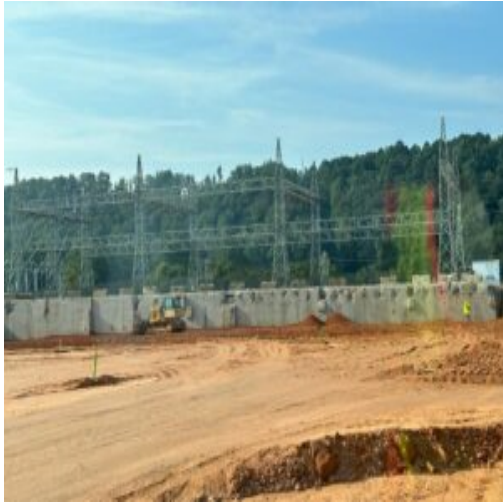
Hauling is performed in section 2

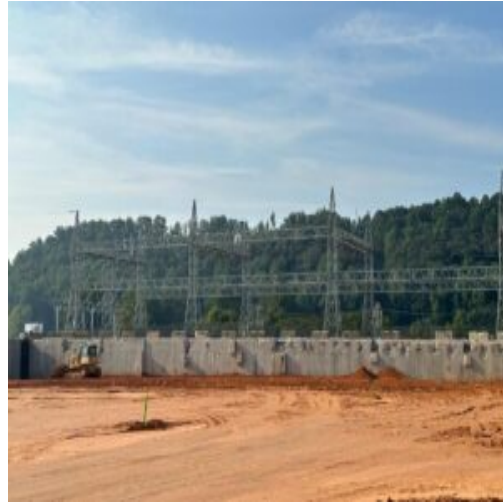
Hauling is performed in section 2

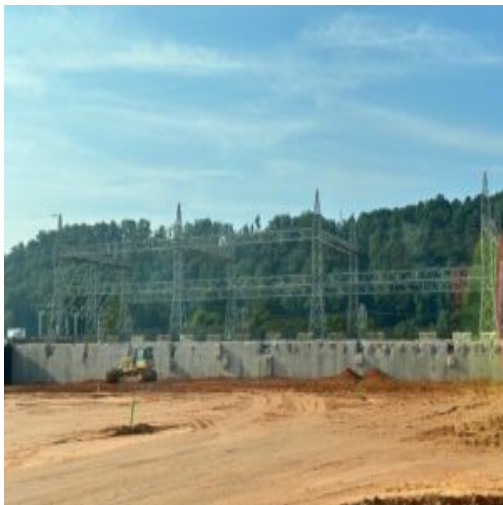
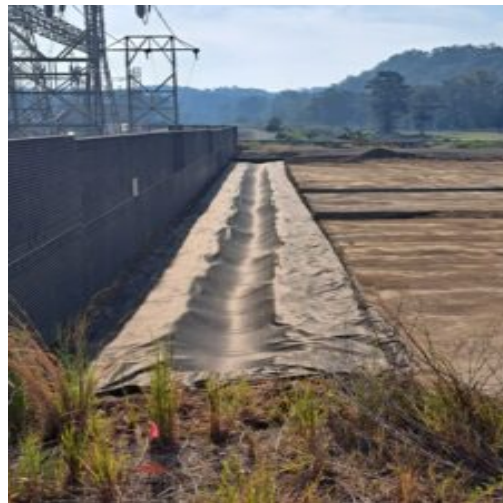
Geo fabric is placed in French Drain Water treatment area
