Date : 08/07/2023  
Project No : 2022C235  
Client Company : Jackson Demolition Service, Inc.  
Arrival Time : 08/07/2023 06:30  
Onsite Hours : 10:00

ASEC Report ID : 60764  
Name of the Project : Plant Gorgas Demolition and Grading  
Project Location : 460 Gorgas Rd, Parrish, AL 35580  
Weather : Partly Cloudy  
Departure Time : 08/07/2023 16:30  
ASEC Technician Name : Ramchandra Mogulla

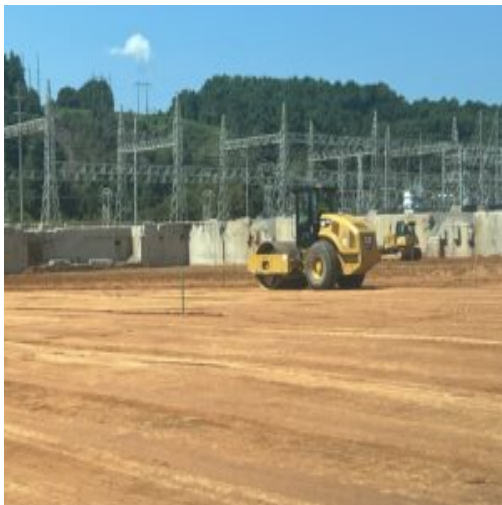
Smooth drum roller performing sealing operation due to impending rain.

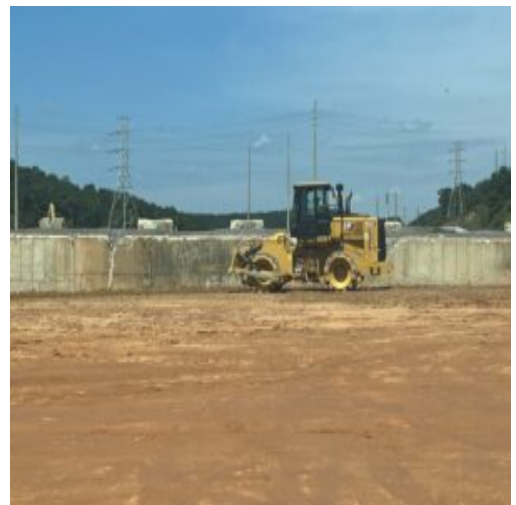
Compaction efforts using an 815 compactor
