Date : 08/09/2023  
Project No : 2022C235  
Client Company : Jackson Demolition Service, Inc.  
Arrival Time : 08/09/2023 06:30  
Onsite Hours : 9:30

ASEC Report ID : 60810  
Name of the Project : Plant Gorgas Demolition and Grading  
Project Location : 460 Gorgas Rd, Parrish, AL 35580  
Weather : Overcast  
Departure Time : 08/09/2023 16:00  
ASEC Technician Name : Ramchandra Mogulla

AS ENGINEERING AND CONSULTING, LLC (ASEC) representative Ram Mogulla visited the site at the request of Jackson Demolition representative Josh Kelly. The undersigned representative was present to monitor, verify and document the ongoing project activities. (reference drawing E720661 S1 - R5, E720659 S1-R5.)

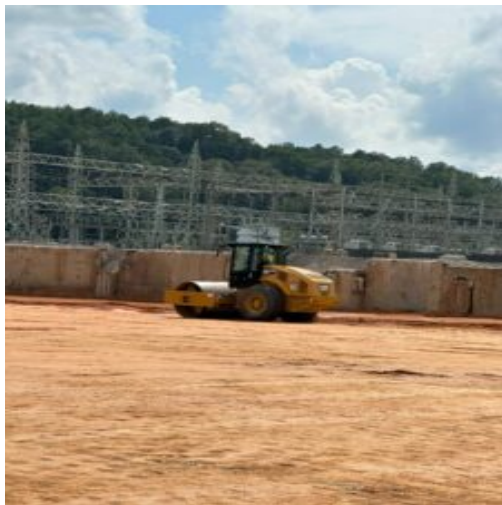
Smooth drum roller sealing areas that have been compacted using a 815.

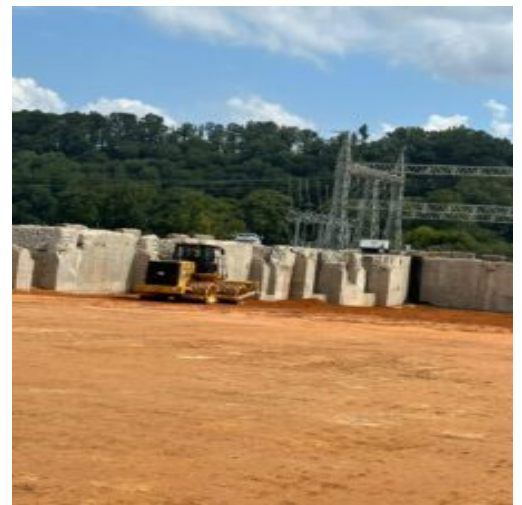
Continued compacting fill using an 815
