Date : 08/28/2023  
Project No : 2022C235  
Client Company : Jackson Demolition Service, Inc.  
Arrival Time : 08/28/2023 06:00  
Onsite Hours : 10:30

ASEC Report ID : 61152  
Name of the Project : Plant Gorgas Demolition and Grading  
Project Location : 460 Gorgas Rd, Parrish, AL 35580  
Weather : SUNNY  
Departure Time : 08/28/2023 16:30  
ASEC Technician Name : Avinash Bandham

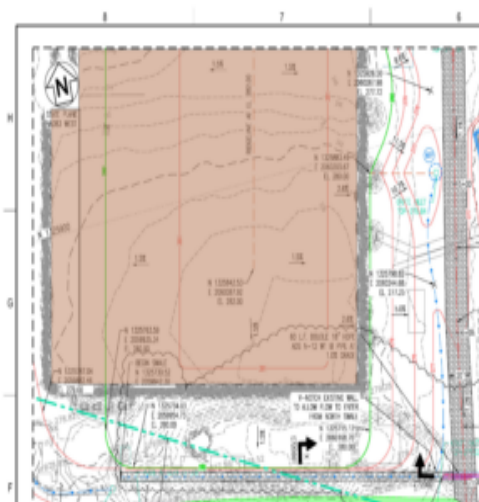
1. Two thousand four hundred and eighty-four (2484) cubic yards of fill materials were placed for lift (35) in section 2 basement area G7 (E720659 S1-R8). The materials were placed and compacted in accordance with ITP-001, and the fill area is highlighted in brown as depicted in the attached drawing.

The highlighted area depicts the placement of fill materials in section 2

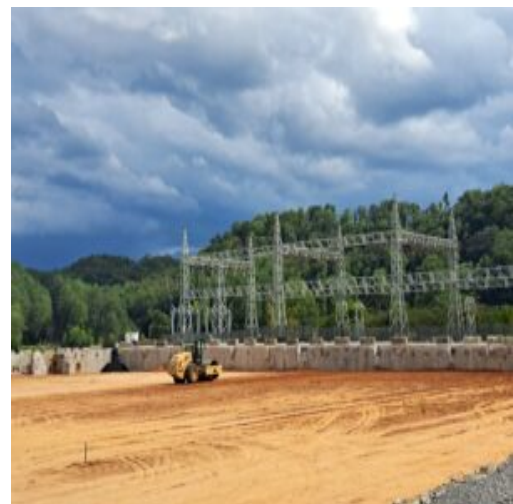
Hauling and compacting in section 2

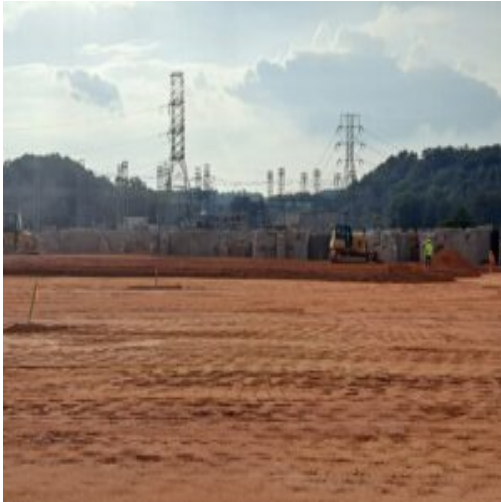
Placement of fill-material in section 2

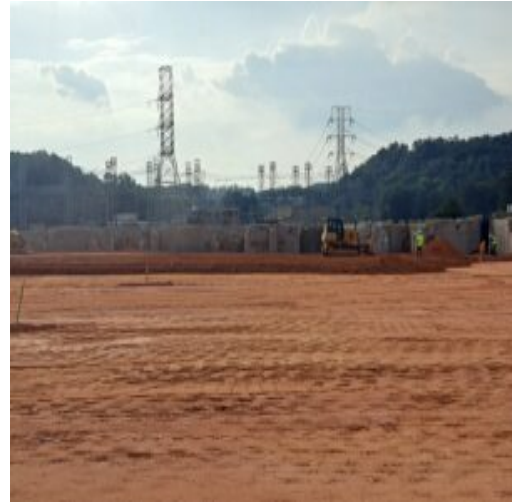
Placement of fill-material in section 2

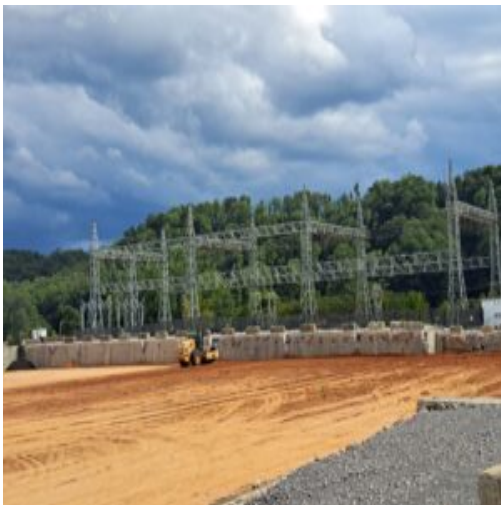
Placement of fill-material in section 2

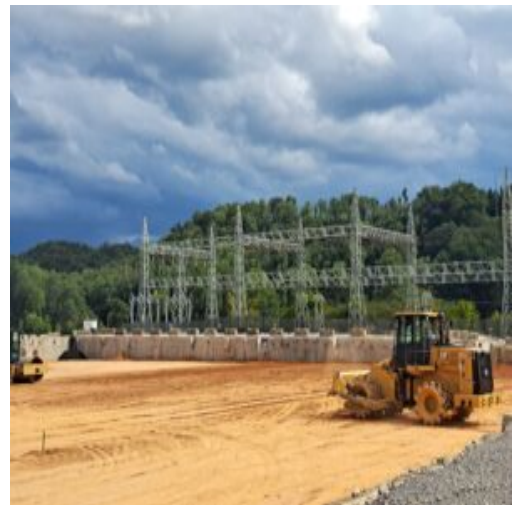
Placement of fill-material in section 2

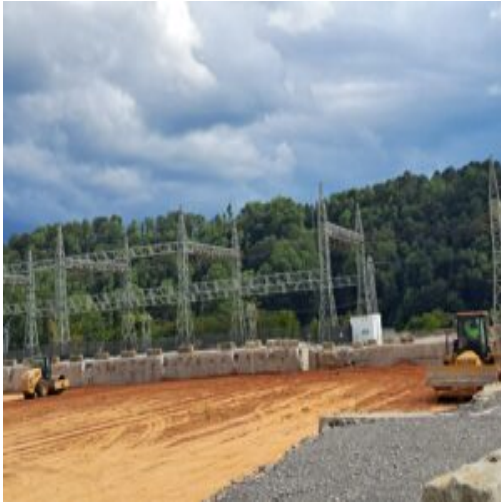
Placement of fill-material in section 2

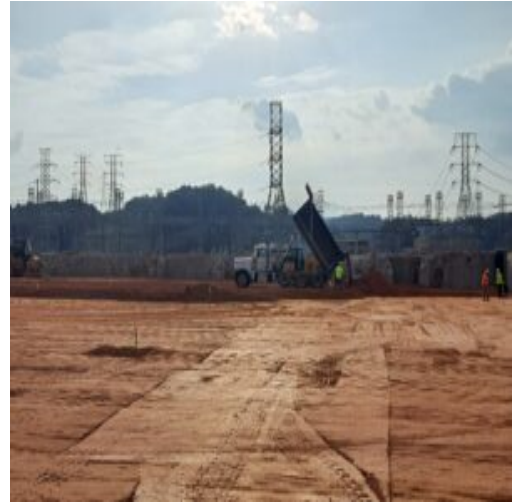
Placement of fill-material in section 2

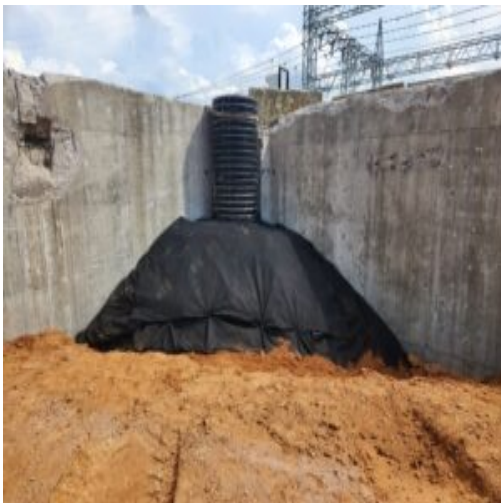
2. HDPE Pipe Installation: Around the HDPE pipe, which functions as a dewatering well located at the southeast corner, aggregate was carefully placed. This serves to facilitate dewatering operations. Subsequently, the aggregate was wrapped with geo-fabric to prevent the migration of fines. This step aligns with the measures specified in ITP-003, aimed at maintaining the integrity of the dewatering system.

Covered the HDPE with Geo-fabric

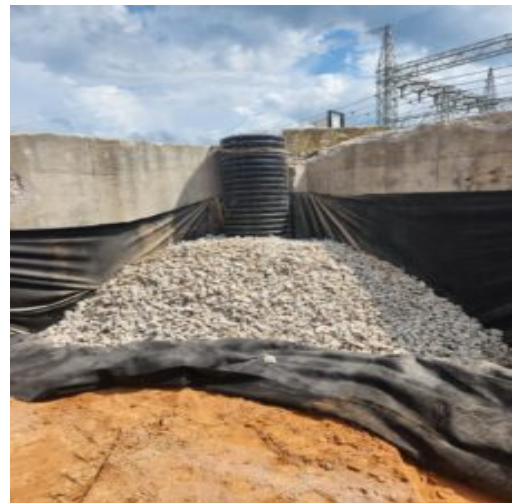
Placed the stone before the coverage of Geo-fabric
