Date : 08/31/2023  
Project No : 2022C235  
Client Company : Jackson Demolition Service, Inc.  
Arrival Time : 08/31/2023 6:00  
Onsite Hours : 10:30

ASEC Report ID : 61189  
Name of the Project : Plant Gorgas Demolition and Grading  
Project Location : 460 Gorgas Rd, Parrish, AL 35580  
Weather : Sunny  
Departure Time : 08/31/2023 16:30  
ASEC Technician Name : Avinash Bandham

AS ENGINEERING AND CONSULTING, LLC (ASEC) representative Avinash Bandam visited the site at the request of Jackson Demolition representative Josh Kelly. The undersigned representative was present to monitor, verify and document the ongoing project activities. (reference drawing E720661 S1 - R5, E720659 S1-R5.)

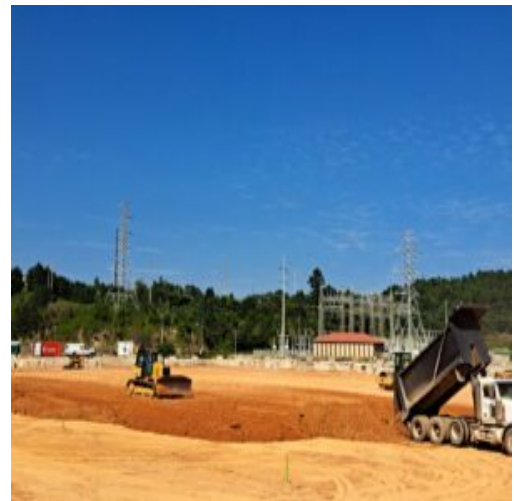
Lift is placed in section 2

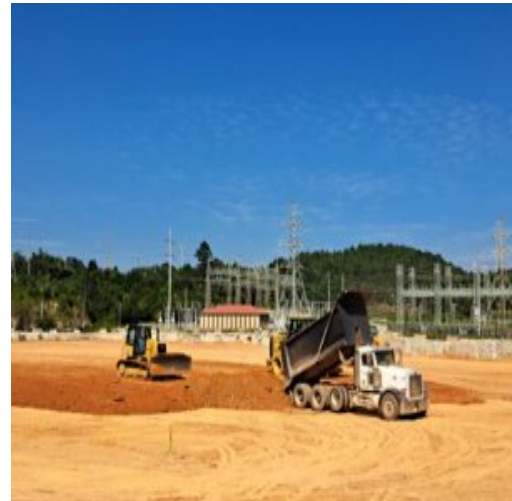
Hauling is performed in section 2

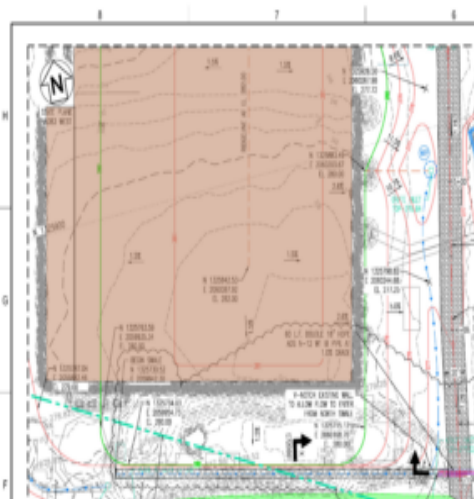
Highlighted region depicts section 2 part 1

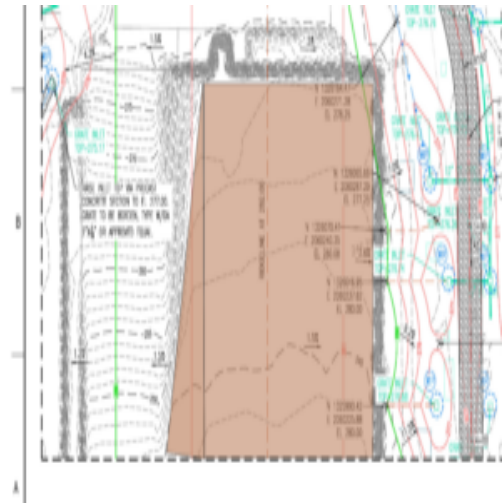
Highlighted region depicts section 1
