Date : 09/05/2023  
Project No : 2022C235  
Client Company : Jackson Demolition Service, Inc.  
Arrival Time : 09/05/2023 6:00  
Onsite Hours : 10:30

ASEC Report ID : 61319  
Name of the Project : Plant Gorgas Demolition and Grading  
Project Location : 460 Gorgas Rd, Parrish, AL 35580  
Weather : Sunny  
Departure Time : 09/05/2023 16:30  
ASEC Technician Name : Avinash Bandham

AS ENGINEERING AND CONSULTING, LLC (ASEC) representative Avinash Bandam visited the site at the request of Jackson Demolition representative Josh Kelly. The undersigned representative was present to monitor, verify and document the ongoing project activities. (reference drawing E720661 S1 - R5, E720659 S1-R5.)

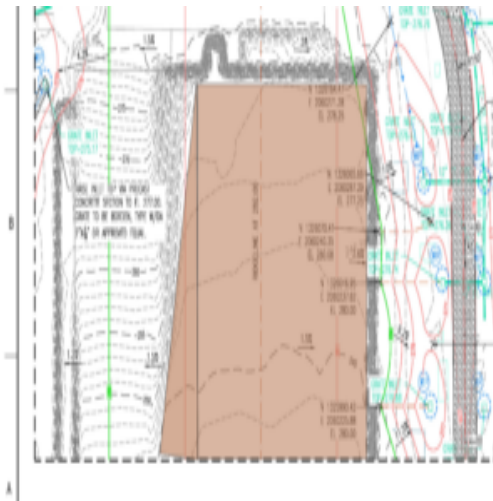
Highlighted region depicts section 1

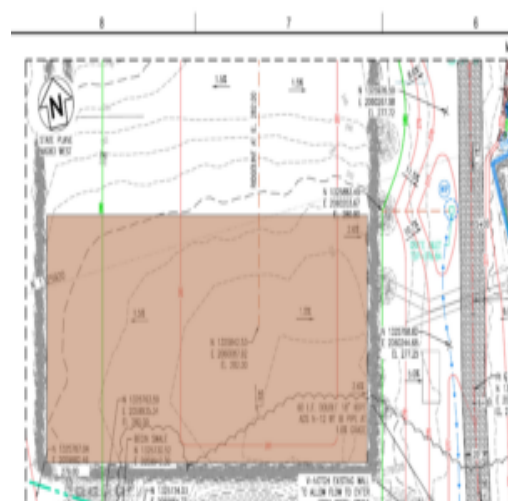
Highlighted region depicts section 2 part 2

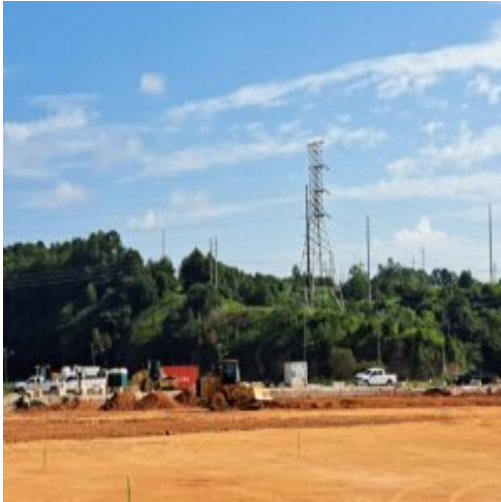
Lift is placed on section 1

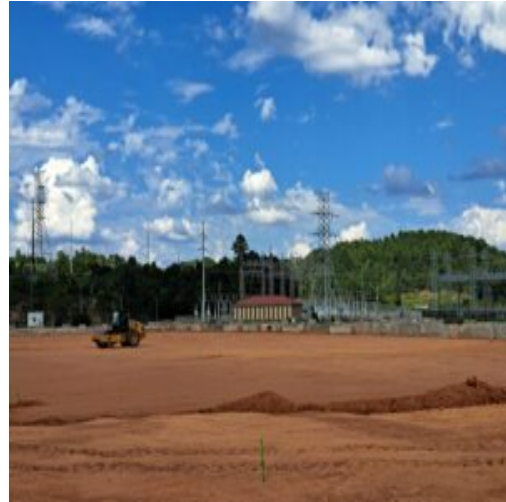
Hauling of structural field material in section 2

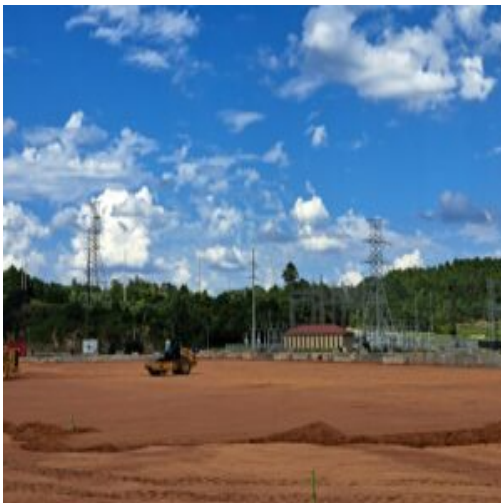
Lift is placed on section 2
