Date : 09/07/2023  
Project No : 2022C235  
Client Company : Jackson Demolition Service, Inc.  
Arrival Time : 09/07/2023 06:00  
Onsite Hours : 10:30

ASEC Report ID : 61437  
Name of the Project : Plant Gorgas Demolition and Grading  
Project Location : 460 Gorgas Rd, Parrish, AL 35580  
Weather : SUNNY  
Departure Time : 09/07/2023 16:30  
ASEC Technician Name : Avinash Bandham

AS ENGINEERING AND CONSULTING, LLC (ASEC) representative Avinash Bandam visited the site at the request of Jackson Demolition representative Josh Kelly. The undersigned representative was present to monitor, verify and document the ongoing project activities. (Reference drawing E720661 S1 - R8, E720659 S1-R8.)

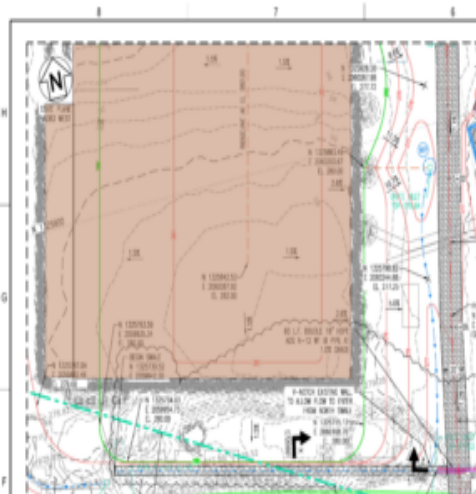
Placement of Structural fill materials in section 2

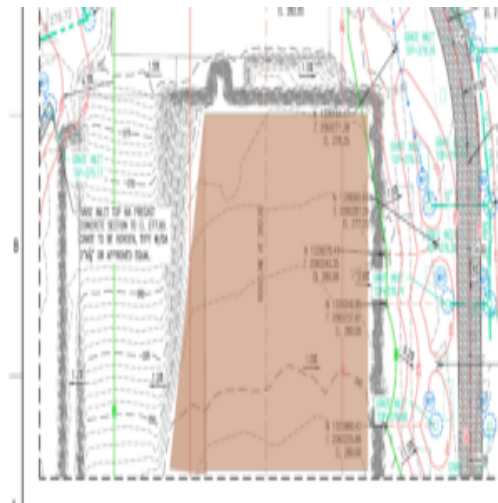
Placement of Structural fill materials in section 1

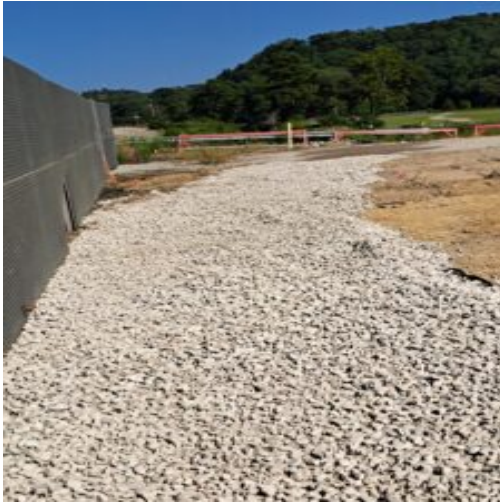
Placed 57-Stone along the trench drain water treatment area

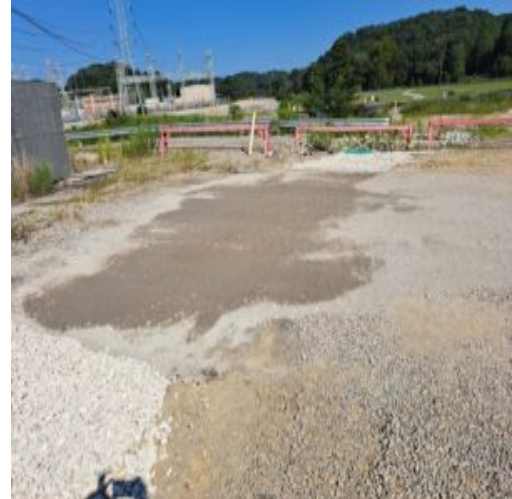
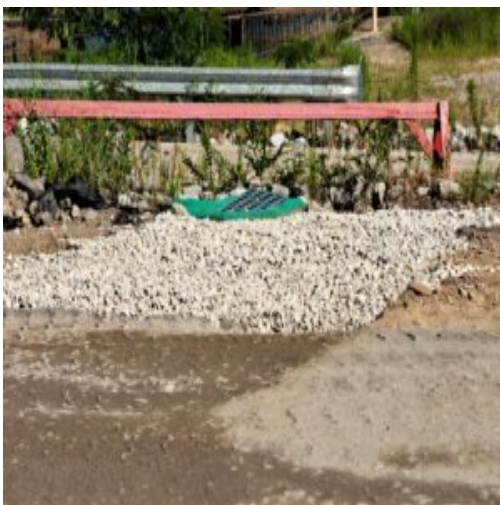
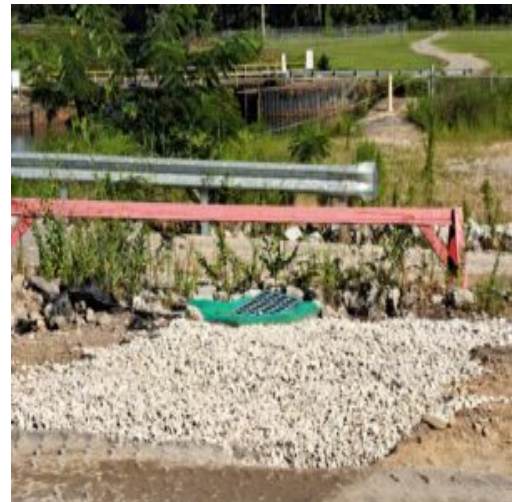
Placed 57-Stone at trench drain water treatment area

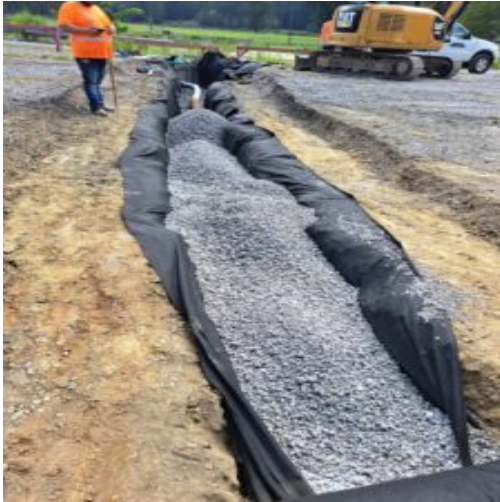
Placed aggregate in the trench after the placement of HDPE pipe was placed in the trench after the Geo-fabric placement.

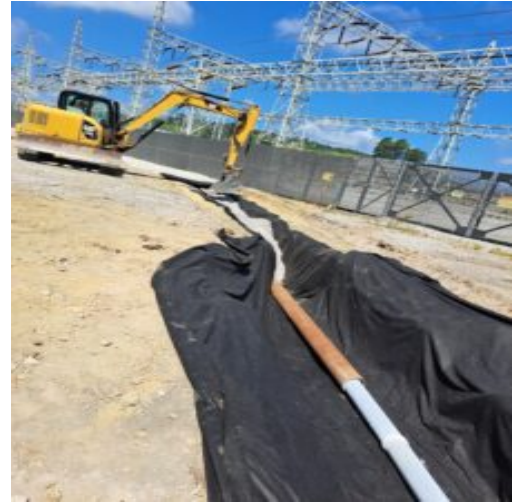
HDPE pipe was placed in the trench after the Geo-fabric placement.

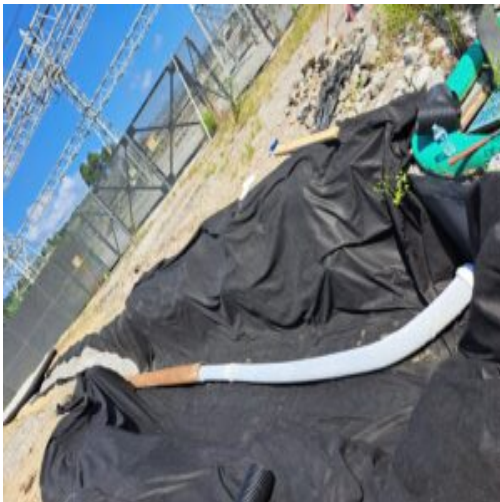
Perforated pipe was placed in the trench after the Geo-fabric placement.

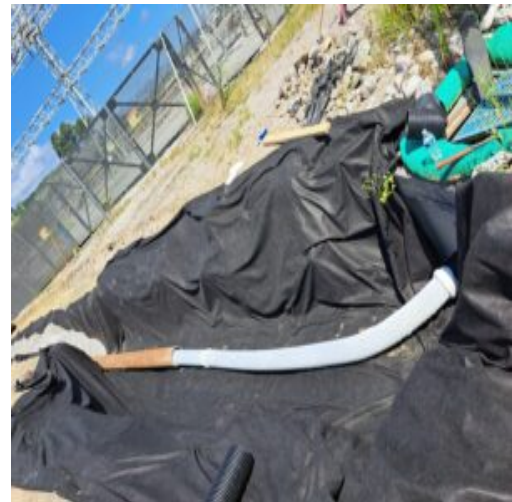
HDPE pipe was placed in the trench after the Geo-fabric placement.

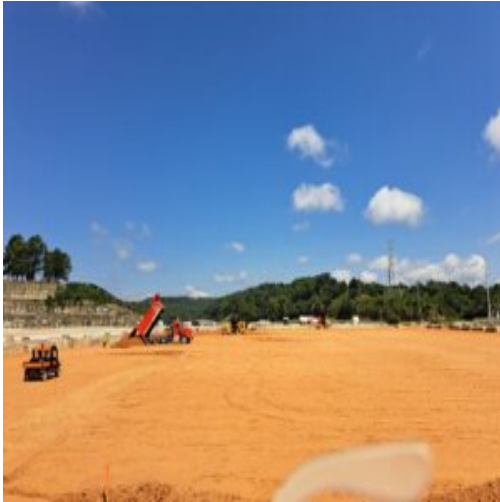
placement of structural fill materials in section near  
the ramp

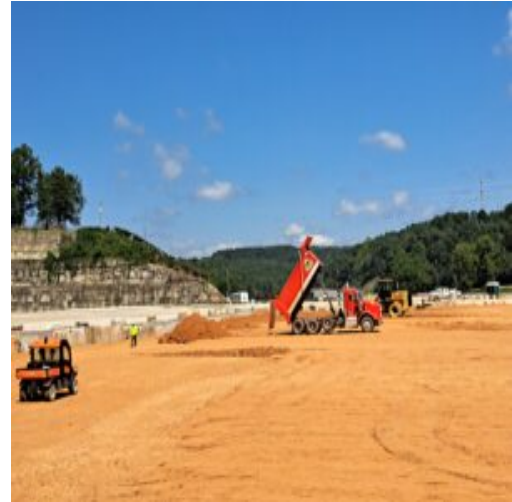
placement of structural fill materials in section  
near the ramp

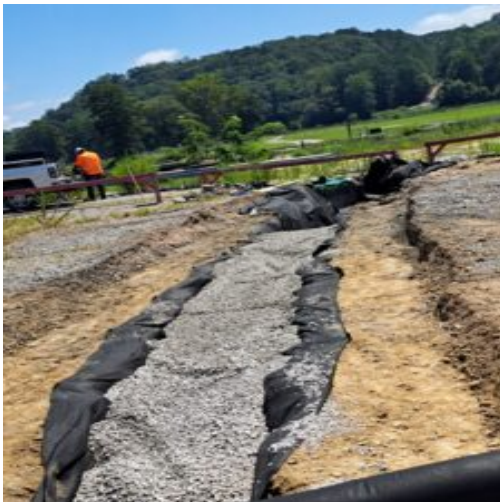
Placed aggregate in the trench after the placement of  
perforated pipe
