Date : 09/11/2023  
Project No : 2022C235  
Client Company : Jackson Demolition Service, Inc.  
Arrival Time : 09/11/2023 06:00  
Onsite Hours : 10:30

ASEC Report ID : 61447  
Name of the Project : Plant Gorgas Demolition and Grading  
Project Location : 460 Gorgas Rd, Parrish, AL 35580  
Weather : SUNNY  
Departure Time : 09/11/2023 16:30  
ASEC Technician Name : Avinash Bandham

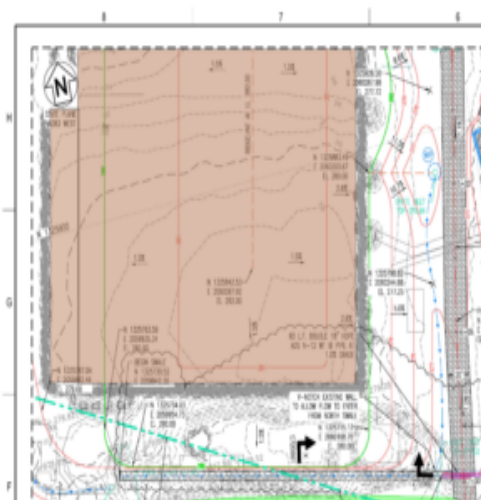
1. Three thousand five hundred and sixty-four (3564) cubic yards of structural-fill materials were placed for lift (6) in section 1 basement area B7 (E720661 S1-R8) and for lift (6) in section 2 basement are G7(E720659 S1-R8). The materials were placed and compacted in accordance with ITP-001, and the fill area is highlighted in brown as depicted in the attached drawing.

The highlighted region depicts the placement of structural fill-material in section 2

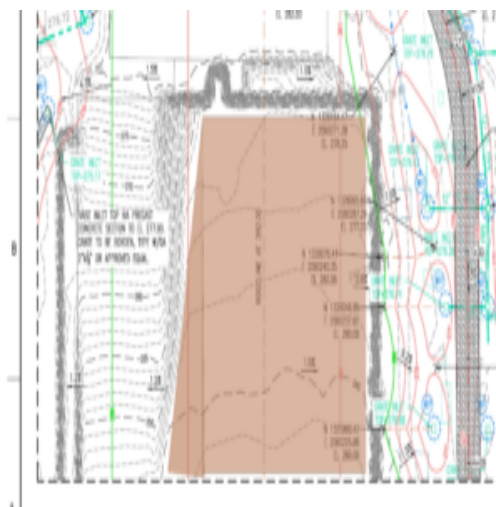
The highlighted region depicts the placement of structural fill-material in section 2

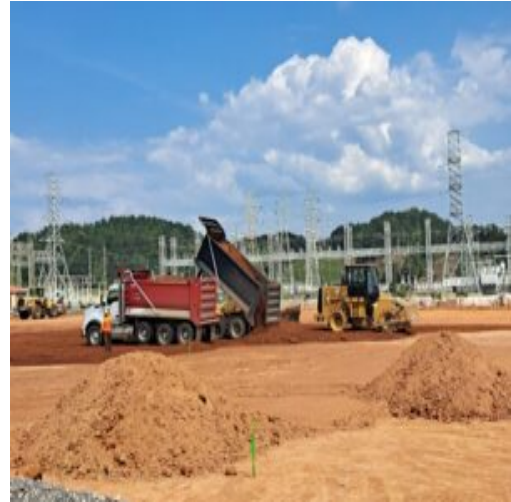
Placement of structural fill material in section 2  
basement area

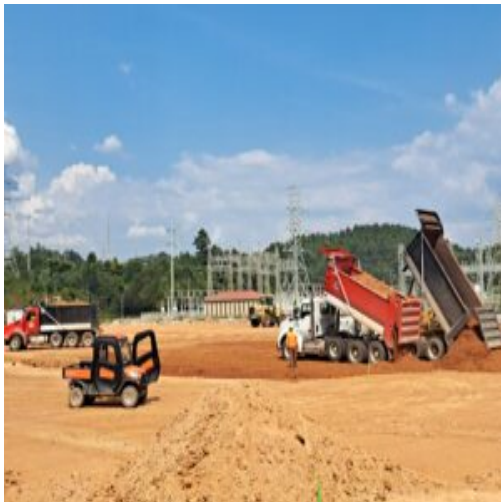
Placement of structural fill material in section 2  
basement area

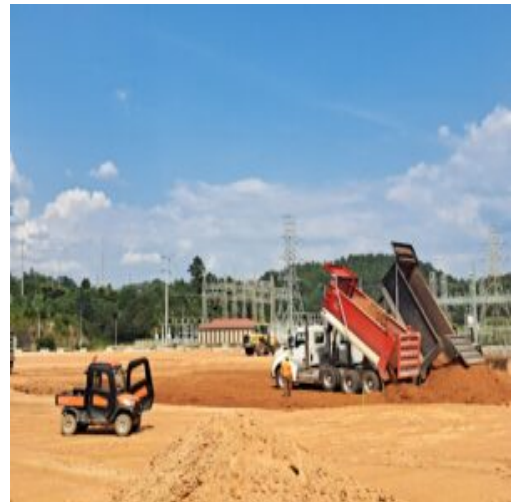
Placement of structural fill material in section 2  
basement area

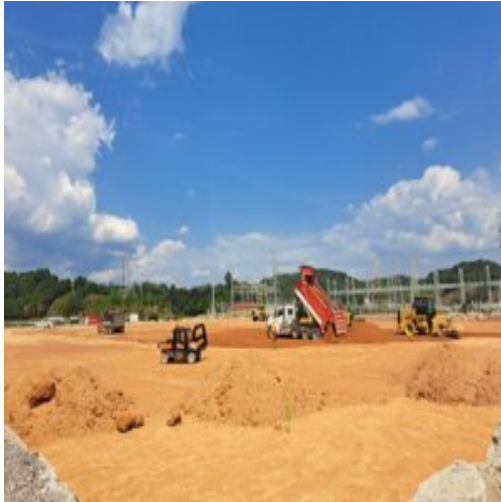
Placement of structural fill material in section 2 basement area

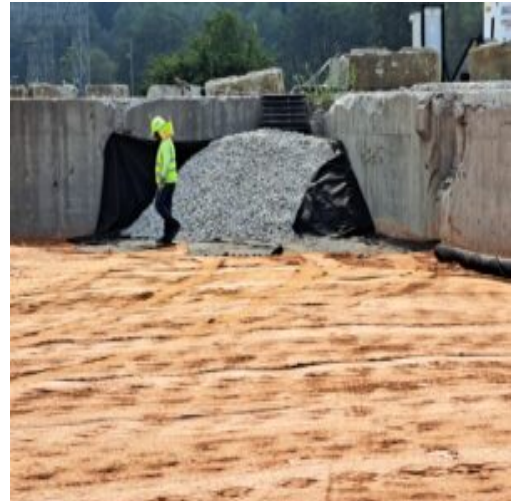
3. Around the HDPE pipe, which functions as a dewatering well located at the southeast corner, aggregate was carefully placed. This serves to facilitate dewatering operations. Subsequently, the aggregate was wrapped with geo-fabric to prevent the migration of fines. This step aligns with the measures specified in ITP-003, aimed at maintaining the integrity of the dewatering system.

Placed the stone-aggregate around the pipe

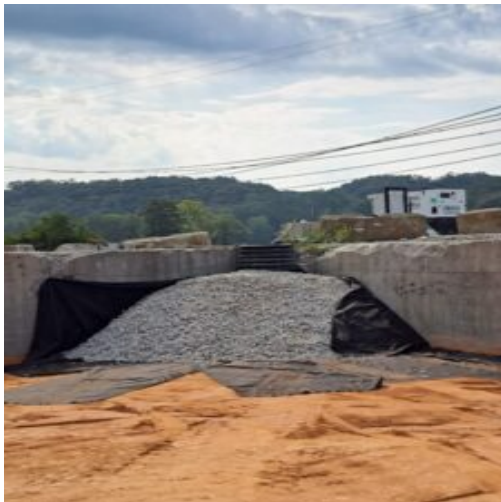
Placed the stone-aggregate around the pipe

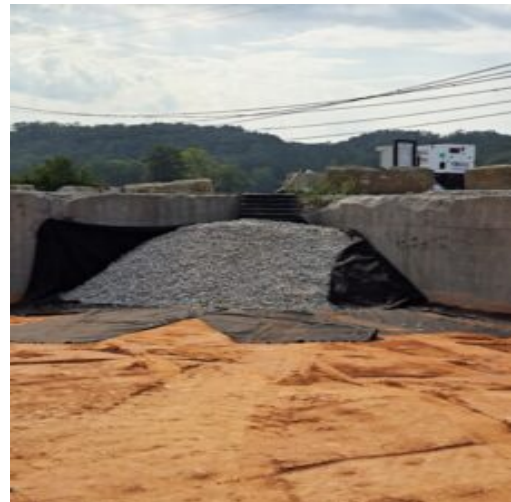
Placed the stone-aggregate around the pipe

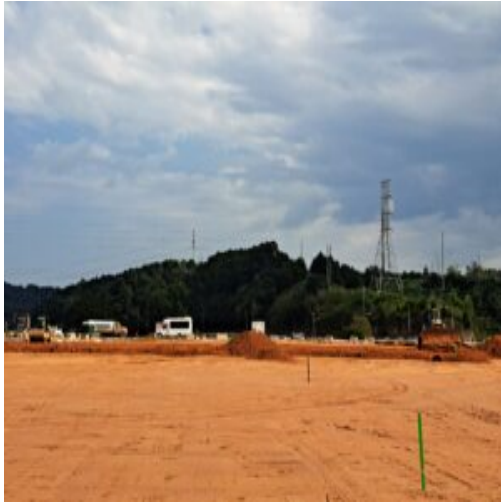
Placement of structural fill material in section 1

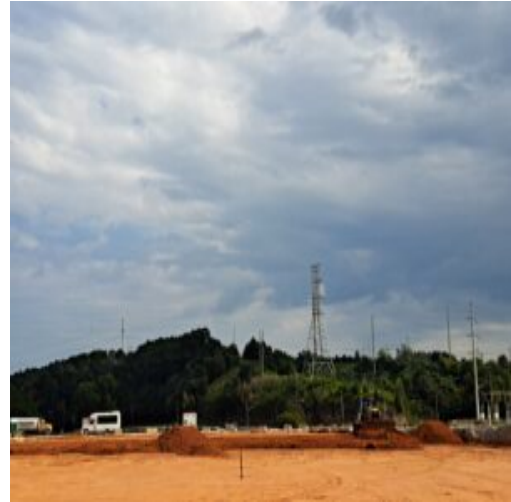
Placement of structural fill material in section 1

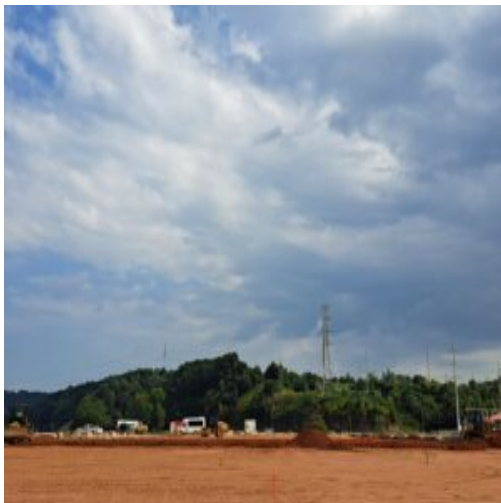
Placement of structural fill material in section 1

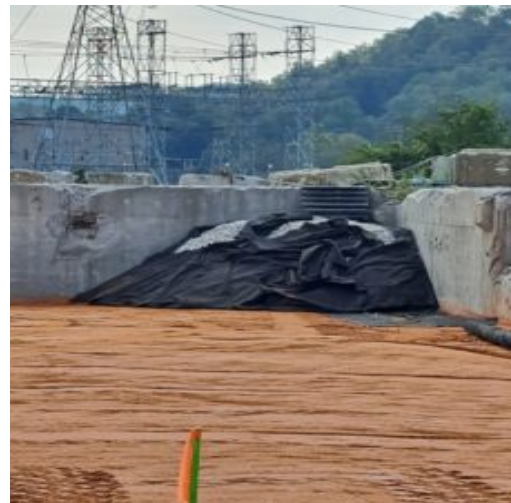
Covered HDPE pipe with Geo-fabric

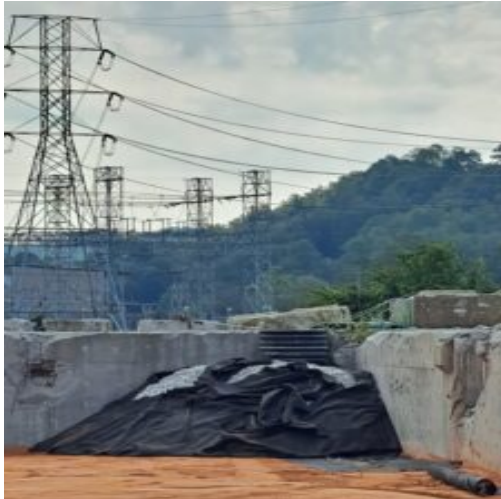
Covered HDPE pipe with Geo-fabric

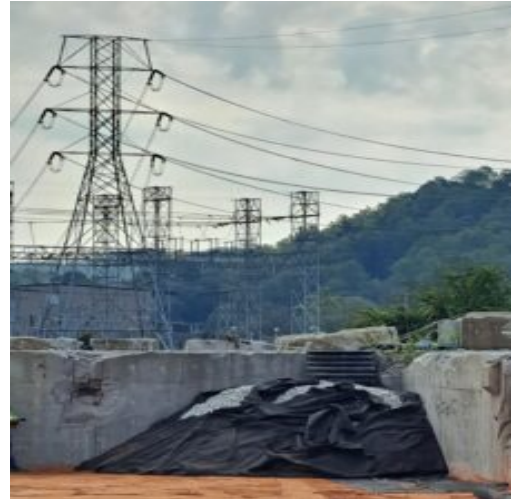
Covered HDPE pipe with Geo-fabric

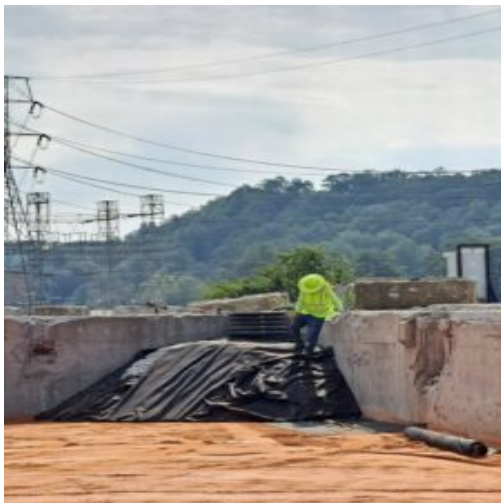
Covered HDPE pipe with Geo-fabric
