Date : 09/15/2023  
Project No : 2022C235  
Client Company : Jackson Demolition Service, Inc.  
Arrival Time : 09/15/2023 6:00  
Onsite Hours : 10:30

ASEC Report ID : 61712  
Name of the Project : Plant Gorgas Demolition and Grading  
Project Location : 460 Gorgas Rd, Parrish, AL 35580  
Weather : Sunny  
Departure Time : 09/15/2023 16:30  
ASEC Technician Name : Avinash Bandham

AS ENGINEERING AND CONSULTING, LLC (ASEC) representative Avinash Bandam visited the site at the request of Jackson Demolition representative Josh Kelly. The undersigned representative was present to monitor, verify and document the ongoing project activities. (reference drawing E720661 S1 - R5, E720659 S1-R5.)

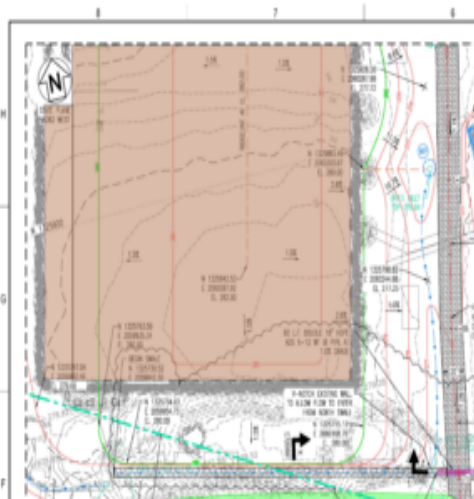
Highlighted region depicts section 2

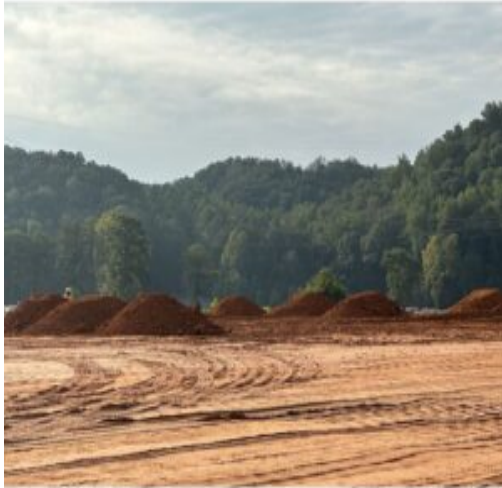
Lift is placed on section 2

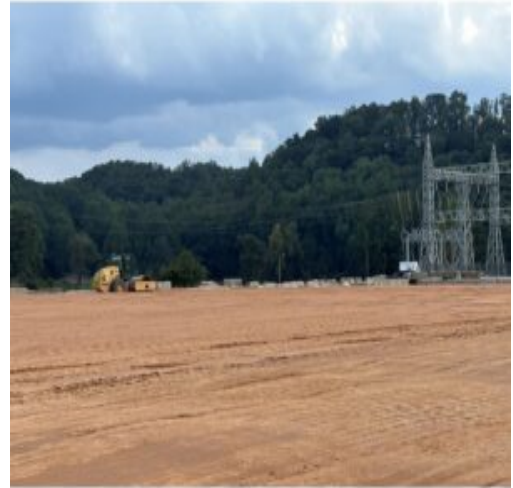
Hauling is performed in section 2
