Date : 10/04/2023  
Project No : 2022C235  
Client Company : Jackson Demolition Service, Inc.  
Arrival Time : 10/04/2023 6:00  
Onsite Hours : 10:30

ASEC Report ID : 62364  
Name of the Project : Plant Gorgas Demolition and Grading  
Project Location : 460 Gorgas Rd, Parrish, AL 35580  
Weather : Sunny  
Departure Time : 10/04/2023 16:30  
ASEC Technician Name : Avinash Bandham

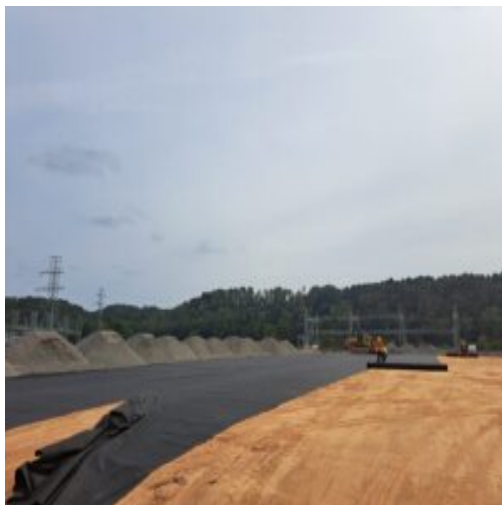
Geo-fabric is placed on other side of basement

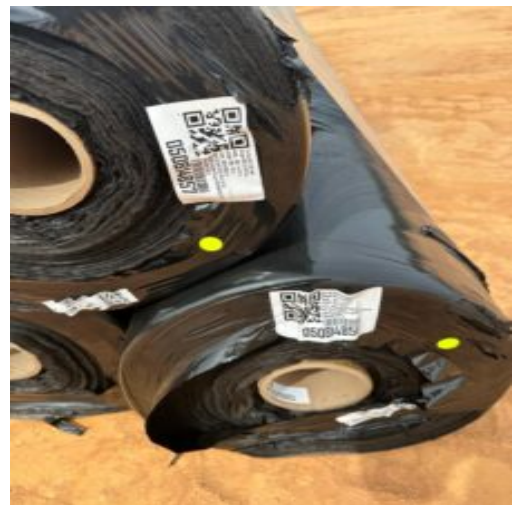
Geo-fabric has been received
