Date : 03/28/2023  
 Project No : 2023C111  
 Client Company : 2MATL  
 Arrival Time : 03/28/2023 08:00  
 Onsite Hours : 07:30

ASEC Report ID : 58183  
 Name of the Project : DOA Fiber Infrastructure Improvements  
 Project Location : HJAIA  
 Weather : Sunny  
 Departure Time : 03/28/2023 15:30  
 ASEC Technician Name : Isaac Davis

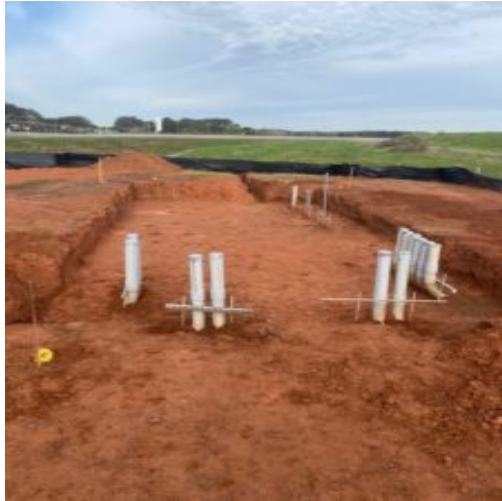
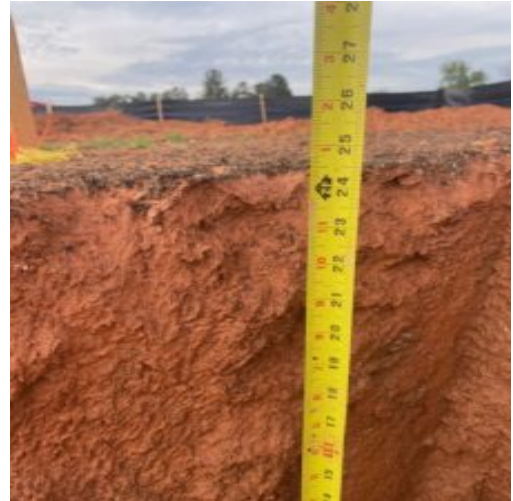
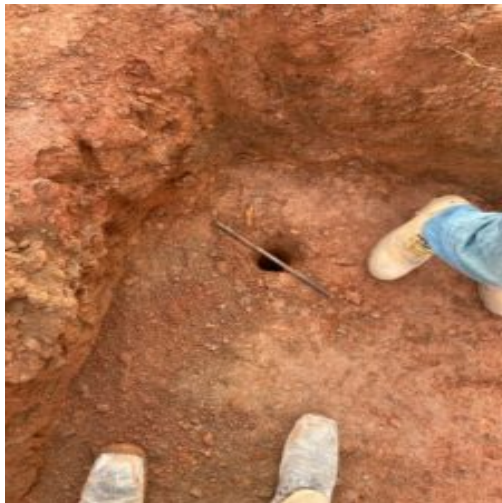
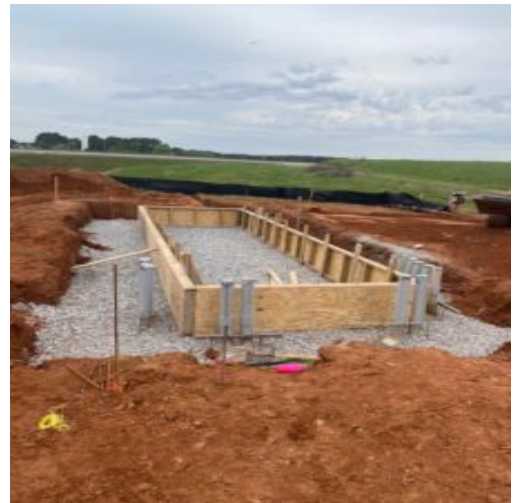
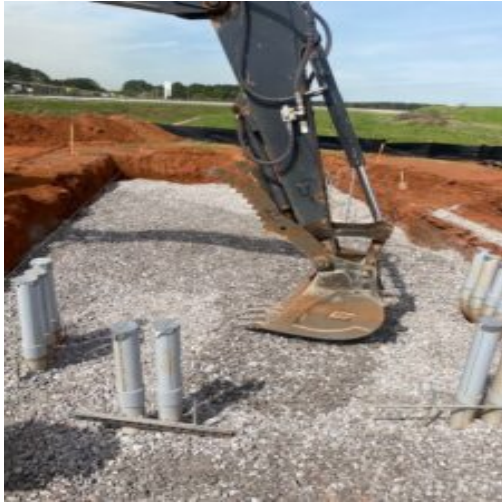
- Work was being performed in the area of proposed Vault 2 on this day.
- Vault 2 foundations require an allowable bearing capacity of 1500 psf.
- The subgrade appeared to be saturated in the top 4 to 6 inches from recent rain events.
- Bearing soils were assessed utilizing a dynamic cone penetrometer in two locations within the footprint of the vault.
- Based on the DCP test data the subgrade soils appear to be capable of supporting the required bearing pressures.
- The upper 4 to 6 inches of the subgrade will need remediation. The contractor was advised to remove and replace the top 4 to 6 inches of soft saturated material with structural fill.
- The contractor elected to remove this material and replace it with #57 stone all the way to the bottom of footing elevation.
