Date : 04/19/2023  
Project No : 2023C111  
Client Company : 2MATL  
Arrival Time : 04/19/2023 08:00  
Onsite Hours : 06:00

ASEC Report ID : 58708  
Name of the Project : DOA Fiber Infrastructure Improvements  
Project Location : HJAIA  
Weather : Sunny  
Departure Time : 04/19/2023 14:00  
ASEC Technician Name : Isaac Davis

As requested, our AS Engineering & Consulting LLC representative was on site to perform a visual reinforcing steel inspection (for Vault #2). Compaction around the manways (tech campus) was also performed.

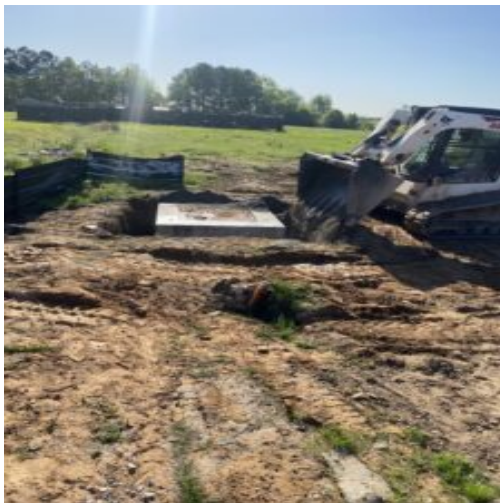
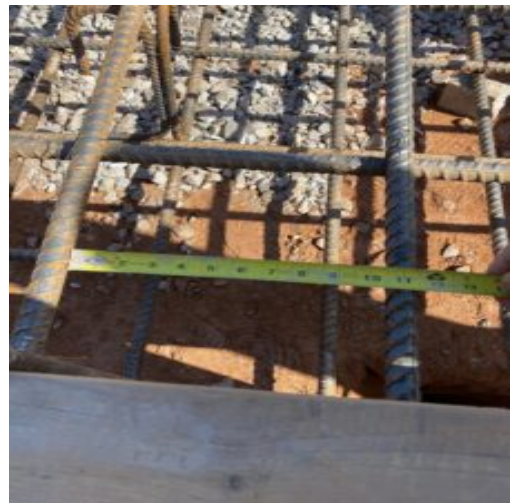
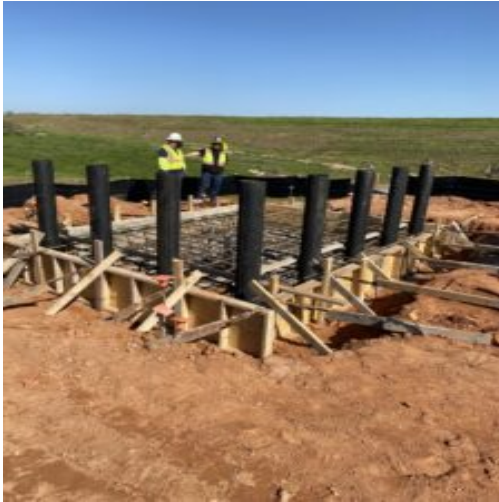
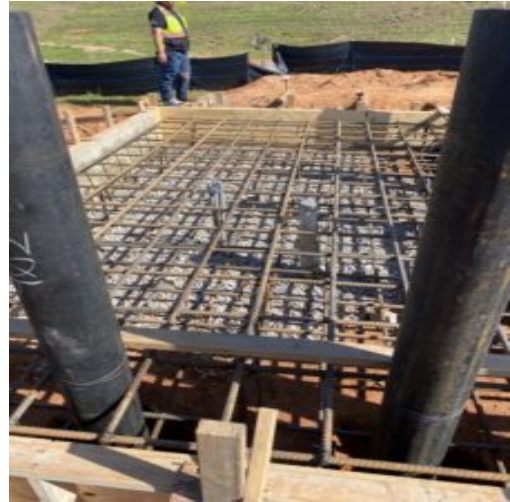
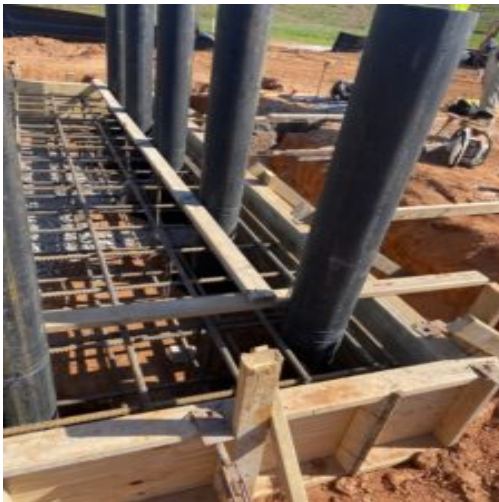
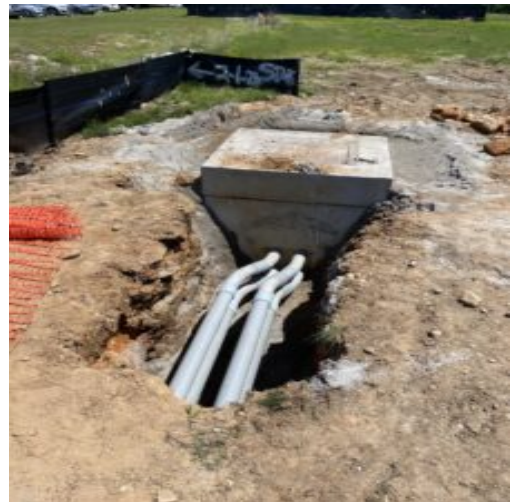
- Rebar spacing met job specifications.
- Rebar gap between both top and bottom layers met job specifications.
- Rebar was tied off and mounted as per job specifications.
- Contractor put additional rebar to reinforce the areas that were deficient due to bollards.

- The contractor filled in back section of manhole with M10 sand.
- This area was probed with a 3/8-inch diameter probe rod and one density test performed. Did not meet compaction requirements so no additional work was performed in this area at this time.
- Following concrete placement around the conduit, compaction around manhole will be performed (and retested).
