Date : 05/22/2023  
Project No : 2023C111  
Client Company : 2MATL  
Arrival Time : 05/22/2023 22:00  
Onsite Hours : 08:30

ASEC Report ID : 59371  
Name of the Project : DOA Fiber Infrastructure Improvements  
Project Location : HJAIA  
Weather : overcast  
Departure Time : 05/23/2023 06:30  
ASEC Technician Name : Isaac Davis

Density testing for DOA Fiber AVS NS.

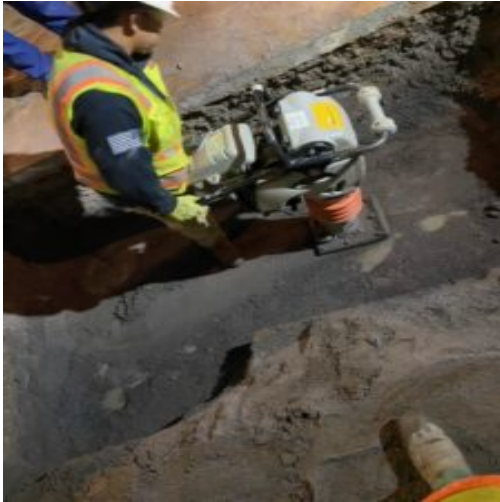
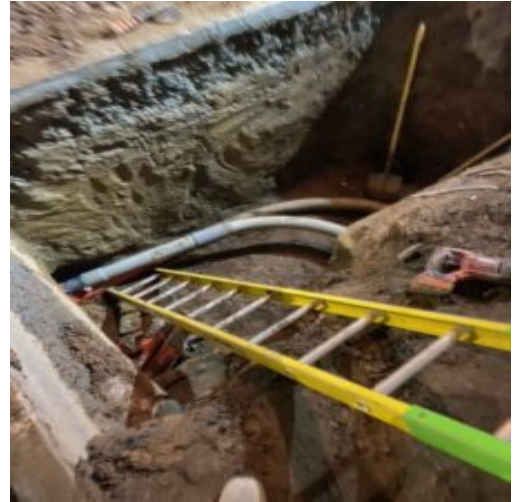
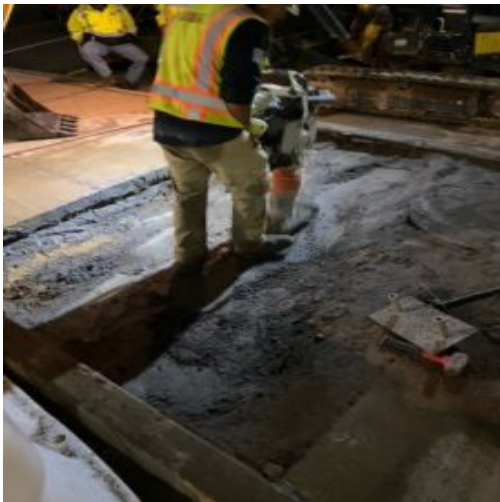
Upon completion of density testing, it was observed that the measured values for all lifts were within the specified limits, indicating satisfactory compaction and moisture levels. The project area at DOA Fiber AVS NS met the required specifications based on the test results.
