Date : 01/04/2024  
Project No : 2023C111  
Client Company : 2MATL  
Arrival Time : 01/04/2024  
Onsite Hours :

ASEC Report ID : 64357  
Name of the Project : DOA Fiber Infrastructure Improvements  
Project Location : HJAIA  
Weather : cloudy  
Departure Time : 01/04/2024  
ASEC Technician Name : Russell Hendrix

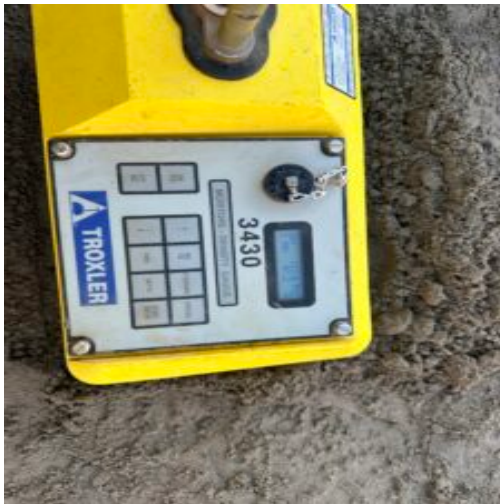
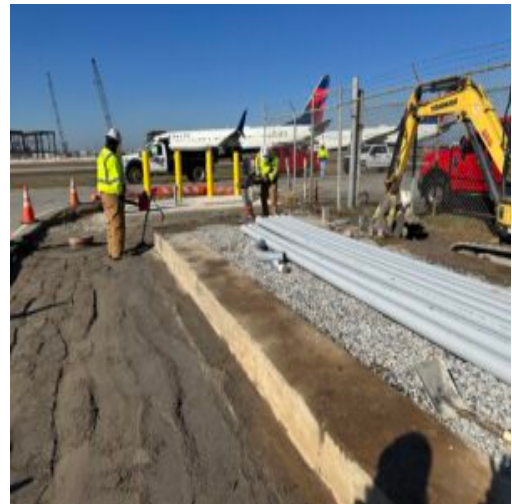
A request was made for M10 sand density testing at vault #3, located next to the fire station. A Troxler 3430 (serial #38069) was utilized for testing, with QA and ATLNext personnel present on-site.

- Test #1:
  - Dry Density: 114.1 DD
  - Moisture: 6.9% (fail)
  - Recommendation: Additional water and compaction
  - Retest #1:
    - Dry Density: 117.6 DD
    - Moisture: 9.0% (fail)

- Test #1:
  - Dry Density: 113.6 DD
  - Moisture: 7.1% (fail)
  - Recommendation: Add water and recompact
  - Retest #1:
    - Dry Density: 117.8 DD
    - Moisture: 6.5% (pass)

- Test #1:
  - Dry Density: 118 DD
  - Moisture: 4.9% (pass)
