Date : 06/05/2023  
Project No : 2023C144  
Client Company : CCG  
Arrival Time : 06/05/2023 08:00  
Onsite Hours : 08:00

ASEC Report ID : 59657  
Name of the Project : Carodel Farms @ Union Church Rd  
Project Location : Flowery Branch  
Weather : sunny  
Departure Time : 06/05/2023 16:  
ASEC Technician Name : Vidal Shengan

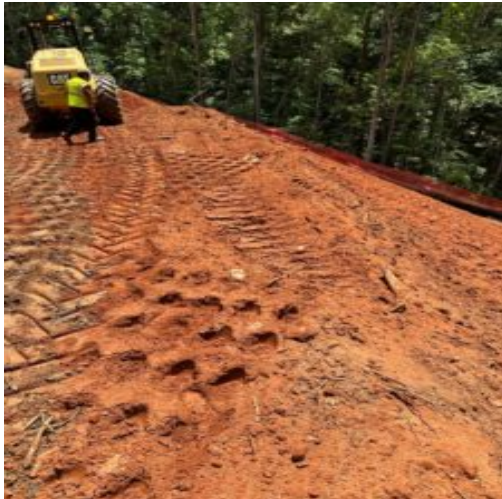
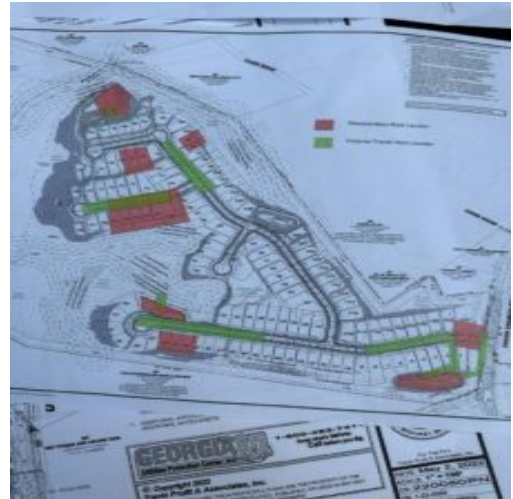
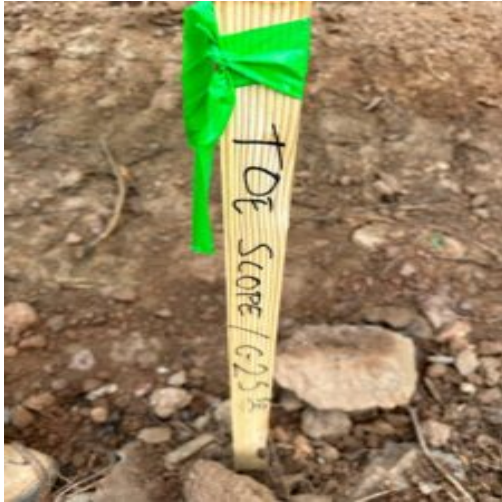
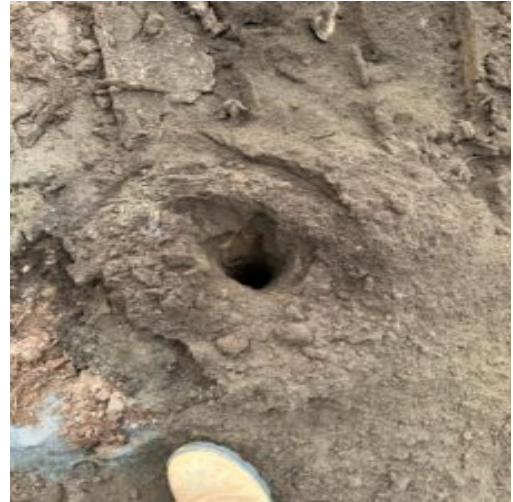
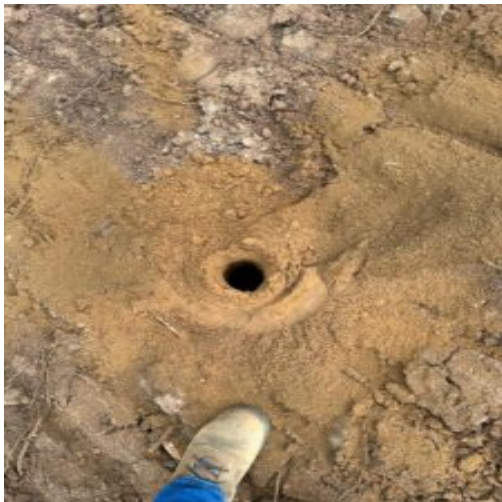
The placement and compaction of backfill soils for Wall A. The contractor used a CP56B CAT to compact the backfill materials.

Our representative also observed the contractor drilling 15 locations of potential rock for Detention Pond 1.

The drilling equipment used was identified as a MPS SANDVIK 101- 82.
