Date : 07/07/2023  
Project No : 2023C144  
Client Company : CCG  
Arrival Time : 07/07/2023 08:00  
Onsite Hours : 08:00

ASEC Report ID : 60117  
Name of the Project : Carodel Farms @ Union Church Rd  
Project Location : Flowery Branch  
Weather : Cloudy  
Departure Time : 07/07/2023 16:00  
ASEC Technician Name : Vidal Shengan

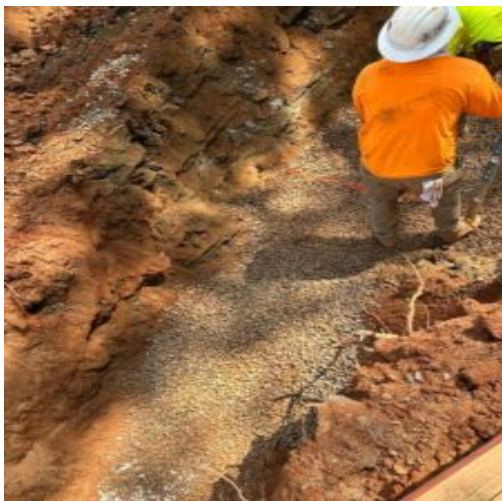
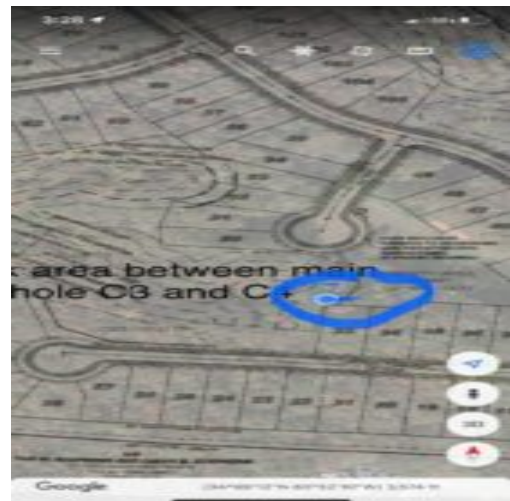
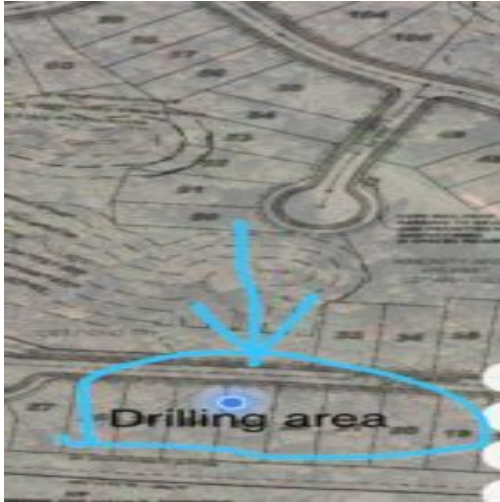
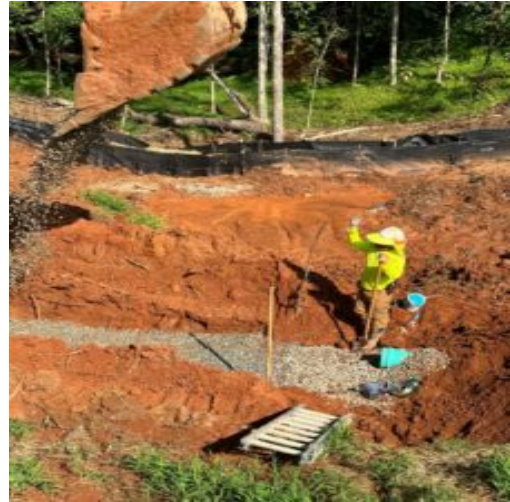
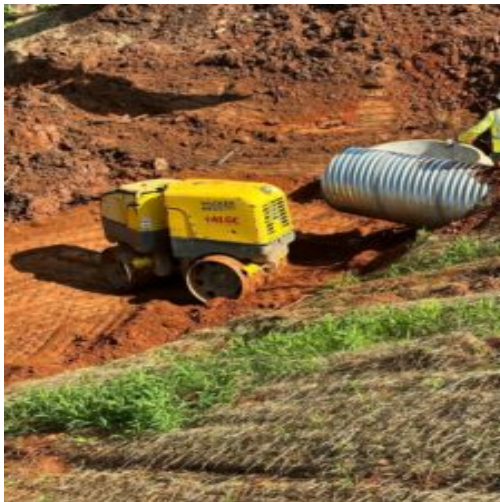
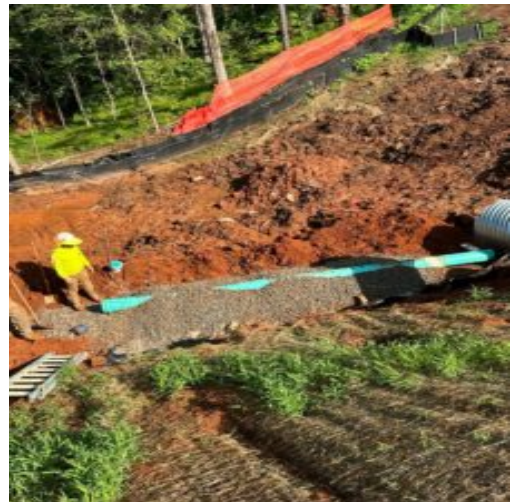
1. Fill Placement: The contractor continued to place and compact fill within the designated area, as previously identified on sheet C 0.1. I visually inspected the placement and compaction activities and determined them to be in compliance with project requirements. No issues were noted during the observation.

2. HDPE Pipe Installation and manhole: The contractor has installed manhole C4 and HDPE (High-Density Polyethylene) pipe, in accordance with the specifications outlined on sheet number C13.10. I visually inspected the installation and confirmed that it was executed in accordance with the project requirements. No deviations or concerns were observed during the inspection.

3. Rock Volume Determination: Rock volume determination was conducted by drilling 26 holes on-site. Data was received from Driller 1 for all 26 holes. However, Driller 2 did not record data for their 8 holes. In order to ensure data completeness, I recorded the data for Driller 2's 8 holes. The collected data will be analyzed and processed by the geotechnical team to calculate the rock volume; they explode the entire area they drilled before yesterday, yesterday and today total of holes drilled on this area was 152 holes and the area was 9728 feet<sup>2</sup>.
