ASEC Report ID : 60282  
Name of the Project : Carodel Farms @ Union Church Rd  
Project Location : Flowery Branch  
Weather : Partly Cloudy  
Departure Time : 07/15/2023 15:00  
ASEC Technician Name : Vidal Dias

**\*\*Carodel Farms Geotechnical Field Report - Friday\*\***

Date: July 14, 2023

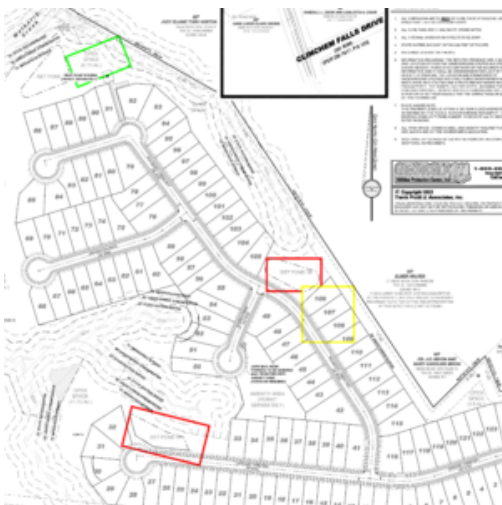
- Excavation of the areas designated for Detention Pond 1A and 1B continued on Friday.
- The ALGC removed rocks from Pond 1A.
- The removed rocks were placed in fill areas shown in yellow on the attached drawing.
