Date : 07/10/2023  
Project No : 2023C144  
Client Company : CCG  
Arrival Time : 07/10/2023 09:00  
Onsite Hours : 06:30

ASEC Report ID : 60226  
Name of the Project : Carodel Farms @ Union Church Rd  
Project Location : Flowery Branch  
Weather : Cloudy  
Departure Time : 07/10/2023 15:30  
ASEC Technician Name : Vidal Shengan

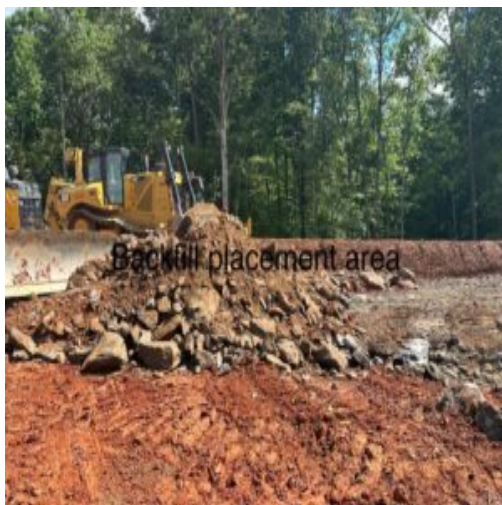
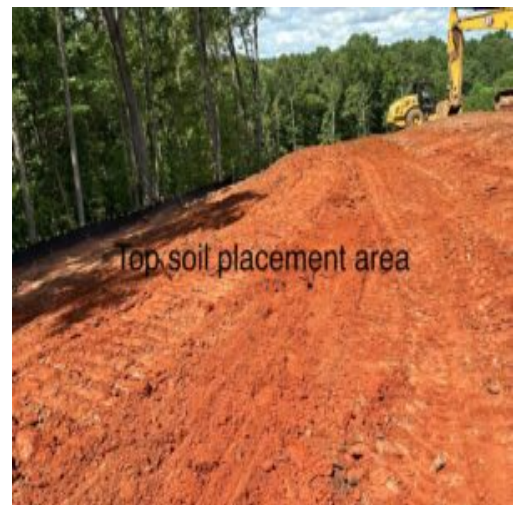
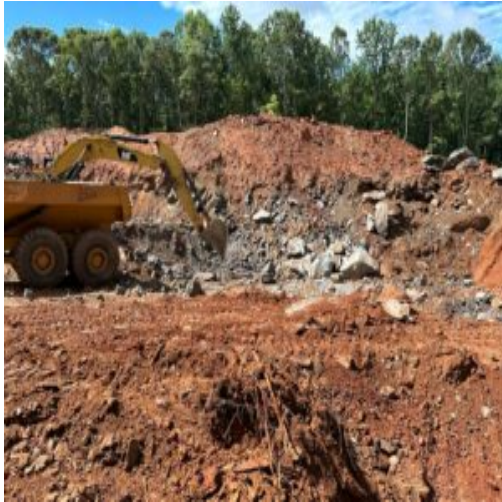
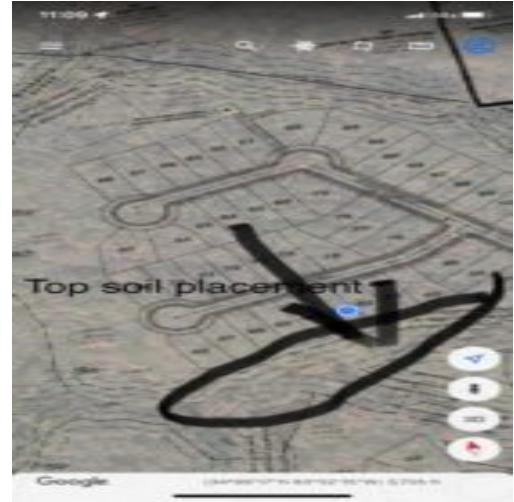
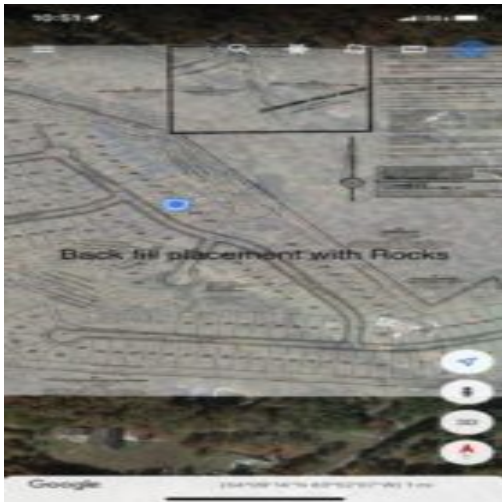
1. Backfill placement continued this day: The contractor continued to place and compact topsoil within the designated area and placed backfill soils mixed with big rocks on Lots #95 to 105 to depths of 8 feet below finished grade. We visually inspected the placement and compaction results were determined be in compliance with project requirements.
2. Manhole and pipe installation: Contractor did not install any piping this day.
3. Rock Volume Determination: Rock drilling and quantifying was not performed this day.
