Date : 07/26/2023  
Project No : 2023C144  
Client Company : CCG  
Arrival Time : 07/26/2023 08:30  
Onsite Hours : 9:30

ASEC Report ID : 60526  
Name of the Project : Carodel Farms @ Union Church Rd  
Project Location : Flowery Branch  
Weather : Cloudy  
Departure Time : 07/26/2023 18:00  
ASEC Technician Name : Vidal Shengan

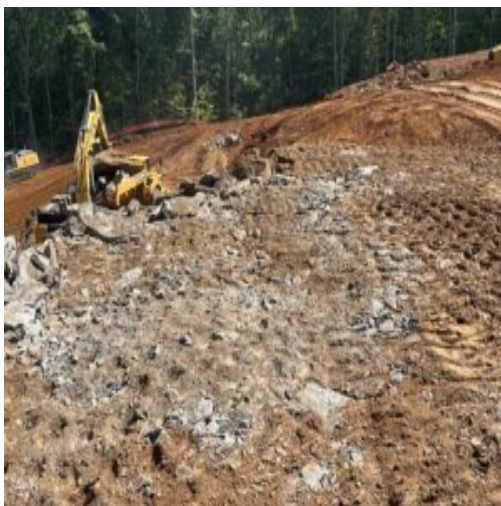
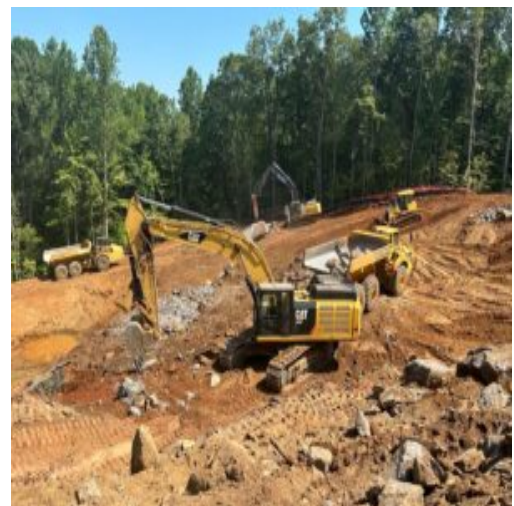
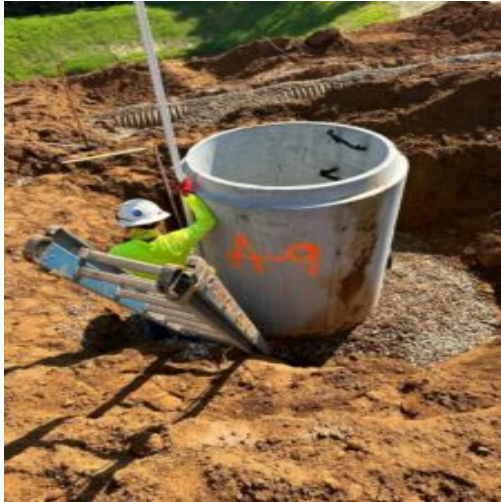
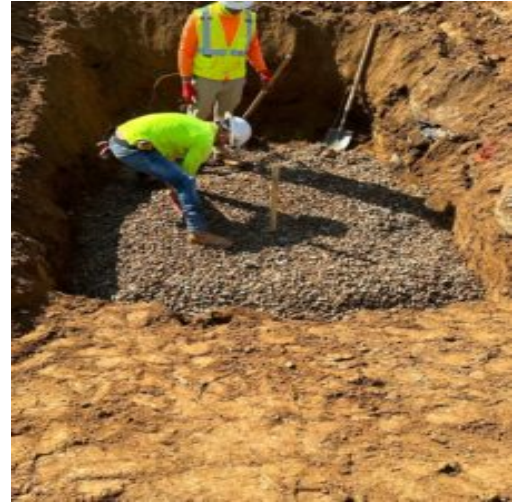
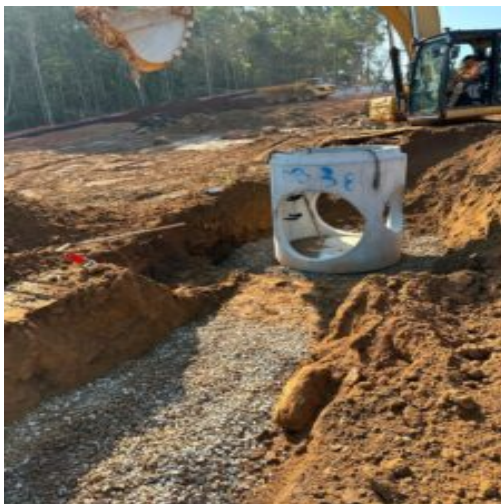
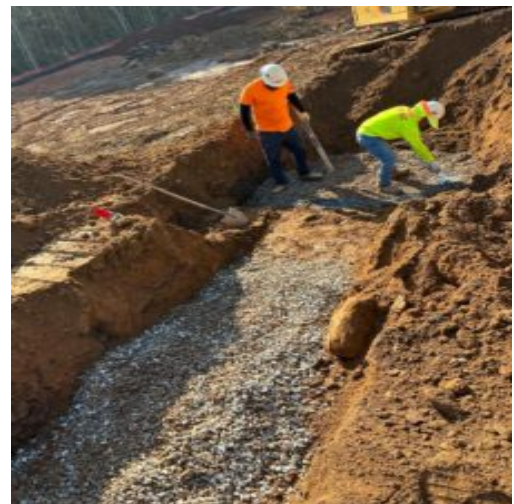
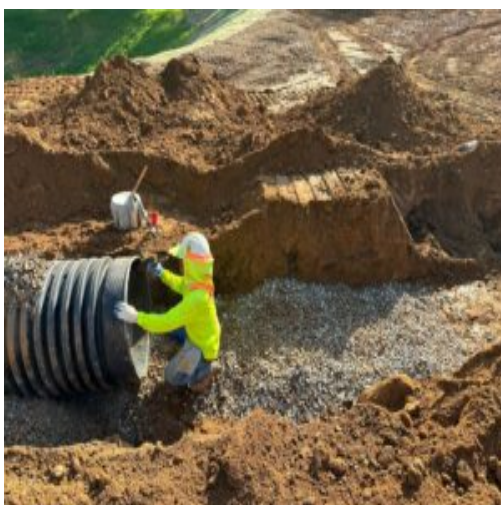
1. Installation of manhole: contractor installed manhole CB 38 and manhole A-9. The quality control representative visually inspected the installation and verified that it met the project requirements for installation. A placement of the 4 inches of stone at the bottom subgrade was observed.

2. Installation of HDPE Pipe: Between manhole 37 and 38, A-9 and A-10 contractor installed HDPE (High-Density Polyethylene) pipe. Before placing the pipes, the contractor prepared the bottom with 4 inches of stone and also covered the pipes with a 4-inch stone layer. The quality control representative visually assessed the installation and confirmed that it was executed according to the project specifications. Sheet no: c11.1

3. Backfilling Operations: Contractor backfilled soils in Detention Pond 1C. The quality control representative visually inspected the backfilling operations and confirmed that they were performed in accordance with project requirements. Drilling and blasting of Rock: The driller continued rock blasting in the areas where drilling had been performed on Monday and Tuesday. The quality control representative observed the blasting operations and noted that they were carried out safely and in compliance with applicable safety protocols. No incidents or concerns were observed during the blasting process.
