Date : 07/19/2023  
Project No : 2023C144  
Client Company : CCG  
Arrival Time : 07/19/2023 08:30  
Onsite Hours : 10:00

ASEC Report ID : 60389  
Name of the Project : Carodel Farms @ Union Church Rd  
Project Location : Flowery Branch  
Weather : Cloudy  
Departure Time : 07/19/2023 18:30  
ASEC Technician Name : Vidal Shengan

Our AS Engineering and Consulting (ASEC) representative visited the Carodel Farms site to conduct quality control inspection and testing services. Visual observation techniques were employed to ensure compliance with project drawing/specifications, applicable codes, and materials submittals. The following observations were made on-site:

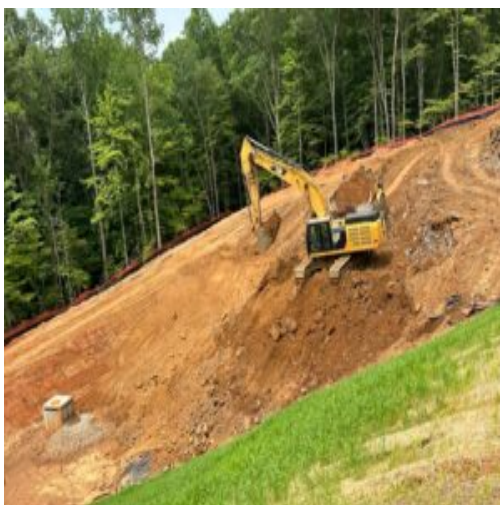
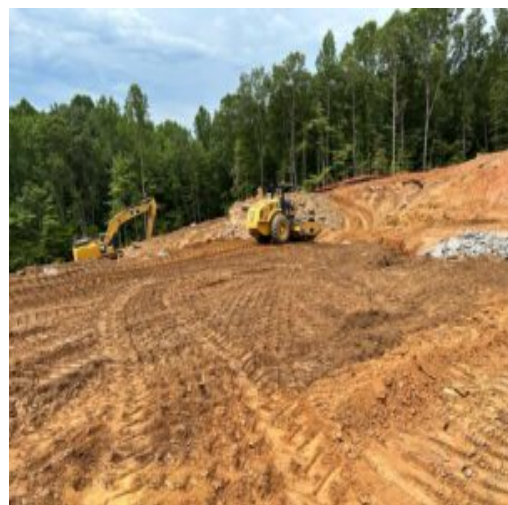
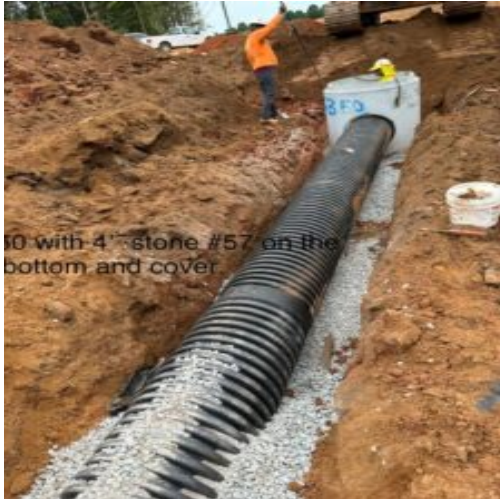
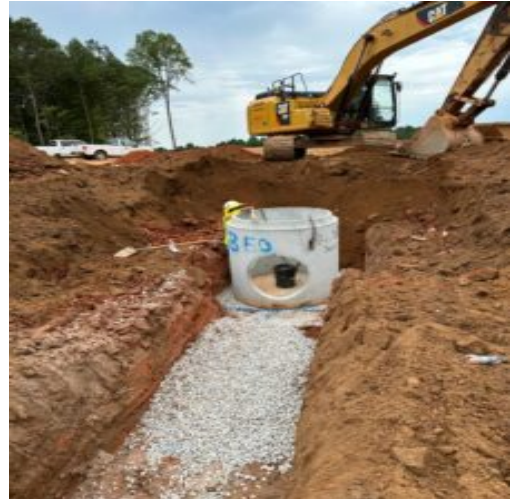
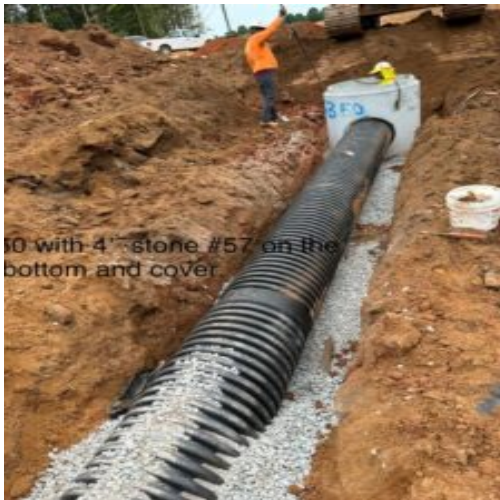
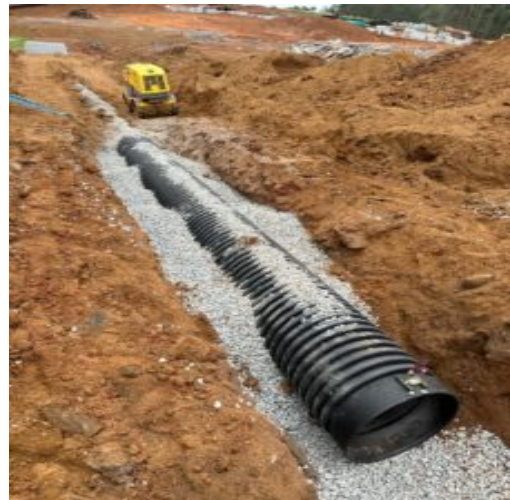
1. Installation of manhole 50: The contractor installed manhole 50 with 4 inches of #57 stone placed at the bottom before placing the manhole. The quality control representative visually inspected the installation and verified that it met the project requirements.

2. Installation of HDPE Pipe: Between manhole 50 and manhole 37, the contractor installed HDPE (High-Density Polyethylene) pipe. Before placing the pipes, the contractor prepared the bottom with 4 inches of #57 stone and also covered the pipes with 4 inches of stone. The quality control representative visually assessed the installation and confirmed that it was executed according to the project specifications.

3. Backfilling Operations: The contractor placed backfill for Detention Pond 1C and Detention Pond 1B. The quality control representative visually inspected the backfilling operations in accordance with project requirements.

4. Drilling Operations: Driller 1 drilled a total of 60 holes with a drilled area of 2,940 cubic feet. The hole spacing length was 7 feet by 7 feet, and the hole diameter was 4 inches. Driller 2 drilled 18 holes with a drilled area of 882 cubic feet. And performed some rock tests on Lots #62 to 72.
