Date : 07/31/2023  
Project No : 2023C144  
Client Company : CCG  
Arrival Time : 07/31/2023 08:00  
Onsite Hours : 10:00

ASEC Report ID : 60638  
Name of the Project : Carodel Farms @ Union Church Rd  
Project Location : Flowery Branch  
Weather : Cloudy  
Departure Time : 07/31/2023 18:00  
ASEC Technician Name : Vidal Shengan

Our AS Engineering and Consulting (ASEC) representative visited the Carodel Farms site to conduct quality control inspection and testing services. Visual observation techniques were employed to ensure compliance with project drawing/specifications, applicable codes, and materials submittals. The following observations were made on-site:

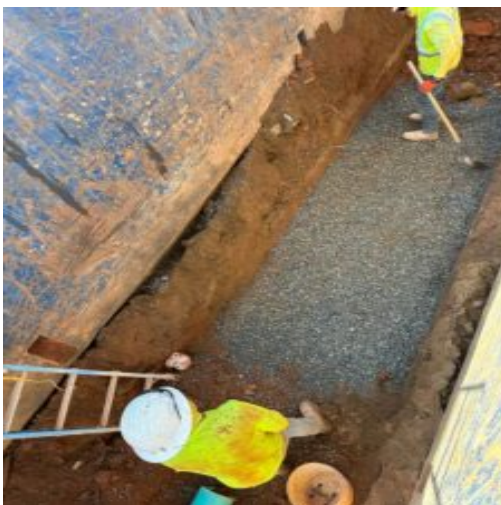
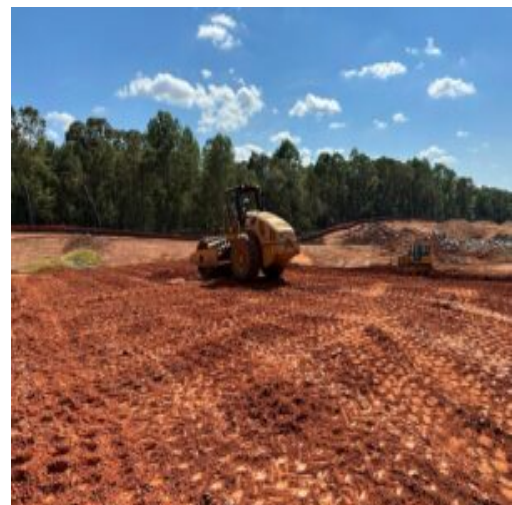
1. Installation of manhole A-8: The contractor installed manhole A-8 with 4 inches of #57 stone placed at the base prior to placing the manhole. The quality control representative visually inspected the installation and verified that it met the project requirements (Sheet no C6.2).

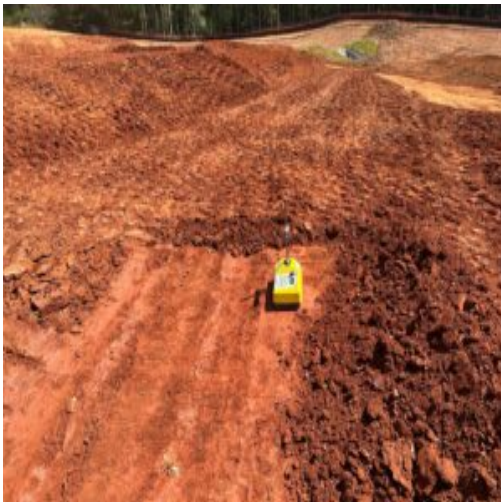
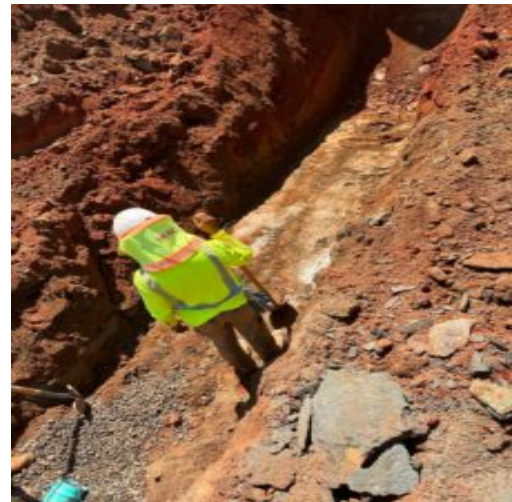
3. Backfilling Operations: The contractor placed backfill in the open space zone x and for Lots #37,38,39,40 and 41. Density testing was performed for fill placed on Lots #39,40,41, at 1 foot below finished grade. Soils were compacted using a CP56 compactor. Testing results indicated that the compaction met the project requirements of 92% of maximum dry density obtained by the ASTM D698-12 standard method. (Test 1; WD:111.2, DD:86.3, M%:28.9) (Test 2 WD:117.1, DD:92.2, M%:27.0), (Test 3 WD:111.1, DD:91.1, M%:21.9).
