Date : 07/27/2023  
Project No : 2023C144  
Client Company : CCG  
Arrival Time : 07/27/2023 08:30  
Onsite Hours : 9:00

ASEC Report ID : 60573  
Name of the Project : Carodel Farms @ Union Church Rd  
Project Location : Flowery Branch  
Weather : Cloudy  
Departure Time : 07/27/2023 17:30  
ASEC Technician Name : Vidal Shengan

On 7-27-2023, the AS Engineering and Consulting (ASEC) representative visited the Carodel Farms site to conduct quality control inspection and testing services. Visual observation techniques were employed to ensure compliance with project drawing/specifications, applicable codes, and materials submittals. The following observations were made on-site:

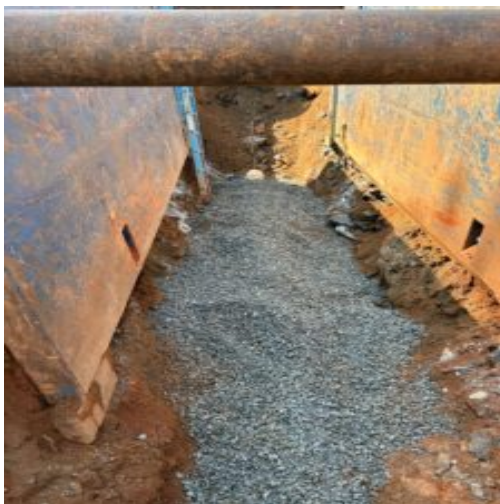
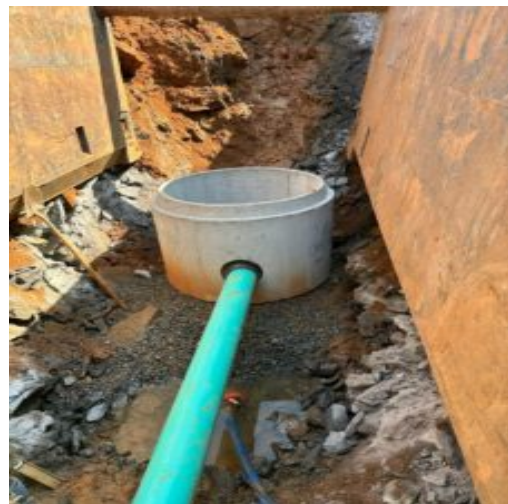
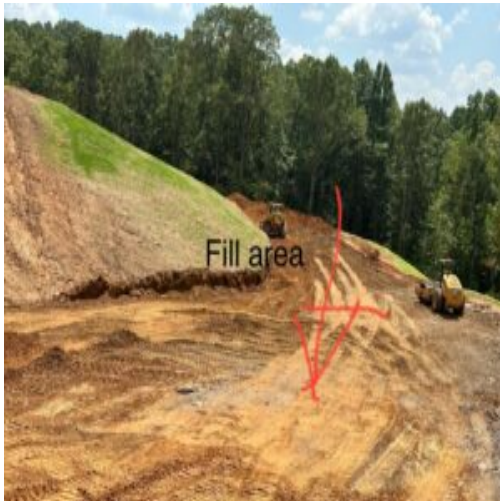
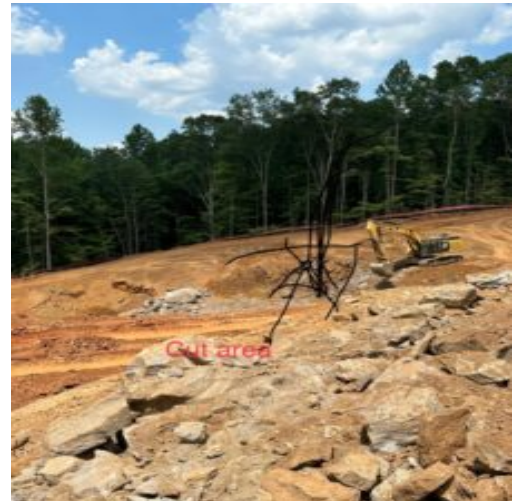
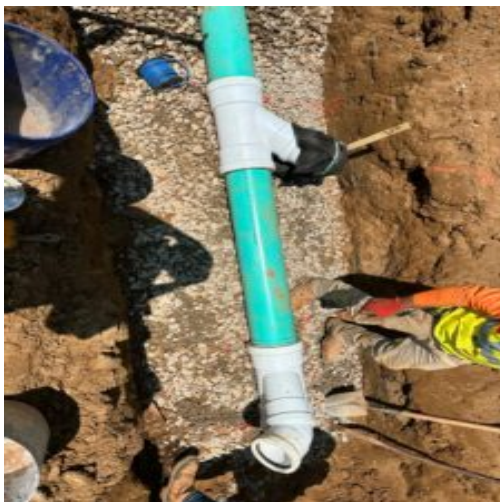
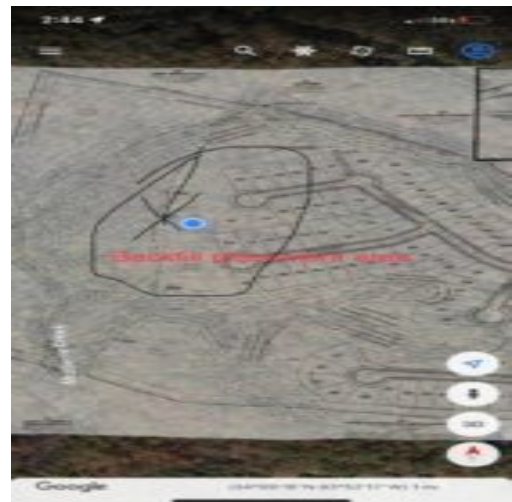
1. Installation of Manhole C-5: The contractor installed Manhole C-5 with 4" stone (057) at the bottom before placing the manhole. The quality control representative visually inspected the installation and verified that the subgrade soils were suitable for placement.

2. Installation of HDPE Pipe: Between Manhole C-5 and Manhole C-4, contractor installed HDPE (High-Density Polyethylene) pipe. Before placing the pipes, the contractor prepared the bottom with 4" stone and also covered the pipes with 4" stone. The quality control representative visually assessed the installation and confirmed that it was performed according to the project specifications.

3. Backfilling Operations: The contractor placed backfill soil in Detention Pond 1C and open space zone x. The quality control representative visually observed the backfilling operations.

4. Drilling Operations: Driller 1 drilled a total of 46 holes with a drilled area of 2352 cubic feet. The hole spacing length was 7 feet by 7 feet, and the hole diameter was 3.5 inches.
