Date : 08/01/2023  
Project No : 2023C144  
Client Company : CCG  
Arrival Time : 08/01/2023 08:30  
Onsite Hours : 08:30

ASEC Report ID : 60724  
Name of the Project : Carodel Farms @ Union Church Rd  
Project Location : Flowery Branch  
Weather : Cloudy  
Departure Time : 08/01/2023 17:00  
ASEC Technician Name : Vidal Shengan

On 08-01-2023, the AS Engineering and Consulting (ASEC) representative visited the Carodel Farms site to conduct quality control inspection and testing services. Visual observation techniques were employed to ensure compliance with project drawing/specifications, applicable codes, and materials submittals. The following observations were made on-site:

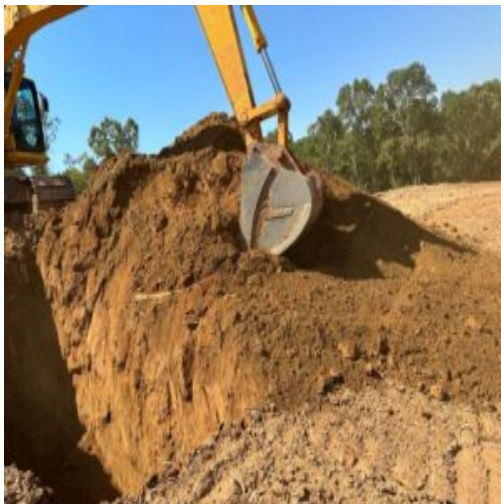
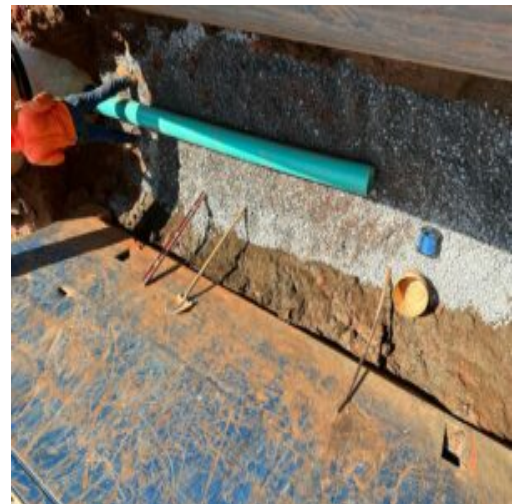
1. Installation of Manhole A-9: The contractor installed Manhole A-9 with 4" stone (057) at the bottom before placing the manhole. The quality control representative visually inspected the installation and noted that it met the project requirements.

2. Installation of HDPE Pipe: Between Manhole A-8 and Manhole A-9, the contractor installed HDPE (High-Density Polyethylene) pipe. Before placing the pipes, the contractor prepared the bottom with 4" stone and also covered the pipes with 4" stone. The quality control representative visually assessed the installation and confirmed that it was performed according to the project specifications.

3. Drilling Operations: We recommended to the contractor to do excavate a few pit tests on Lots 60 through 68 near the road to determine the exact mass of rocks in this area so as not to let the driller do unnecessary work and save time. No appreciable rock was encountered in these areas. Contractor then began to lay pipe within the street.
