Date : 08/25/2023  
Project No : 2023C144  
Client Company : CCG  
Arrival Time : 08/25/2023 10:00  
Onsite Hours : 04:00

ASEC Report ID : 61158  
Name of the Project : Carodel Farms @ Union Church Rd  
Project Location : Flowery Branch  
Weather : Sunny  
Departure Time : 08/25/2023 14:00  
ASEC Technician Name : Vidal Dias

On August 25th, an ASEC representative was present on-site to observe the contractor's field activities related to the construction of Retaining Wall B. The primary objective was to visually assess the work in progress, verifying with the Project Plans, Specifications, Codes and Standards, and Material Submittals.

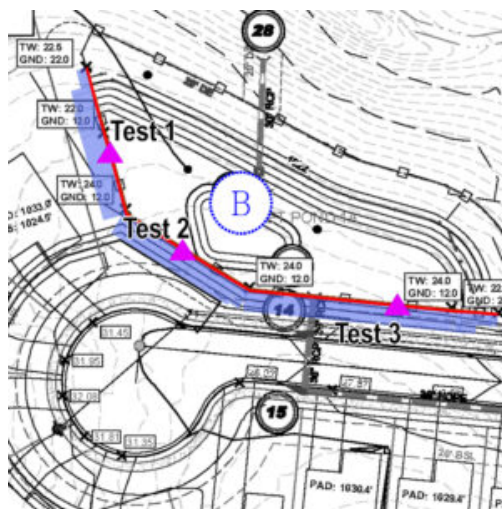
- The contractor was actively engaged in compacting fill for Wall B, verifying it reached the specified

elevation as per the project plans. The work was observed to be in line with the job specifications.
