Date : 08/16/2023  
Project No : 2023C144  
Client Company : CCG  
Arrival Time : 08/16/2023 10:00  
Onsite Hours : 04:00

ASEC Report ID : 61164  
Name of the Project : Carodel Farms @ Union Church Rd  
Project Location : Flowery Branch  
Weather : Sunny  
Departure Time : 08/16/2023 14:00  
ASEC Technician Name : Vidal Dias

On August 16th, 2023, an ASEC representative was present on-site to observe the contractor's field activities related to the proposed Wall A. The primary objective was to visually observe the work in progress, verifying alignment with the Project Plans, Specifications, Codes and Standards, and Material Submittals.

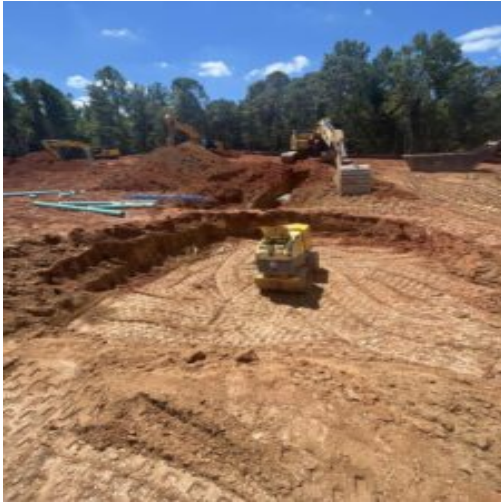
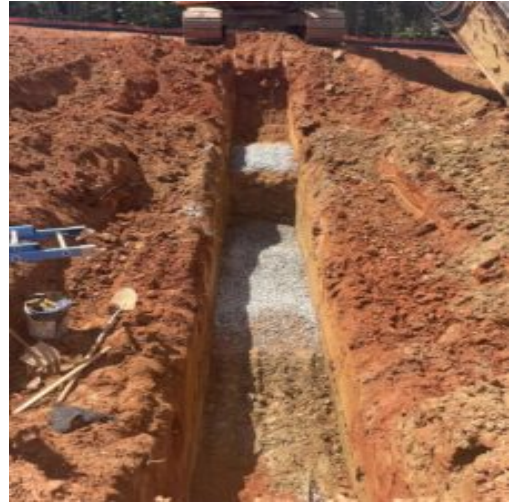
The excavation process for the proposed shallow footings revealed loose, wet, red tan micaceous silty fine sands. The DCP measurements suggest that the density and consistency of the subsurface soils are satisfactory to support the planned retaining wall, as detailed in the reference drawing on Sheet RW-4.0.

- The grading contractor was observed placing sewage pipe for lots numbered #33-37. The depth of the excavations was approximately 4 feet below the existing grade. Notably, no groundwater was detected in the utility trenches.
- The excavation process for Wall A footings was in progress. The contractor indicated that the footings would be excavated the subsequent day.

The subsurface conditions appear to be conducive for the construction of retaining Wall A footings. If the excavations become excessively wet or freeze before the concrete is placed, it's recommended to contact ASEC for a reevaluation of the site conditions. For any further queries or clarifications, please do not hesitate to get in touch directly.
