Date : 04/27/2026  
Project No : 2023C159  
Client Company : CW Matthews  
Arrival Time : 04/27/2026  
Onsite Hours : N/A

ASEC Report ID : 93765  
Name of the Project : Airfield Repairs 2021-23  
Project Location : HJAlA, Atlanta, GA  
Weather : overcast  
Departure Time : 04/27/2026  
ASEC Technician Name : Russell Hendrix

As requested, the site was visited by our AS Engineering and Consulting (ASEC) representative for the purpose of providing quality control inspection and testing services. Visual observation techniques were employed to verify compliance with project drawing/specifications, applicable codes, and materials submittals. The following observations were observed on site this day:

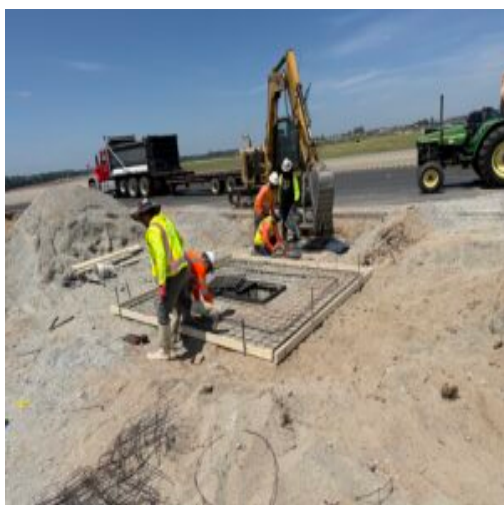
The area was prepared for sod placement, and sod was installed on the east side. Concrete was placed for a Type B drain collar. The collar form and rebar placement was observed by 2MNext and AtlNext. Topsoil was placed, and curb repairs were completed (see photos).

form/rebar collar area 1 observed by 2MNext and AtlNext before concrete placement.

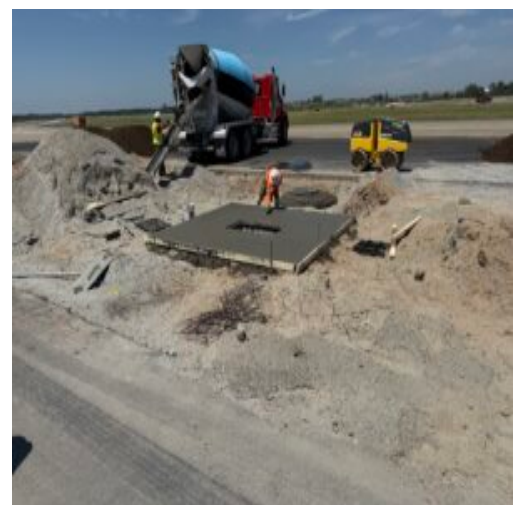
Placed concrete Collar area 1

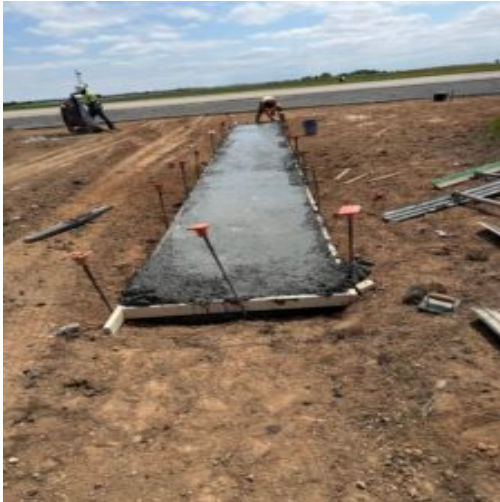
Flume

A flume and drain collar were formed, and concrete was placed. Concrete testing was performed (see testing report). All collars and the flume, including rebar placement, were observed by 2MNext and AtlNext prior to concrete placement.

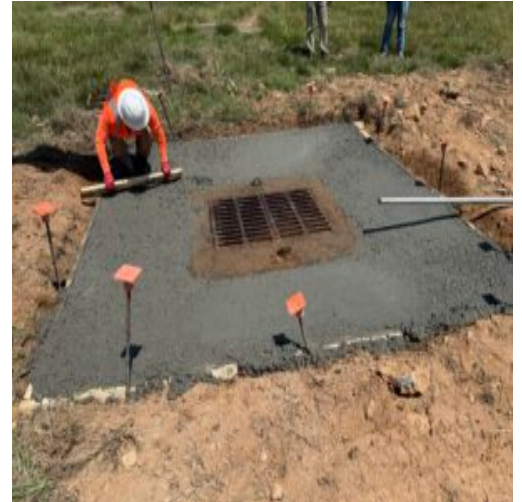
completing collar next to flume

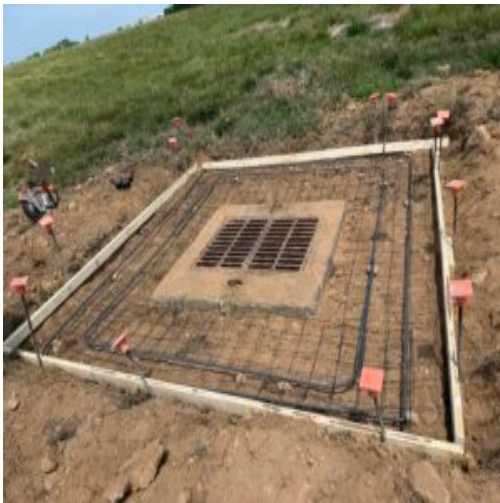
Formed/rebar Collar next to flume observed by 2MNext and AtlNext before concrete placement.

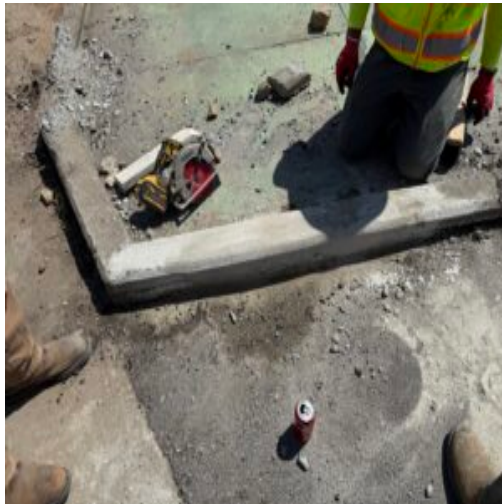
Curb repair area 1

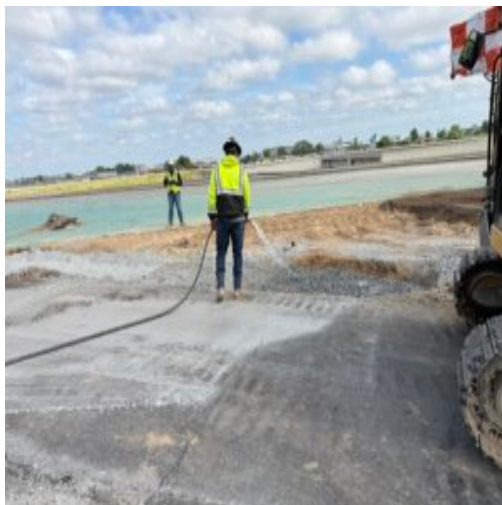
GAB was placed for the final lift, moisture-conditioned with added water, and compacted using a trench packer. Compaction testing of the GAB was completed (see testing report).

Adding water to GAB
